# **Fire and Seismic performances of Hybrid fire WALLs in case of single-storey industrial and commercial steel buildings (FISHWALL)**

## **Fire test report on fire wall connected to an unprotected steel structure by means of fusible links**

### **WP3: Fire behaviour of a hybrid fire wall solution associated with unprotected steel structure**

#### **Deliverable: D3.3**

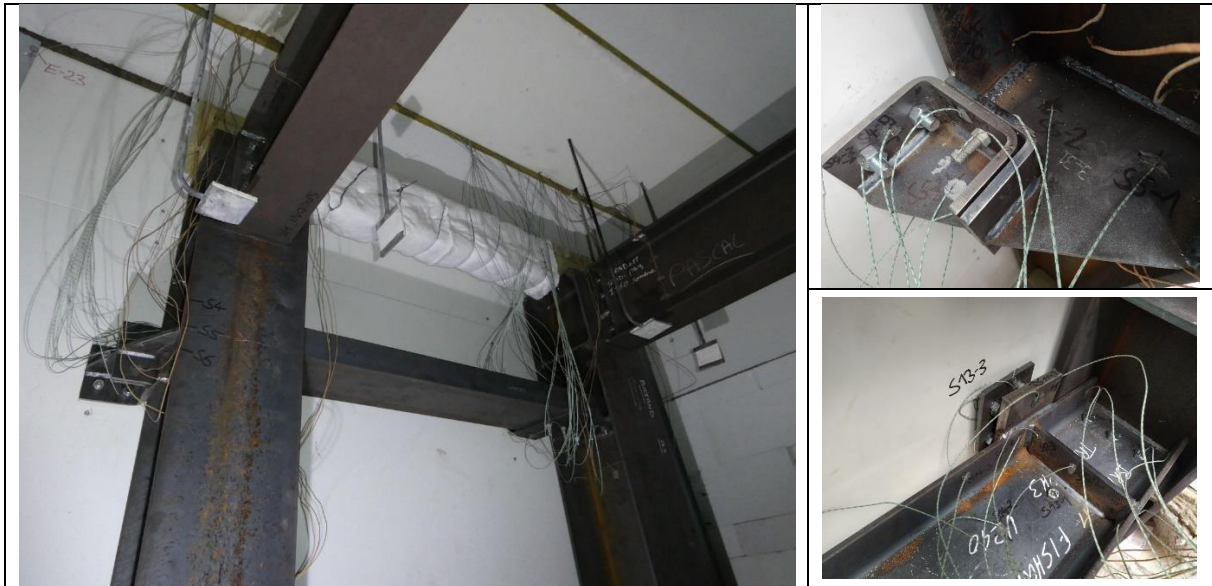
Figure 5: View of fusible systems inside the furnace

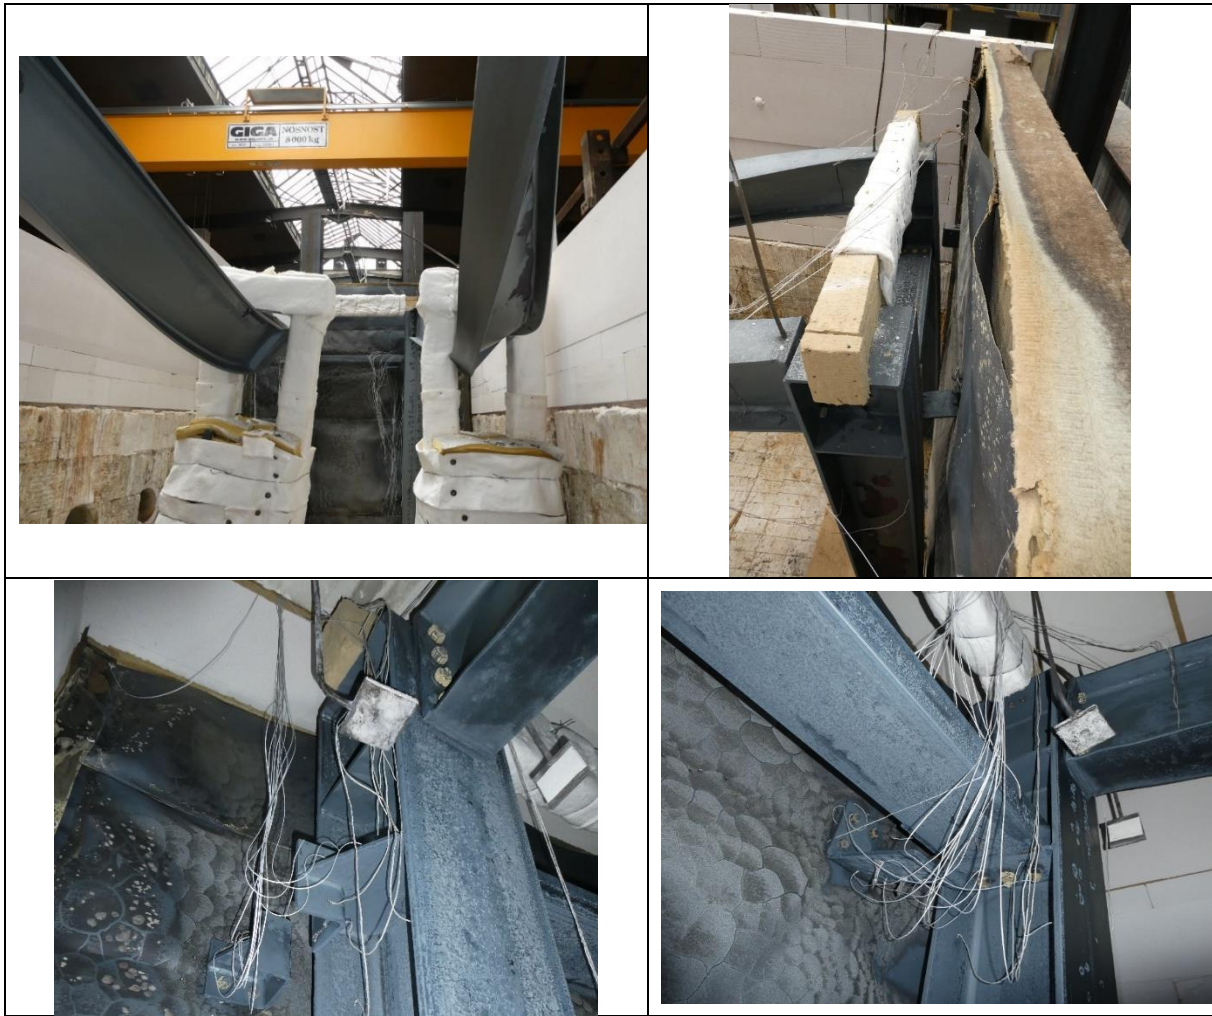
The results confirmed the appropriate fire behaviour of tested fusible system solutions, which allowed the wall to be disconnected from the steel portal frames exposed to fire without endangering the separating function of the wall, which remained fixed to the steel structure on the other side of the wall and therefore not exposed to fire (see Figure 14).

Figure 14: View of the test specimen after the test

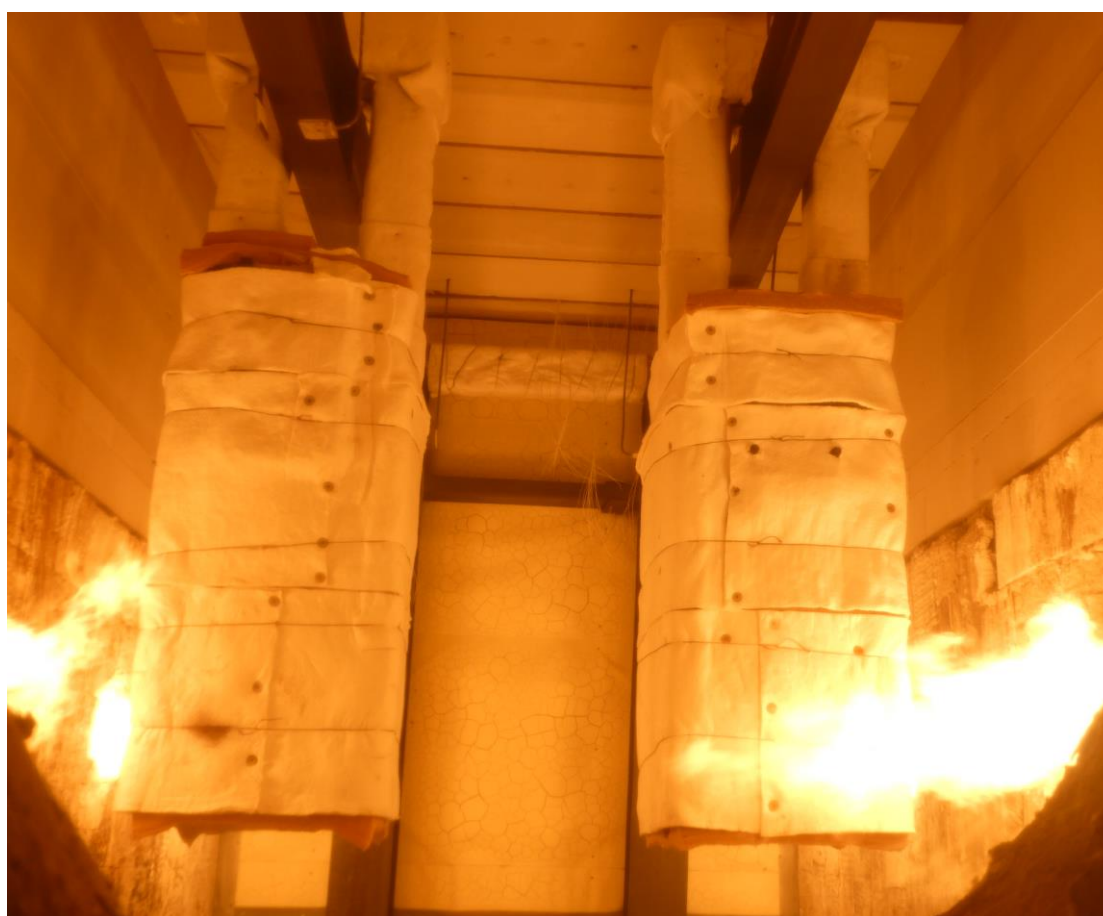
EF after 20 minutes of the test

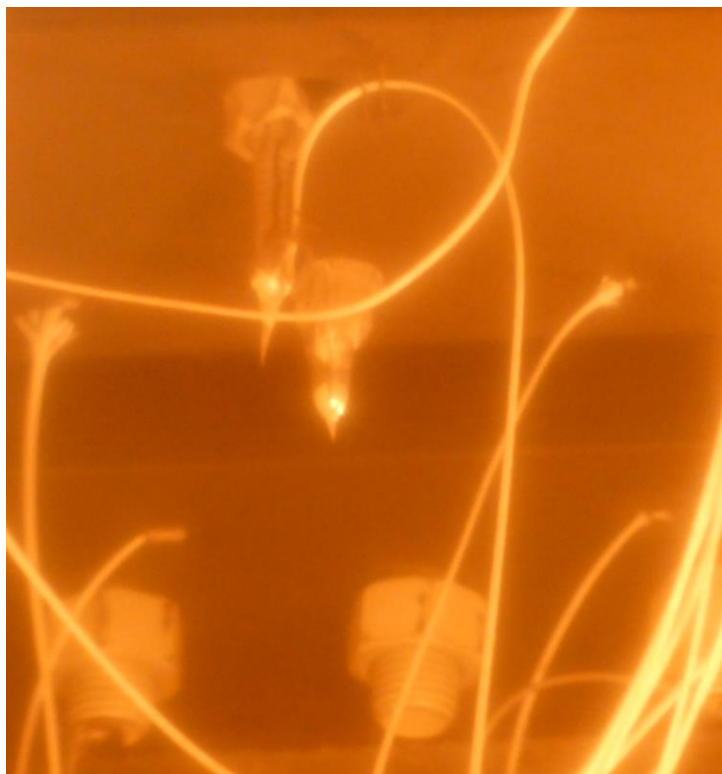
View of the fusible link No. 2 after 25 minutes of the test

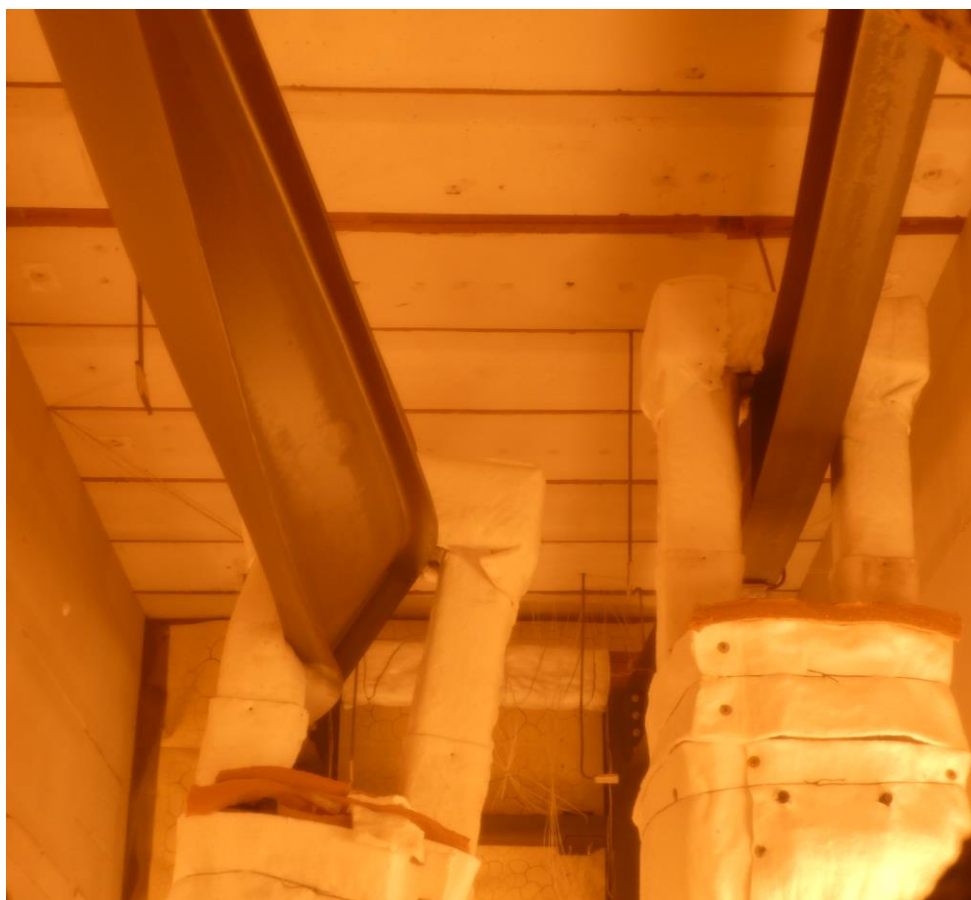
As expected, the steel frames failed due to the lateral torsional buckling of beams under the combined effect of the applied mechanical load and the temperature rise (see Figure 12). The collapse of steel frames was not simultaneous, with one frame failing before the other: after 27 and 29 minutes of standard fire exposure, respectively.

EF after 27 minutes of the test

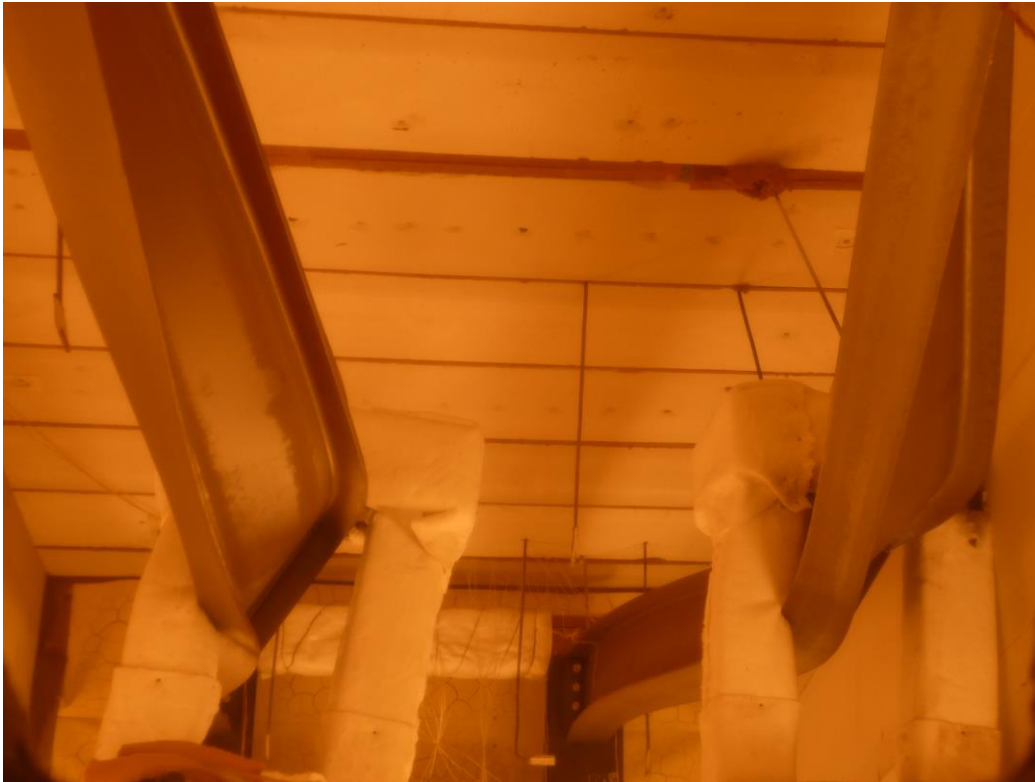
EF after 30 minutes of the test

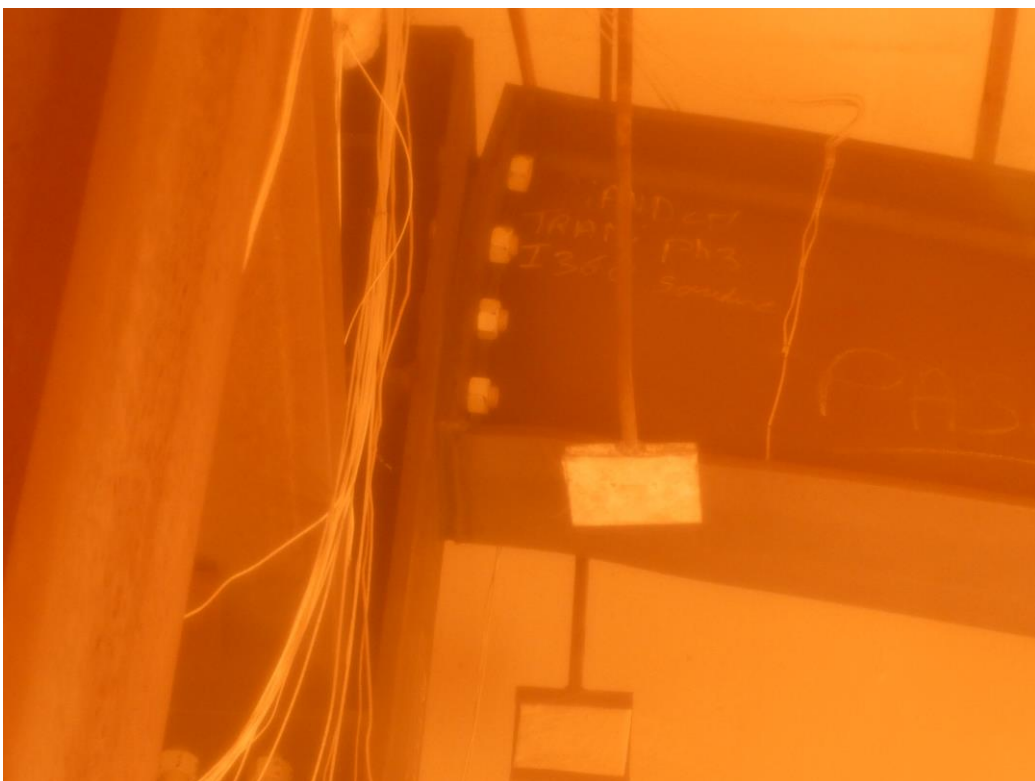
Detail of the beam to column connection of steel portal frame No. 2 after 32 minutes of the test

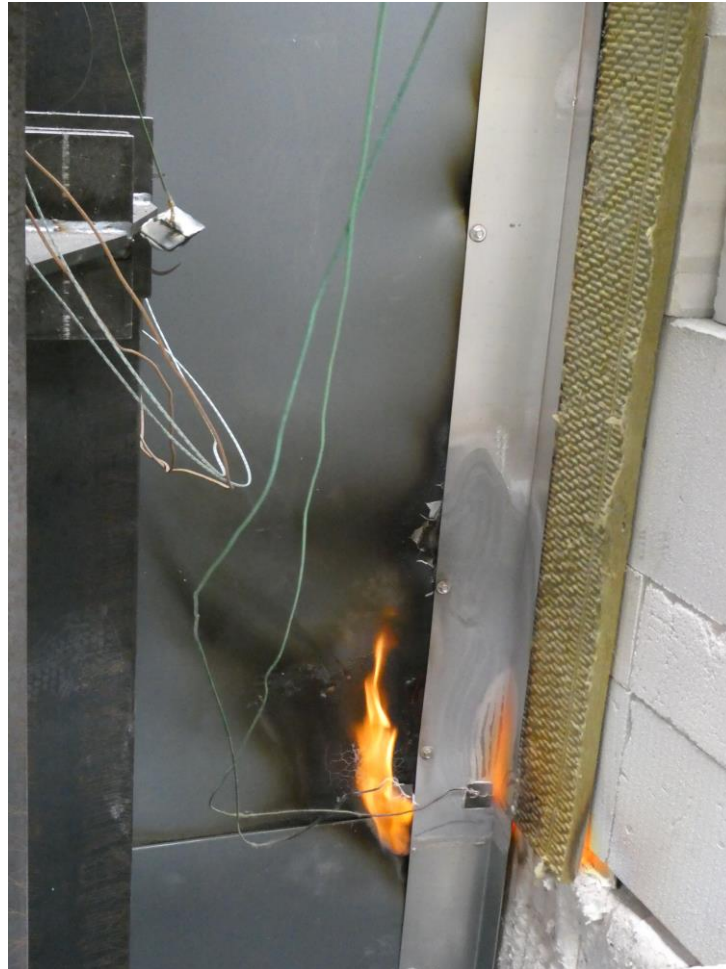
However, it should be noted that the temperature criteria related to the insulation performance of the wall was reached after 18 minutes only, on a thermocouple placed in the upper corner of the wall. At 69th minute of the test, there was also integrity loss of the wall due to sustained flaming in the half of the wall's height, on one vertical edge (see Figure 13). This is mainly because the steel flashings placed on the edges of the wall could not be fixed to the furnace walls, therefore the sandwich panels were on vertical sides without fixing.

Sustained flaming of the vertical edge of the wall from 69<sup>th</sup> minute of the test

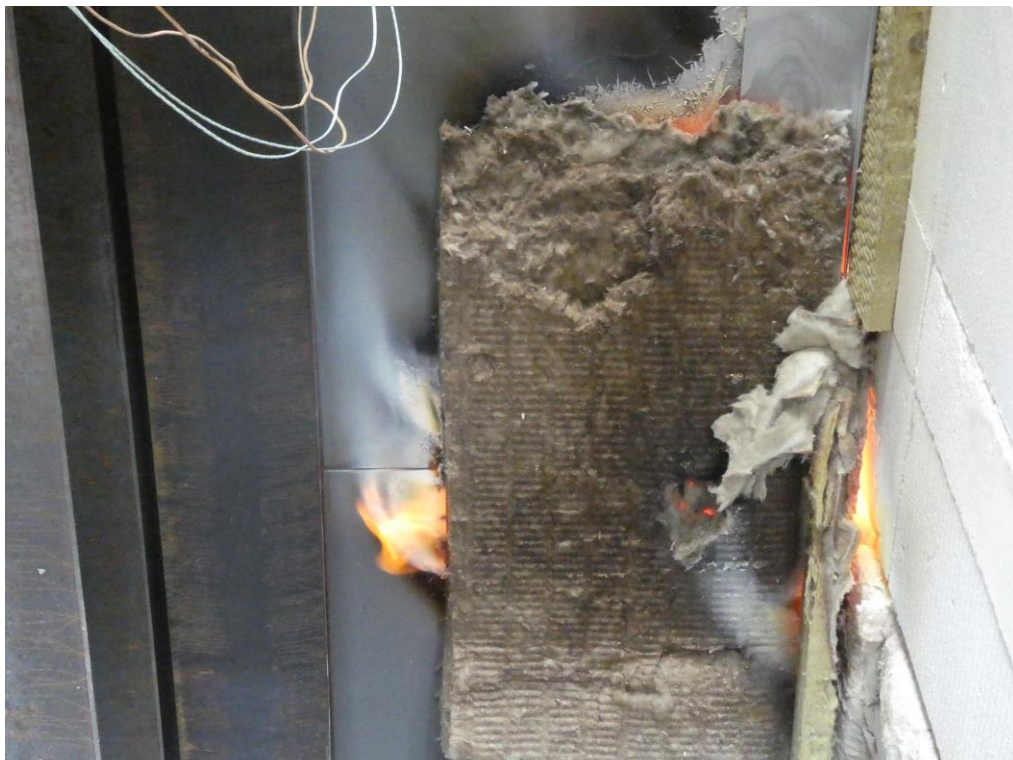
UF of the wall after 110 minutes of the test

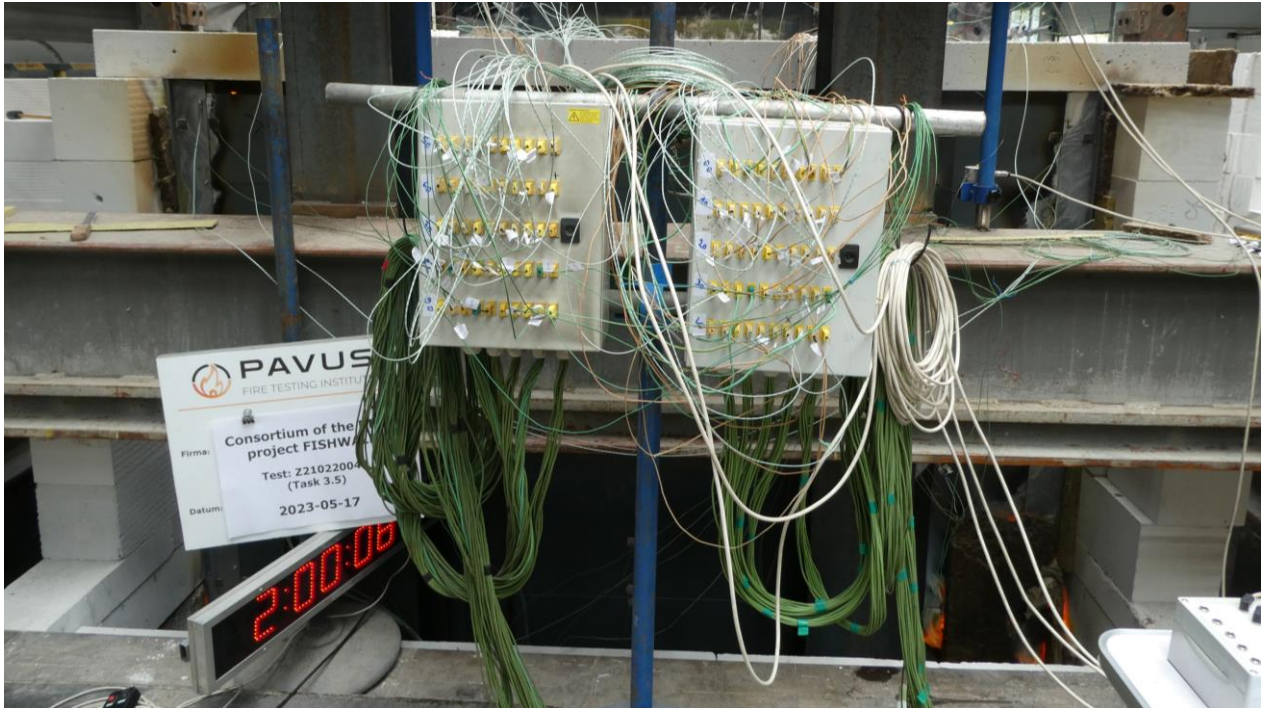
UF after 120 minutes of the test

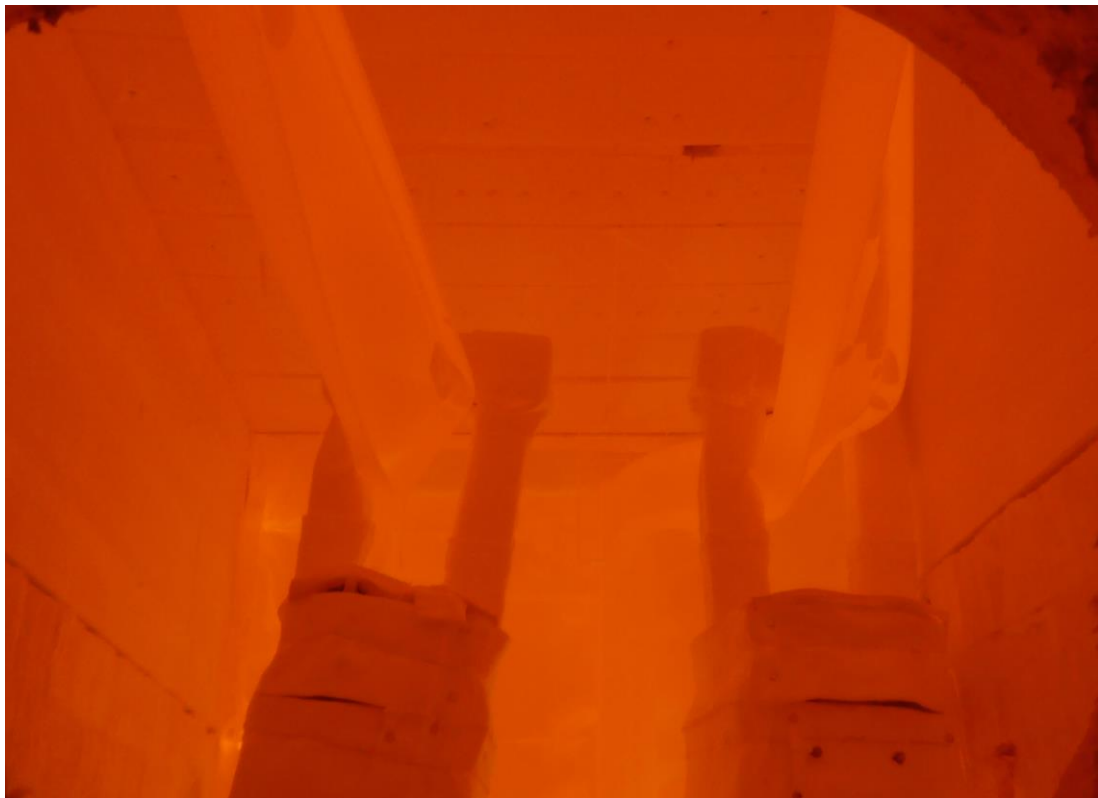
EF after 120 minutes of the test and turn off the burners

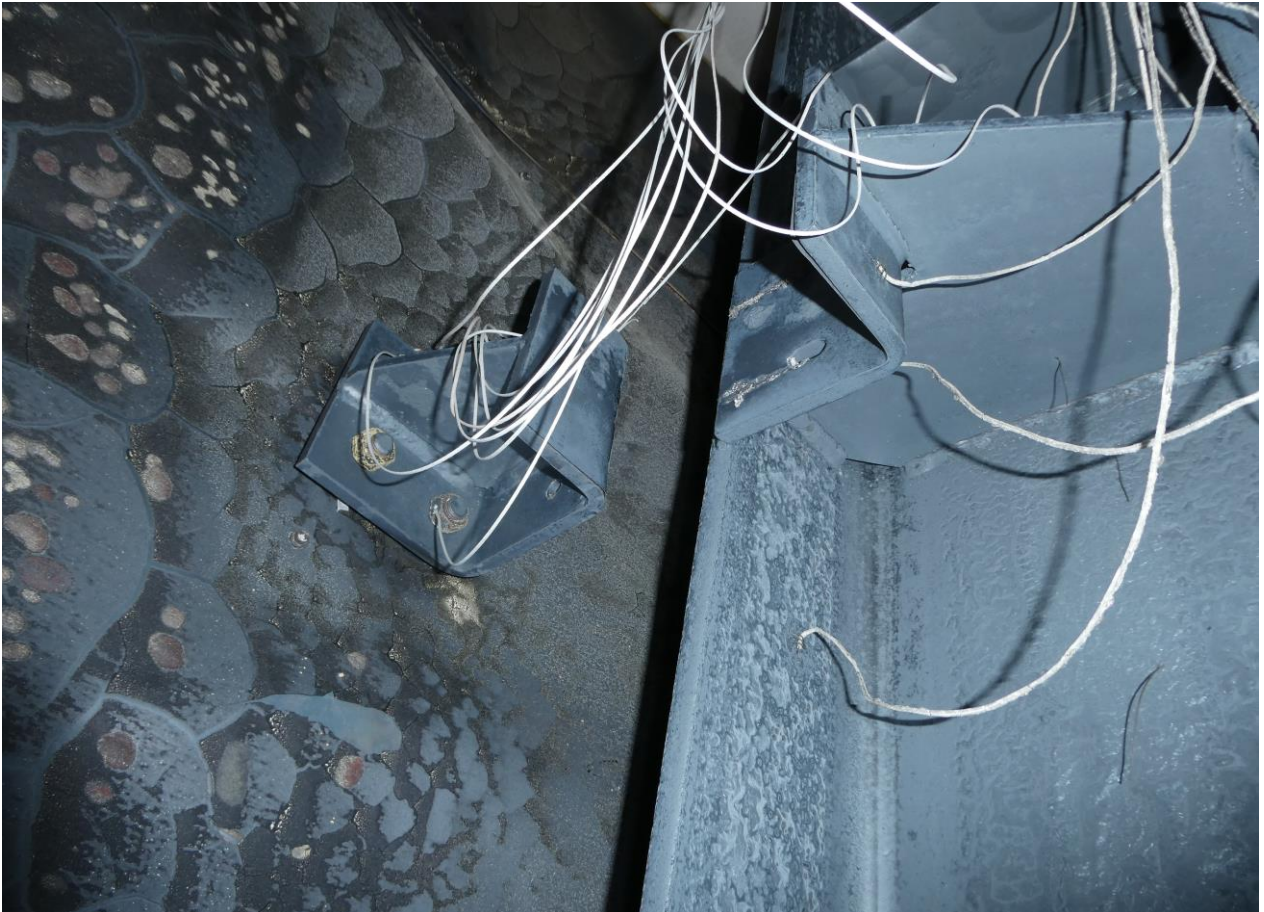
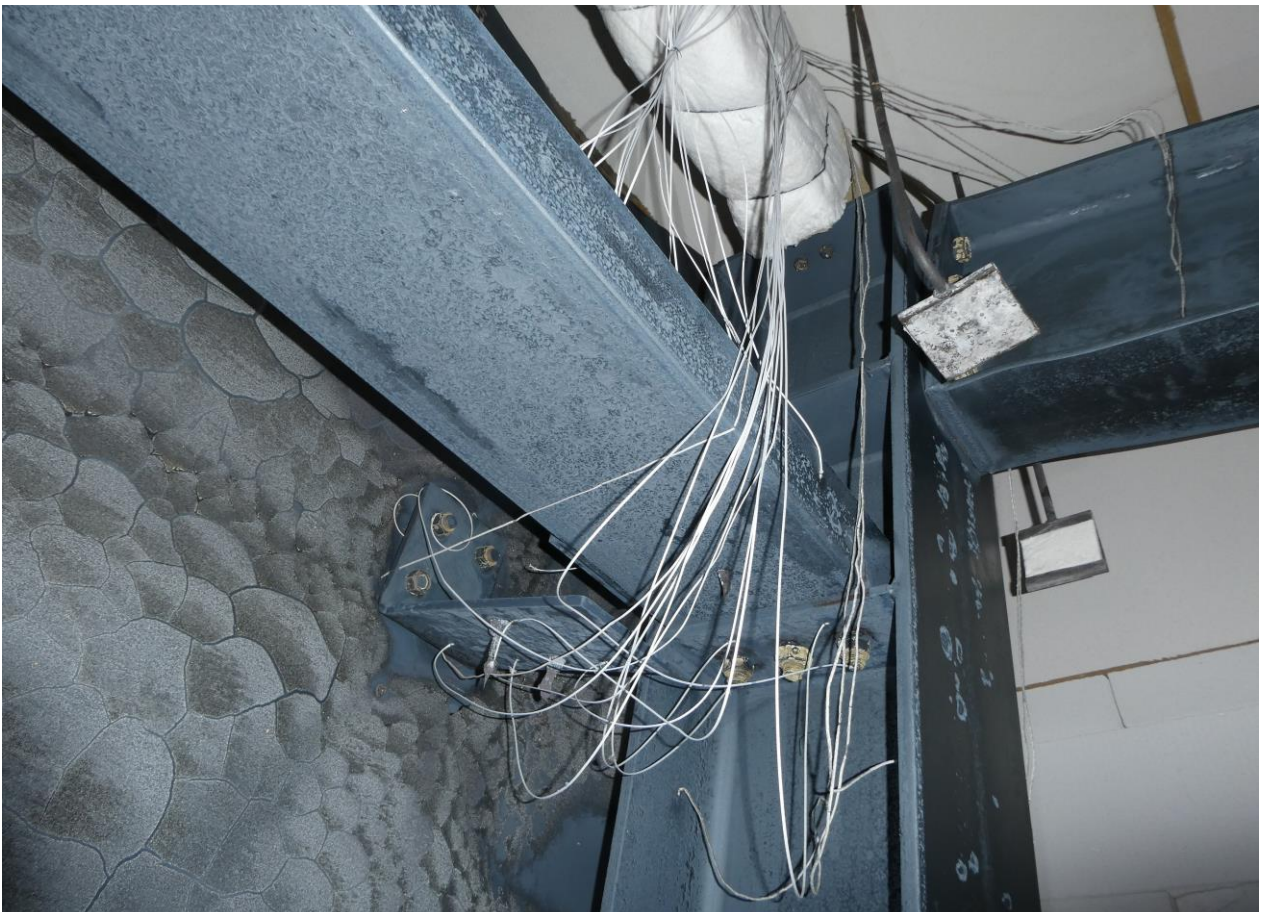
EF the second day after the test
