# FISHWALL

**Fire and Seismic performances of Hybrid fire WALLs in case of single-storey industrial and commercial steel buildings**

- **Title:** Sandwich panel fire wall with steel purlins penetration
- Jiri Vanek
- PAVUS, a.s.

**Fire wall connected to an unprotected steel  
structure and penetrated by steel purlins  
(Task 3.2)**

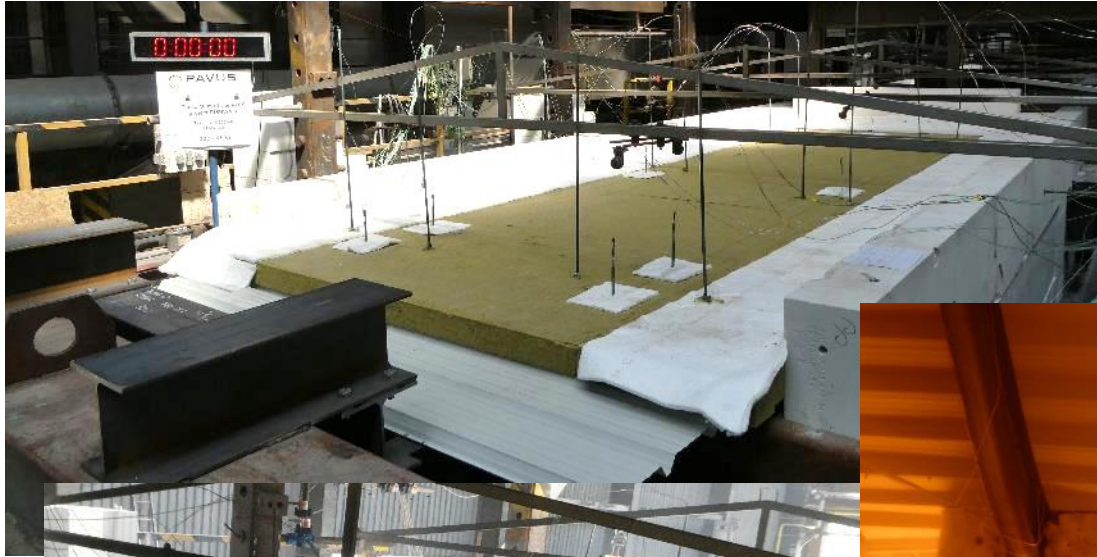
Integrity failure  
in 58<sup>th</sup> minute

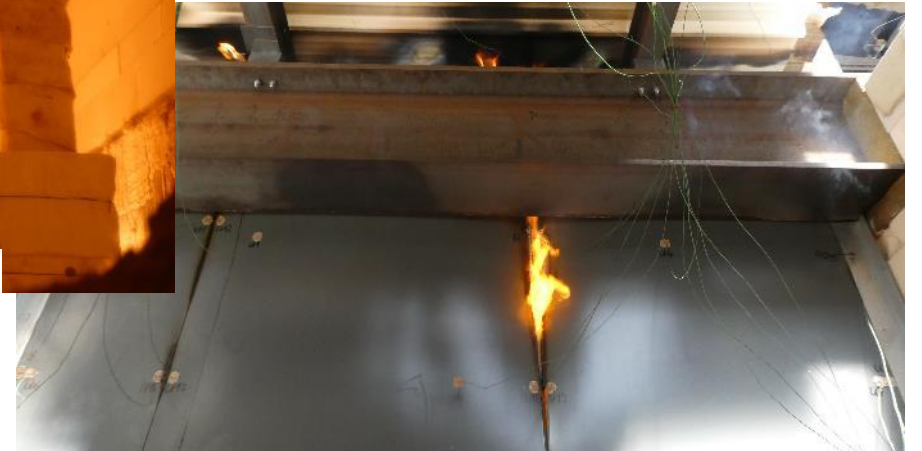
Purlins in the furnace  
after collapse  
(around 18 minutes)

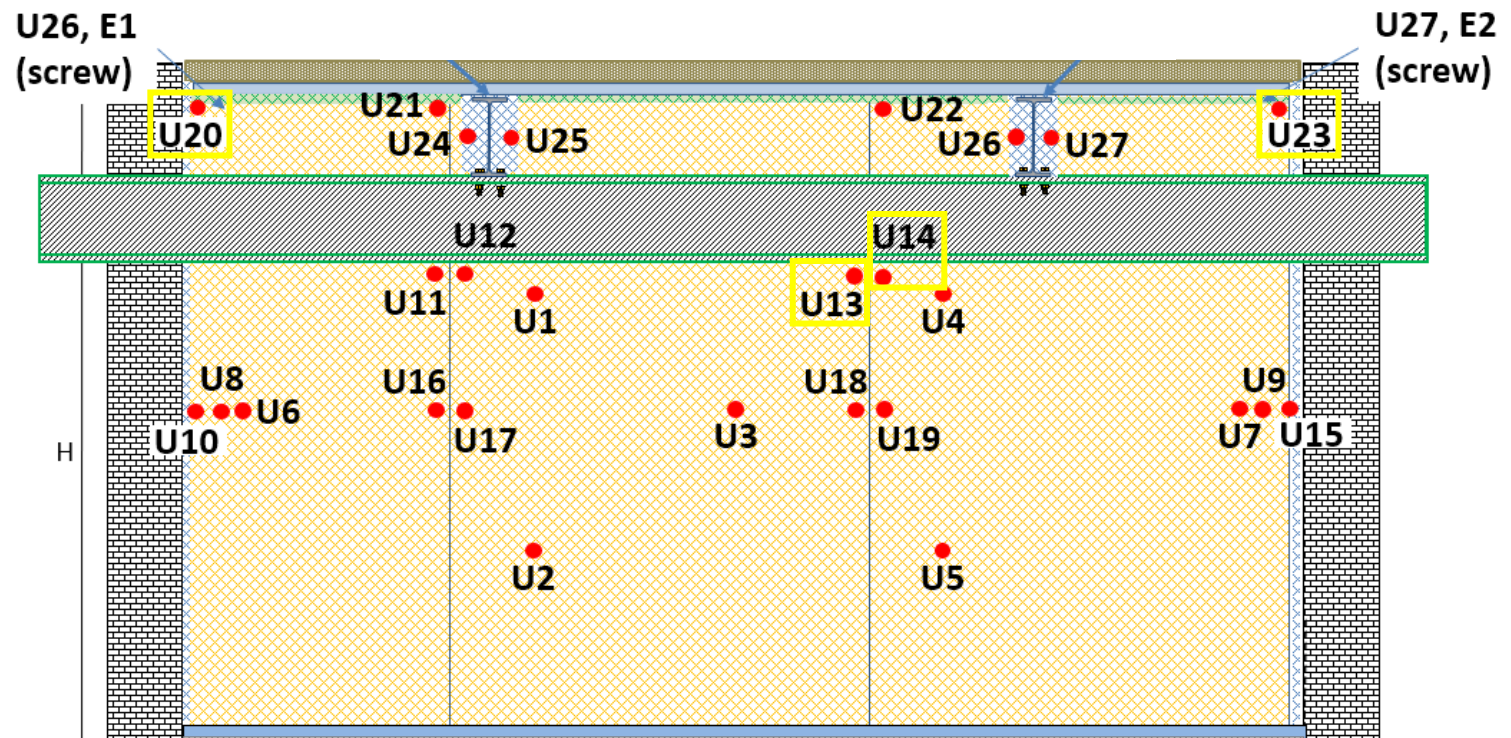
The temperature criteria related to the insulation performance of the wall was reached after 22 minutes on thermocouples U20 and U23. In 58<sup>th</sup> minute of the test there was integrity failure of the wall due to ignition of the cotton pad and sustained flaming in vertical joint by TCs U13, U14.

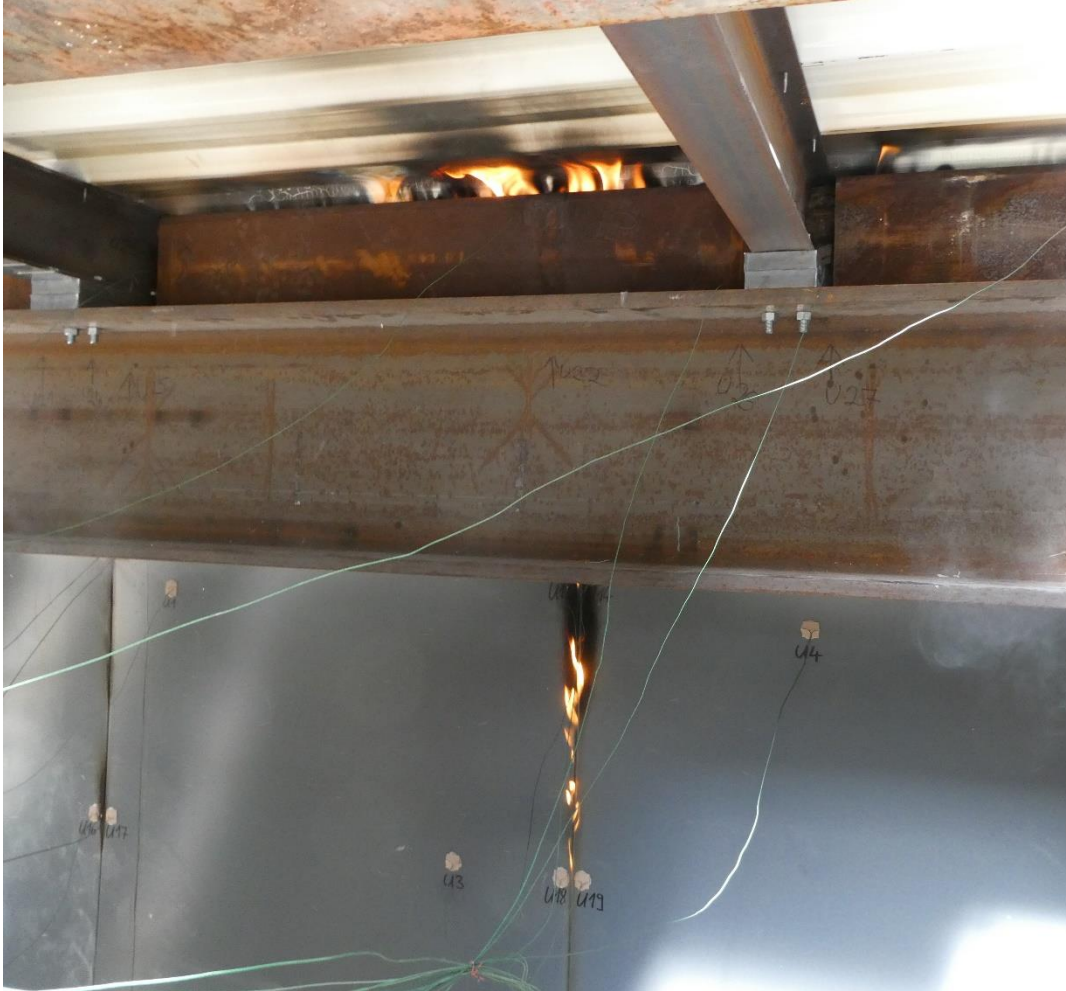
After 58 minutes of the test strong flaming appeared also below the steel decks at the junction with the wall. It was necessary to stop the test after 80 minutes due to safety of personnel and impending damage to the equipment of the laboratory.

This was probably caused by the imperfect filling of the wall openings managed at the level of purlins and the void formed between the wall top and the rib of the steel deck placed above. It is recommended to use mineral wool with the higher density. Maybe using of some intumescent product (for example together with mineral wool) could also be the solution.

The test results showed that the tested encasement system placed around purlins remained undamaged and was enable to avoid large wall damage in spite of the collapse of the heated steel purlins.
