Fire and Seismic performances of Hybrid fire WALLs in case of single-storey industrial and commercial steel buildings (FISHWALL)

Fire test report on a sliding steel framed door system built into a lightweight sandwich wall panel

Deliverable: D2.7

**Sliding steel framed door system
Novoferm Novoslide built into a lightweight
sandwich wall panels Eurobond Rainspan**

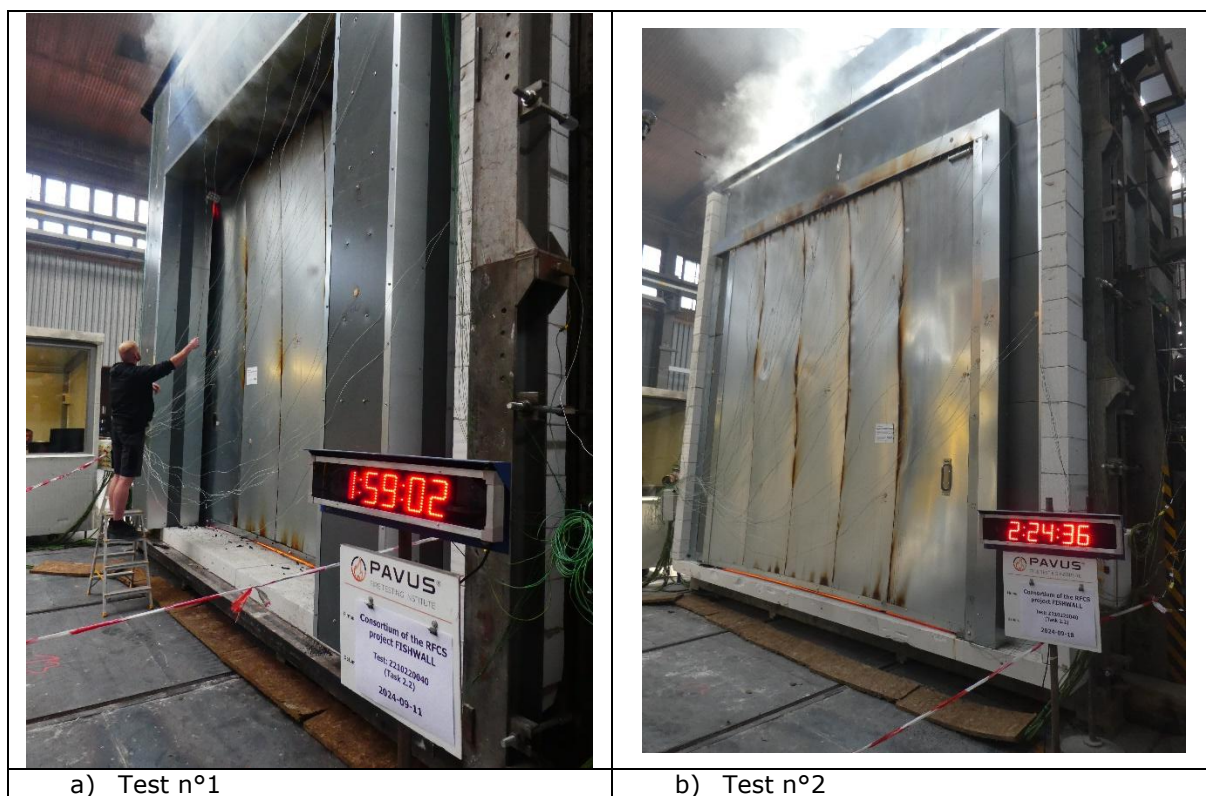
Figure 6: Views of the two specimens during tests

In the first test, with the door rail on exposed side, there was integrity failure in 120th minute caused by glowing of the cotton pad in left upper corner of the doors. In 124th minute, there was visible sustained flaming in through right upper corner of the doors and subsequently the test was stopped. Insulation failed after 108 minutes of the test on thermocouple placed nearby left upper corner of the doors, resp. after 91 minutes of the test in case of supplementary procedure (criterion I₁) on thermocouple placed nearby right upper corner of the doors. On the surface of the steel portal frame (under fire protection), there was measured temperature max. 100 °C in the end of the test (124 minutes). The highest values of deflection were measured in the middle of the door leaf's width, in the mid-height and on the bottom, around 170 mm after 124 minutes of the test.

The second test, with the door rail on unexposed side, was without integrity failure during whole testing time, i.e. 144 minutes. Time of insulation failure was similar to the first test, it failed after 105 minutes on the thermocouple placed on the top of the specimen, nearby joint in the door leaf. Insulation according to supplementary procedure failed after 45 minutes on the thermocouples placed on the top of the specimen, 25 mm from the visible edge of the door leaf, nearby joint in the door leaf. Maximum temperature of the steel portal frame was measured from 400 to 600 °C in the end of the test. The deflection was lower than measured in the first test, almost 130 mm in the centre of the specimen after 144 minutes of the test.

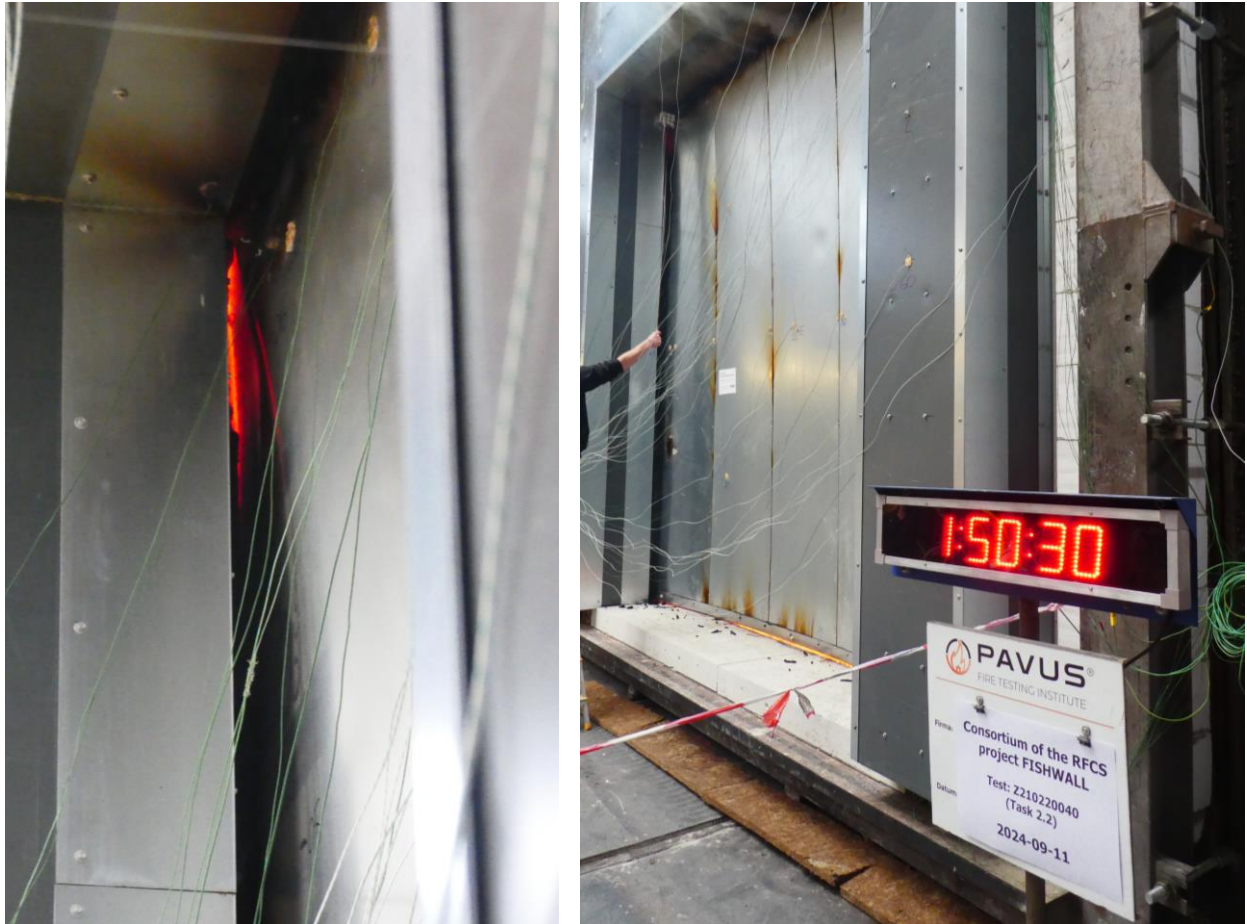
UF in 111th minute of the test

| 111. | UF - cotton pad test in the corner nearby TC 38 - without integrity failure |

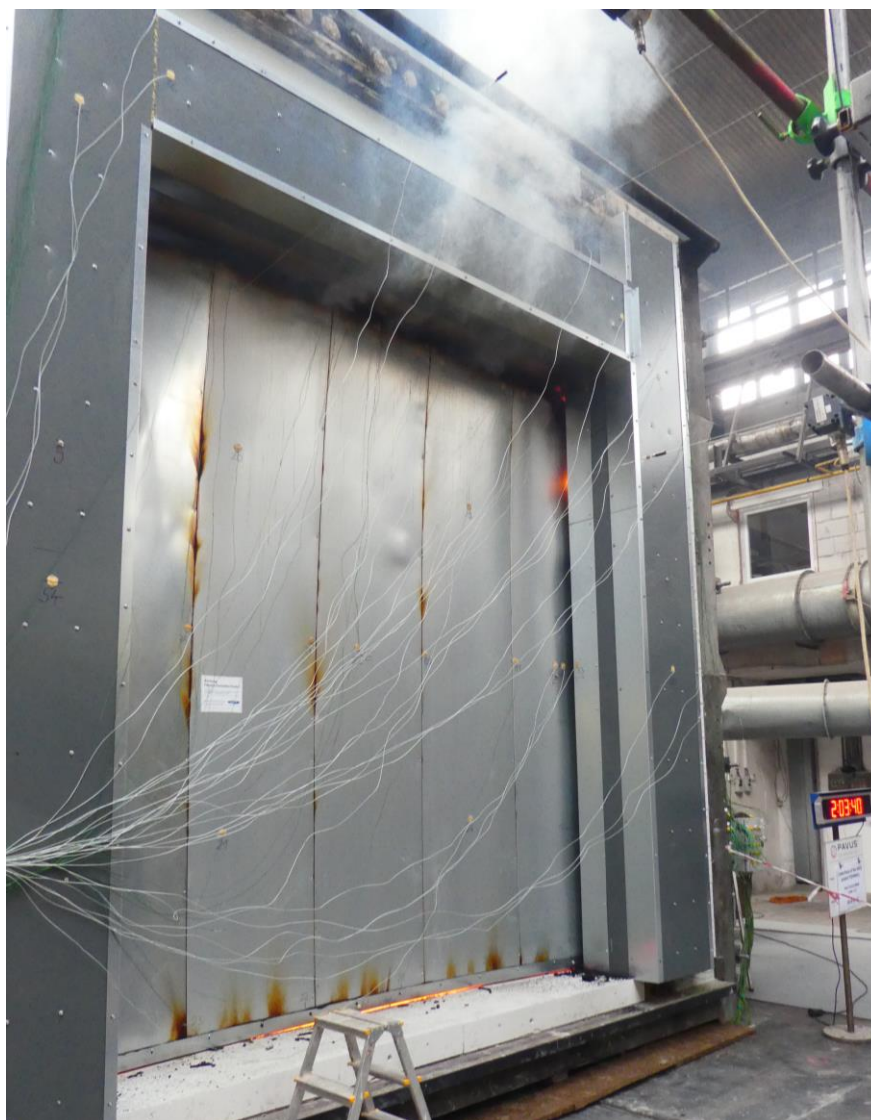
UF after 123 minutes of the test

| 124. | UF - sustained flaming of right top corner (between door leaf and doorframe) - integrity failure |
