# **Fire and Seismic performances of Hybrid fire WALLs in case of single-storey industrial and commercial steel buildings (FISHWALL)**

## **Fire test report on a fire wall solidly attached to an unprotected steel structure**

#### **Deliverable: D3.2**

**No. Pr-23-2.086-En**

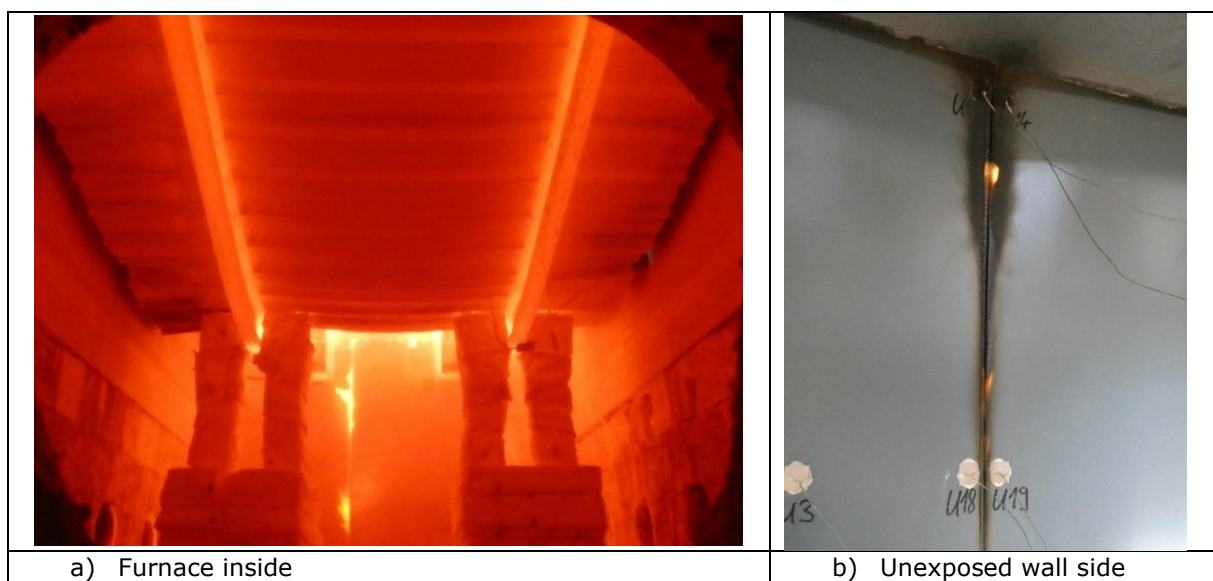
Figure 11: View of the test specimen during the test

With regard to the structural behaviour of purlins, it can be noted that no lateral torsional buckling was observed during the test, which leads to the conclusion that the purlins failed mainly by flexural bending (see Figure 11). The purlins were restrained in the lateral direction by the steel decks forming the roof, so that they were unable to move laterally. Some local buckling of purlin flanges in compression was observed at the end of encasement systems placed around the purlins. However, purlins deformation at the wall level remained very limited and the purlin encasements made of sandwich panels were undamaged (see Figure 12). Indeed, observations after the test showed that the part of purlins fire-protected by panels still appeared to be straight, in spite of the large bending of the heated parts of purlins.

Moreover, delamination of steel sheets at elevated temperature was observed for sandwich panels. The temperature criteria related to the insulation performance of the wall was reached at the 23<sup>rd</sup> minute on a thermocouple placed in the upper corner of the wall. At the 58<sup>th</sup> minute of the test there was integrity failure of the wall due to sustained flaming and ignition of the cotton pad in a vertical joint below the supporting steel beam. Next, strong flaming appeared below the steel decks at the junction with the wall, forcing to stop the test long before the targeted time, namely 120 minutes, due to staff safety and impending damage to the equipment. This is probably due to imperfect filling of the wall openings managed at the level of purlins and the void formed between the wall top and the rib of the steel deck placed above. To avoid this, a solution could be to use a harder mineral wool with the higher density. Maybe using of some intumescent product (for example together with mineral wool) could be also solution.

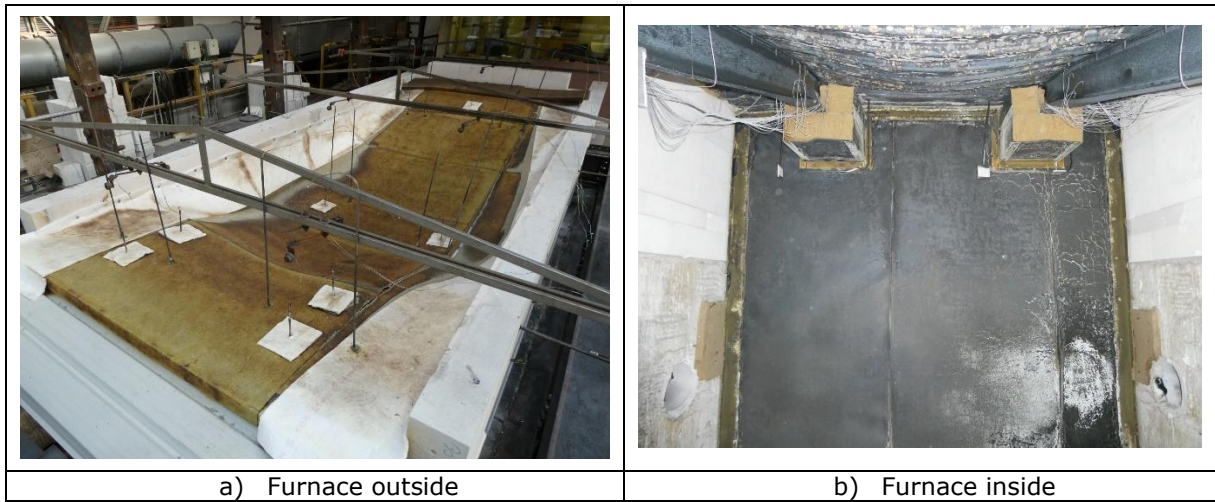
Figure 12: View of the test specimen after the test

The test results showed that the tested encasement system placed around purlins remained undamaged and was enable to avoid large wall damage in spite of the collapse of the heated steel purlins, as expected. However, after 60 minutes approximately, there was an integrity failure of the wall due to sustained flaming appearing at the wall-roof junction and at some joints between panels.

Regarding the wall-roof junction, the integrity failure is believed to be due to imperfect filling of the wall openings managed at the level of purlins and the void formed between the wall top and the rib of the steel deck placed above. One possible solution to easily avoid this problem may be the use of harder, higher-density mineral wool . Some intumescent product (for example together with mineral wool) could be also a solution.

The integrity failure observed due to flaming in some joints between panels can easily be solved. This type of issue has previously been observed in standard fire tests conducted on firewalls made of sandwich panels, and solutions are available. The most popular solutions are securing the panels to each other at the junction using stitching screws or adding intumescent seals to the joint. When exposed to temperatures typically above 180°C, the intumescent seal expands many times its original size, sealing the gaps between the panels and slowing the passage of fire, smoke, and hot gases. It should be also noted that the test conducted did not fully adhere to the standard procedure. Due to the wall sides being unable to be fixed in the furnace, two vertical free edges were used instead of one, as is standard in fire resistance tests. This could have had an adverse effect on the behaviour of the panels, particularly with regard to their deflection and joint opening.

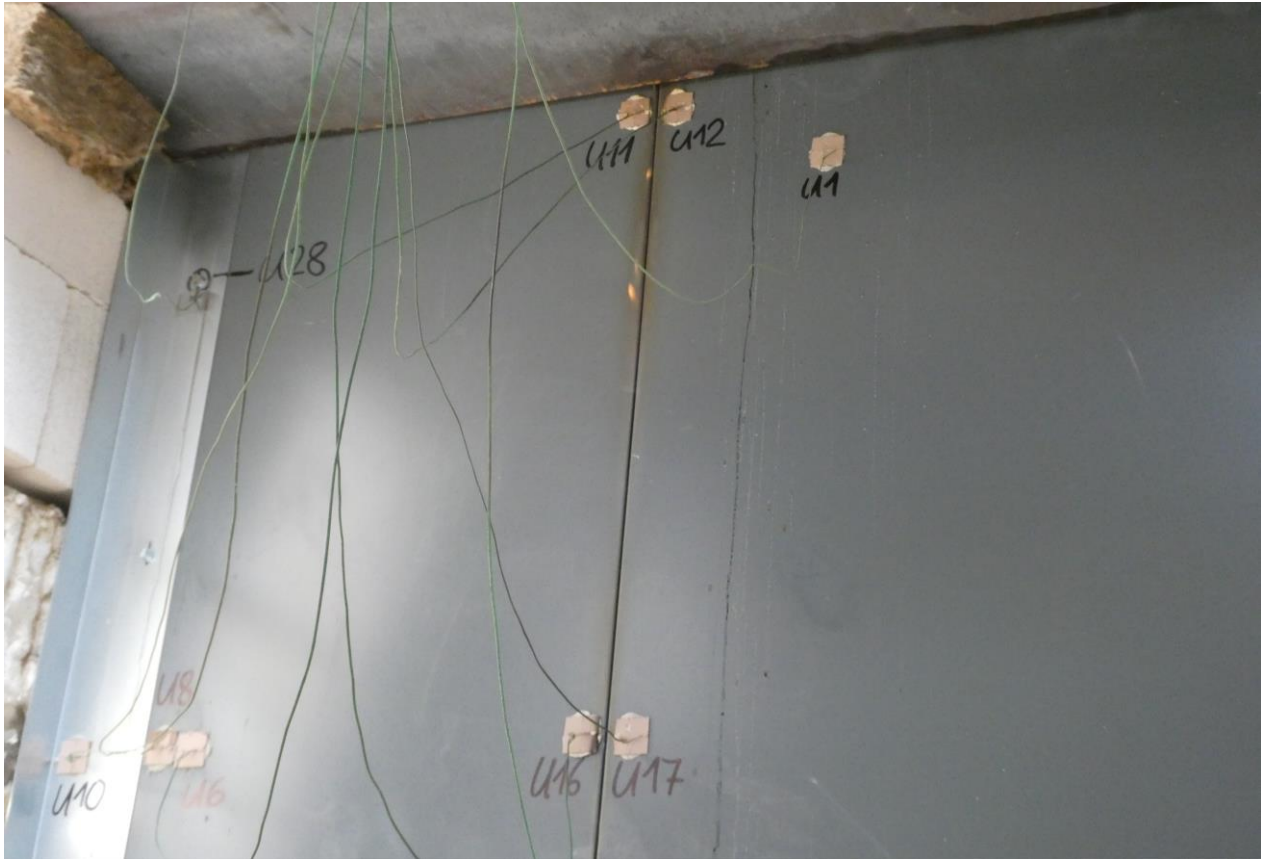
UF in 40<sup>th</sup> minute of the test - small flames from the vertical joint between sandwich panels

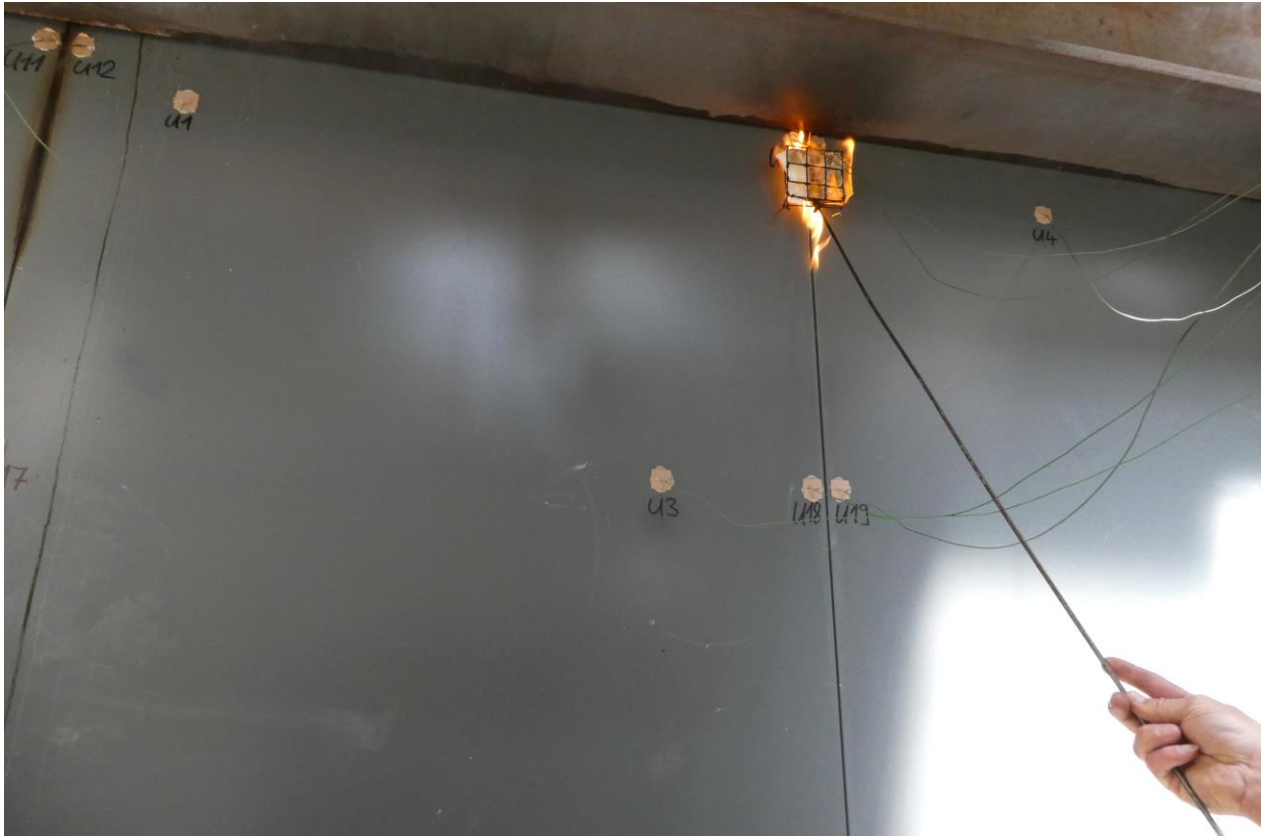
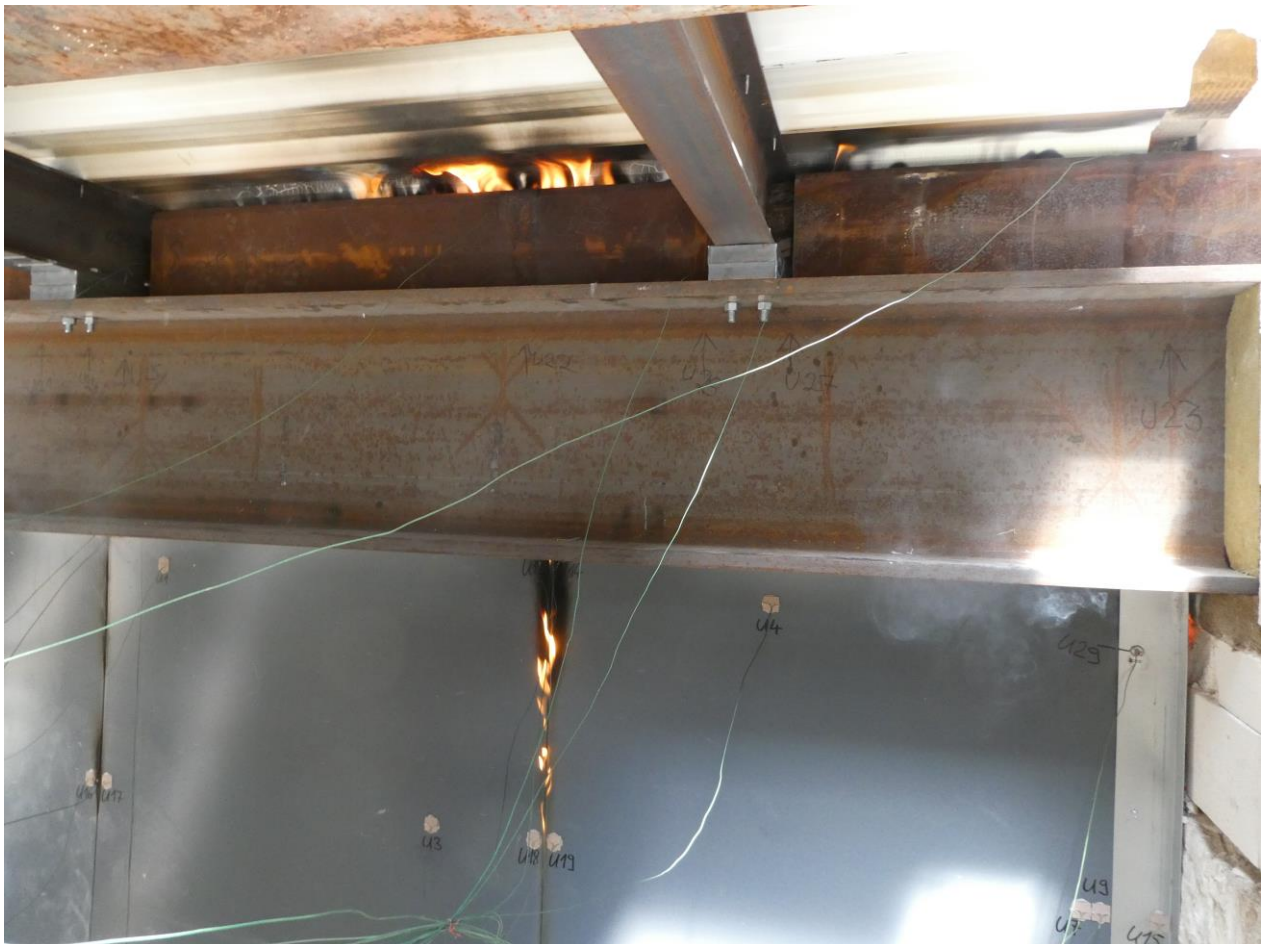
Criterion	Partial criterion	Measured value	Evaluation
<b>Integrity</b>	Cotton pad ignition	57 min	57 min
	Gap gauge passage	80 min, no failure	80 min
	Sustained flaming	57 min	57 min
<b>Insulation</b>	Average temperature	80 min, no failure	57 min <sup>1)</sup>
	Maximum temperature	22 min	22 min

Ignition of the cotton pad and sustained flaming in 58<sup>th</sup> minute of the test

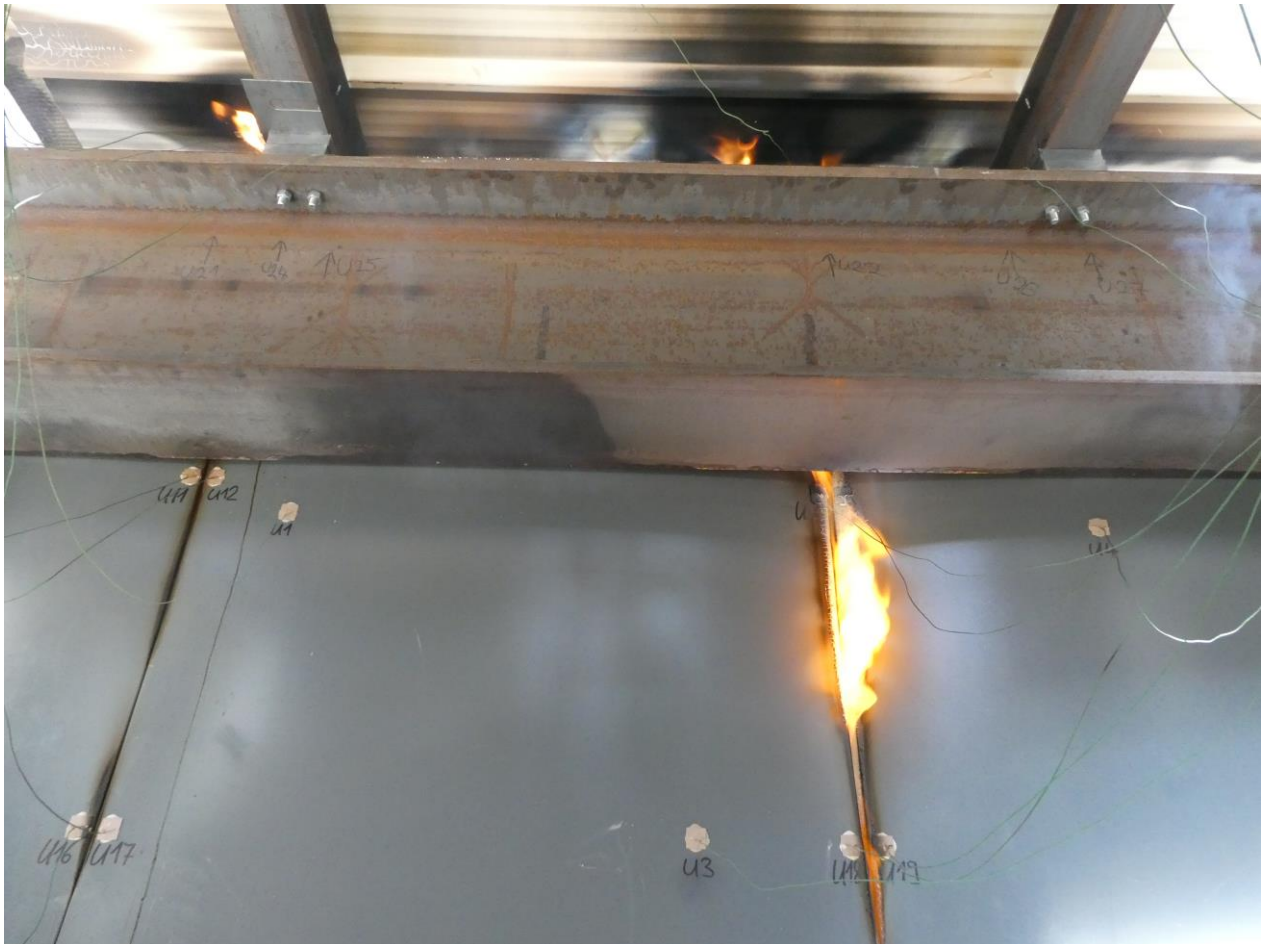
Continuous flaming of the specimen in 70<sup>th</sup> minute of the test
