FISHWALL

Fire and Seismic performances of Hybrid fire WALLs in case of single-storey industrial and commercial steel buildings

SESSION: Experimental campaign – Results and exploitation of fire tests

- Sandwich panel fire wall associated with “fusible” links
- Christophe RENAUD
- CTICM

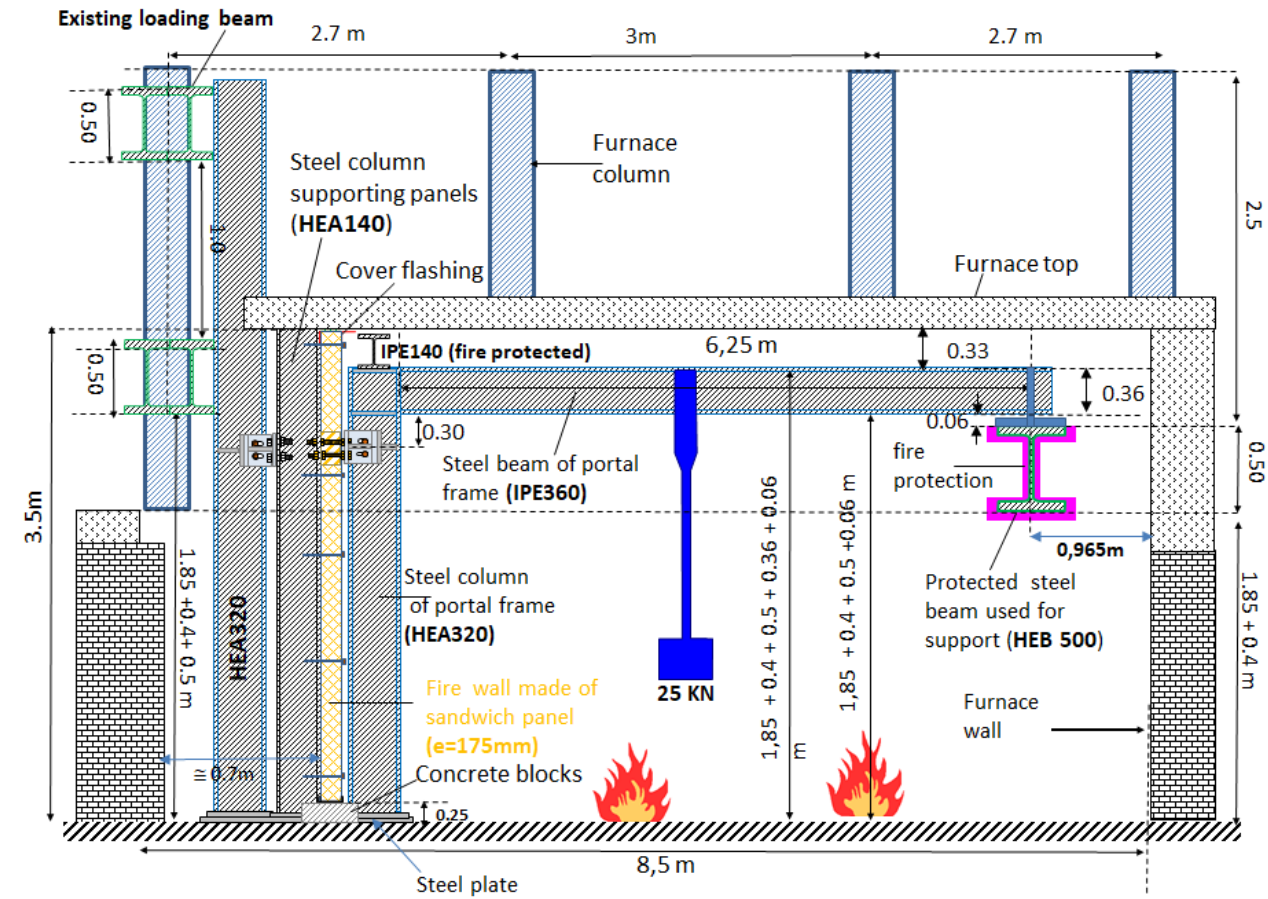
➤ Schematic views

- ❖ A partition fire wall made of lightweight sandwich panels spanning horizontally between two steel columns connected to two fire-exposed semi-portal frames by means of two different “fusible” systems

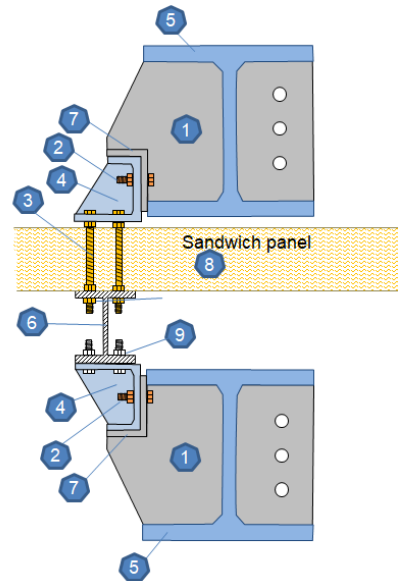
- 1 Gusset steel plate (10 mm thick, S355)
- 2 M12 aluminium bolts
- 3 M16 class 8.8 steel rods
- 4 U-shaped steel profile (12 mm thick, S355) with stiffener
- 5 Steel column of portal frame HEA320 (S275)
- 6 HEA140 steel column (S275)
- 7 L-shaped folded profile (10mm thick, S355)
- 8 Sandwich panels (175 mm thick)
- 9 M16 class 8.8 bolts

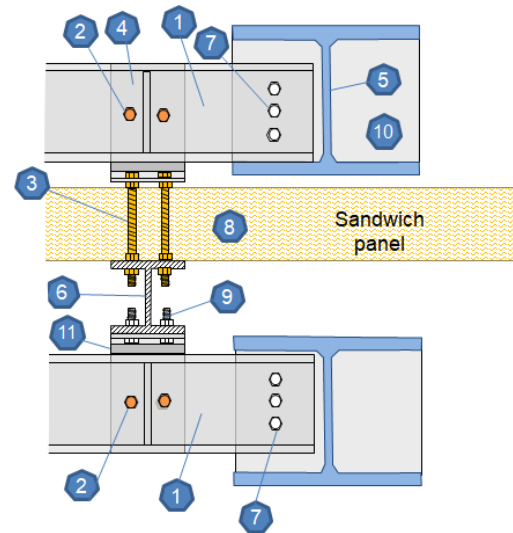
- 1 UPN 240 steel profile (S275)
- 2 M12 aluminium bolts
- 3 M16 class 8.8 steel rods
- 4 L-shaped steel profile (10mm thick, S355)
- 5 Steel column of portal frame HEA320 (S275)
- 6 HEA140 steel column (S275)
- 7 M20 class 8.8 bolts
- 8 Sandwich panels (175 mm thick)
- 9 M16 class 8.8 bolts
- 10 Welded steel plate (10mm thick, S355)
- 11 Steel shim (20mm thick, S355)

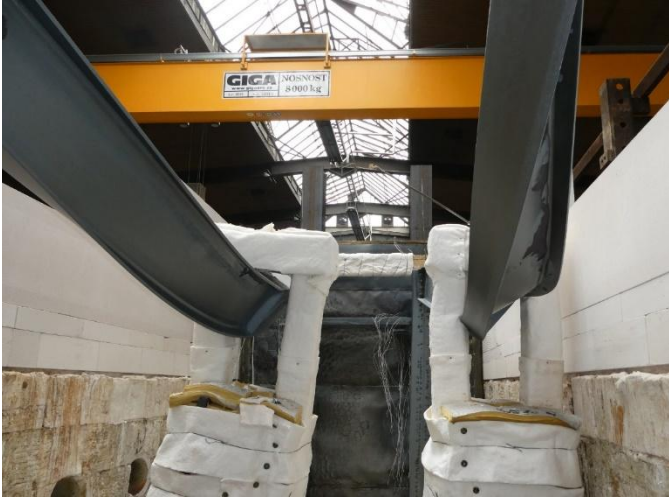
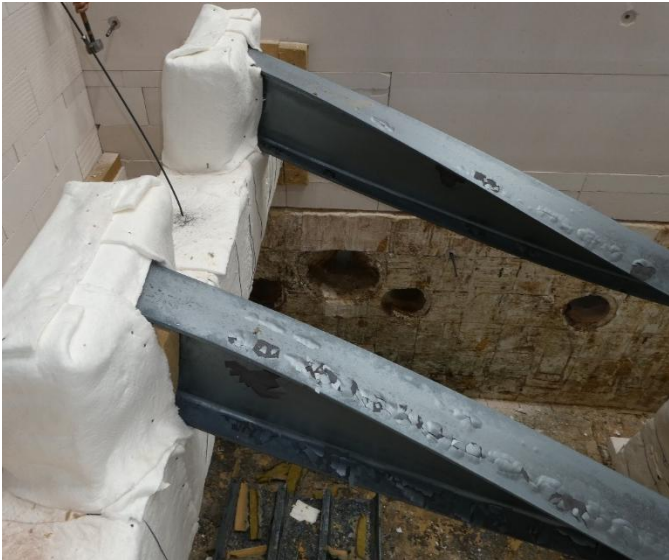
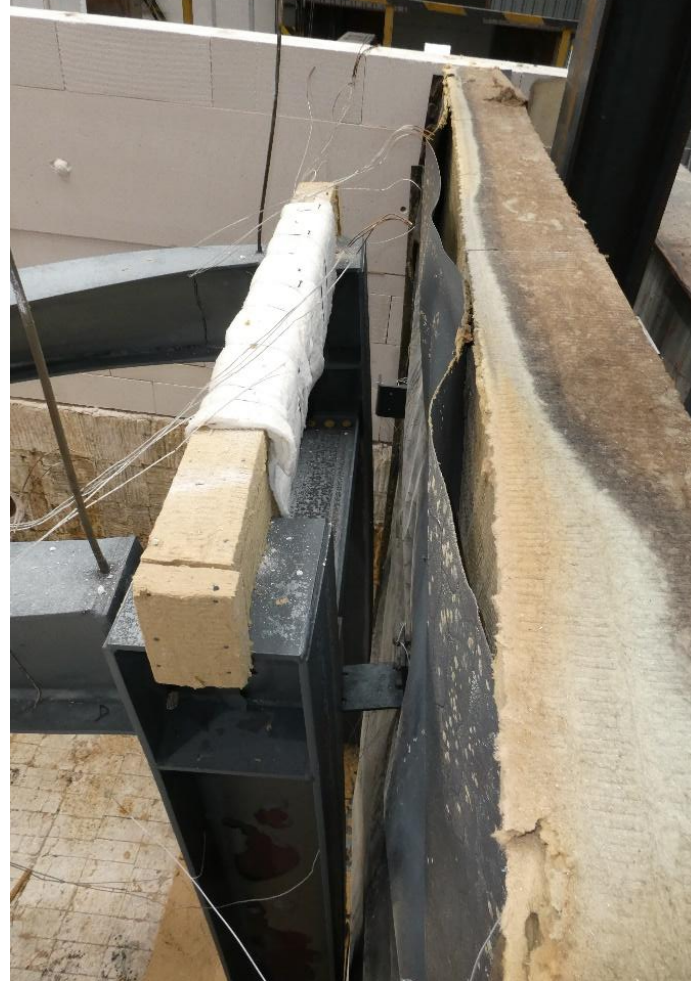
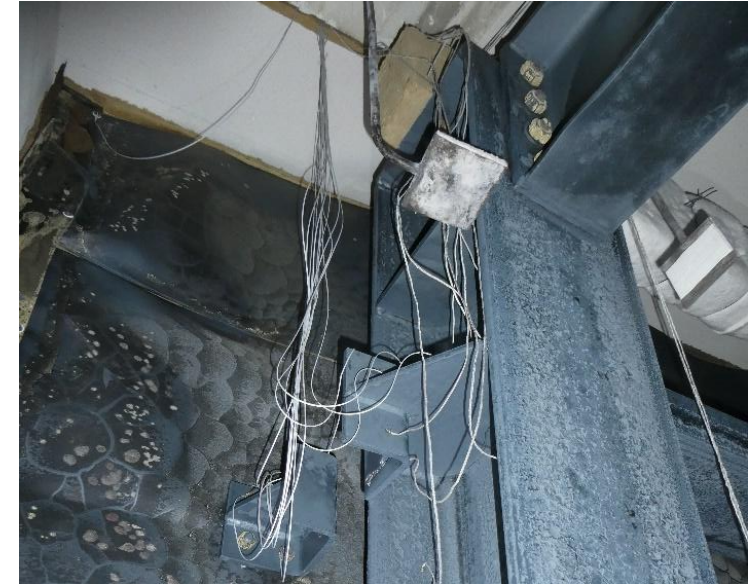
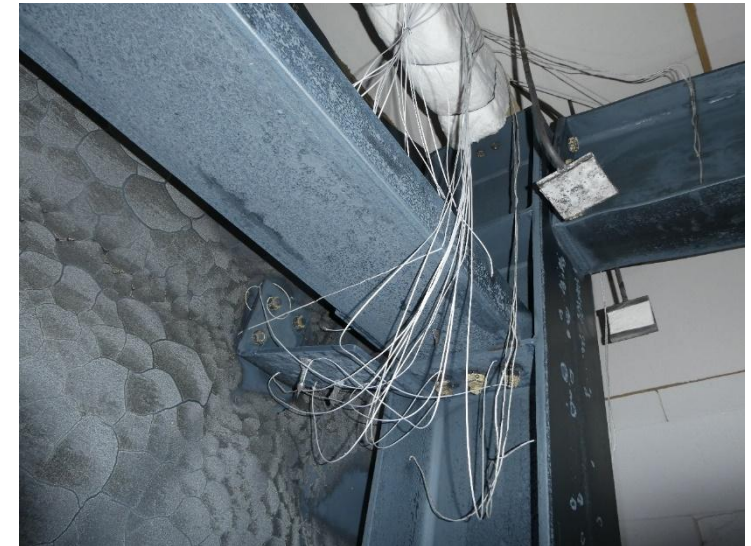
➤ Specimen after the test

- The test result confirmed the appropriate fire behaviour of tested fusible system solutions which allowed the wall to be disconnected from the steel portal frames exposed to fire without endangering the separating function of the wall, which remained fixed to the steel structure on the other side of the wall and therefore not exposed to fire.
- There was also integrity loss of the wall due to sustained flaming in the half of the wall's height, on one vertical edge. However, this would not have happened if steel flashings placed on the edges of the wall could have been fixed to the furnace walls, as usually happens in standard fire test on walls.
