FISHWALL

Fire and Seismic performances of Hybrid fire WALLs in case of single-storey industrial and commercial steel buildings

SESSION: Experimental campaign – Results and exploitation of seismic tests

- **Fusible links**
- Sara Pasquali | Nicola Tondini | Gabriele Zanon
- UNITN

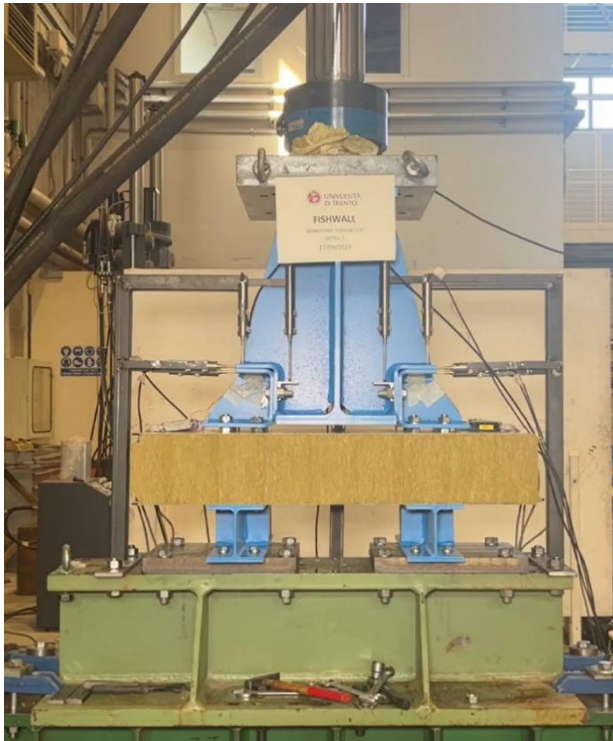
Test set-up

- Hydraulic actuator of 1000 kN capacity and ± 250 mm of stroke
- Strain-gauges, inclinometers and displacement transducers.
- Tests performed in displacement control

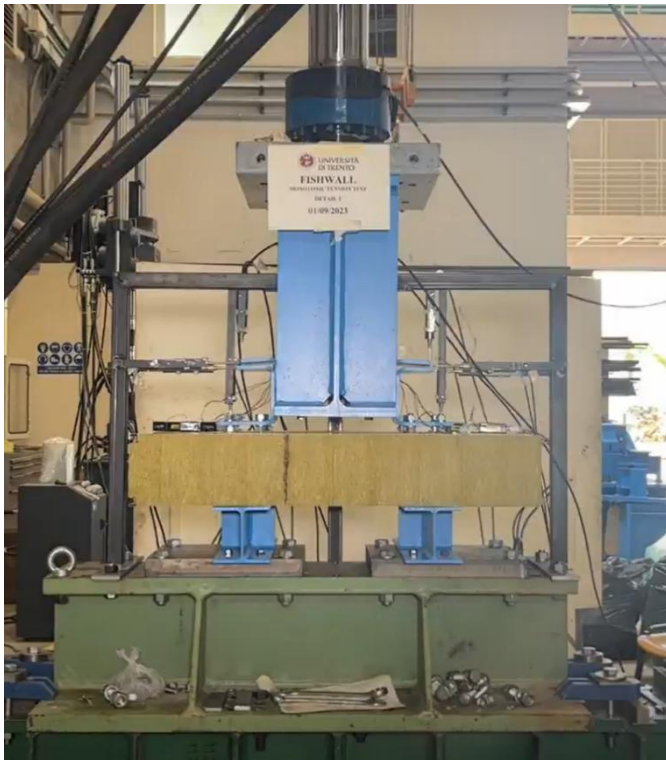
Tension test – max force reached: 128.8 kN

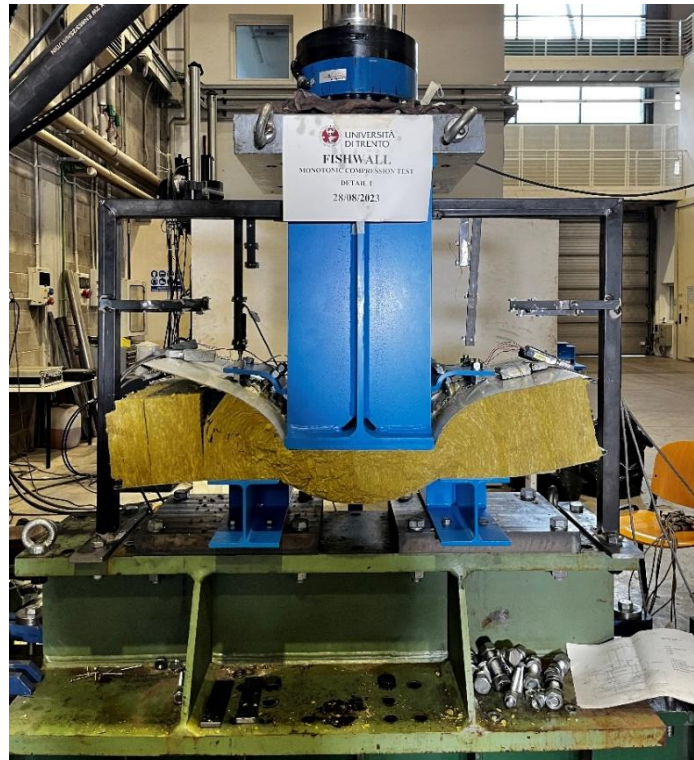
Compression test - max force reached: 116.0 kN*

*Steel inelastic behaviour and no failure of the aluminium bolts

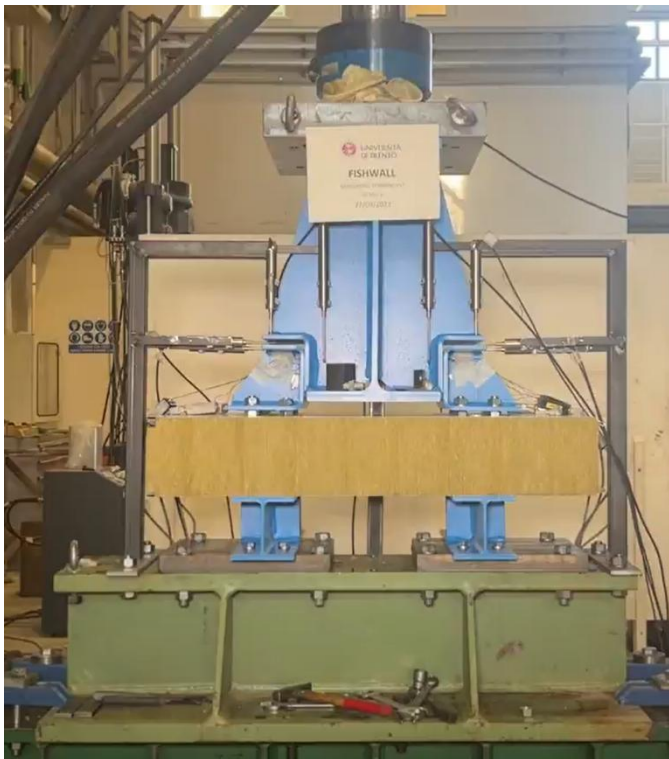
Tension test – max force reached: 325.8 kN

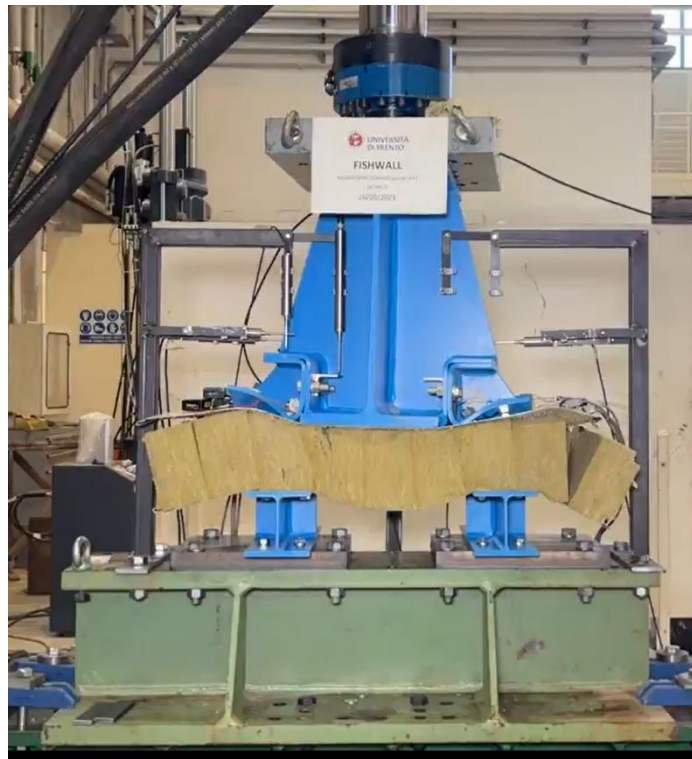
Compression test - max force reached: 560.0 kN*

*Steel inelastic behaviour and no failure of the aluminium bolts

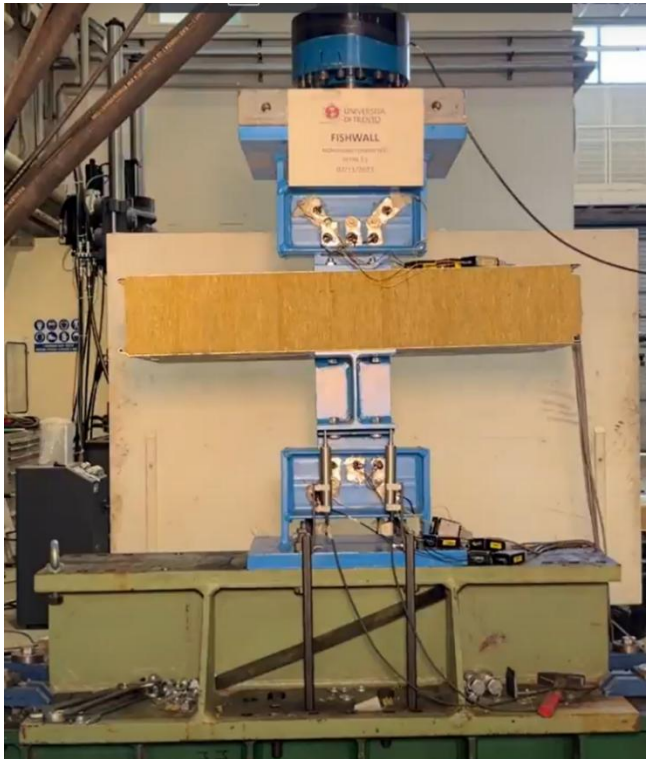
**Tension test – max force
reached: 190.7 kN**

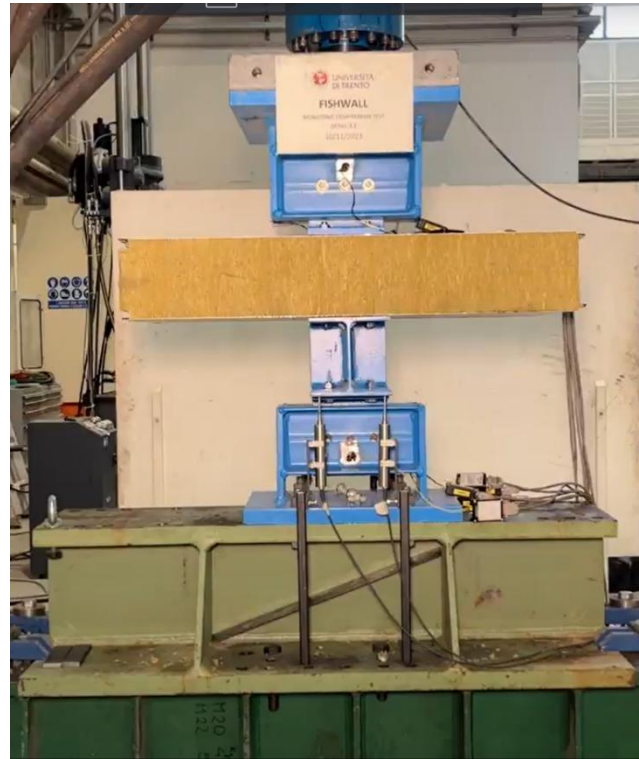
**Compression test - max force
reached: 215.2 kN**

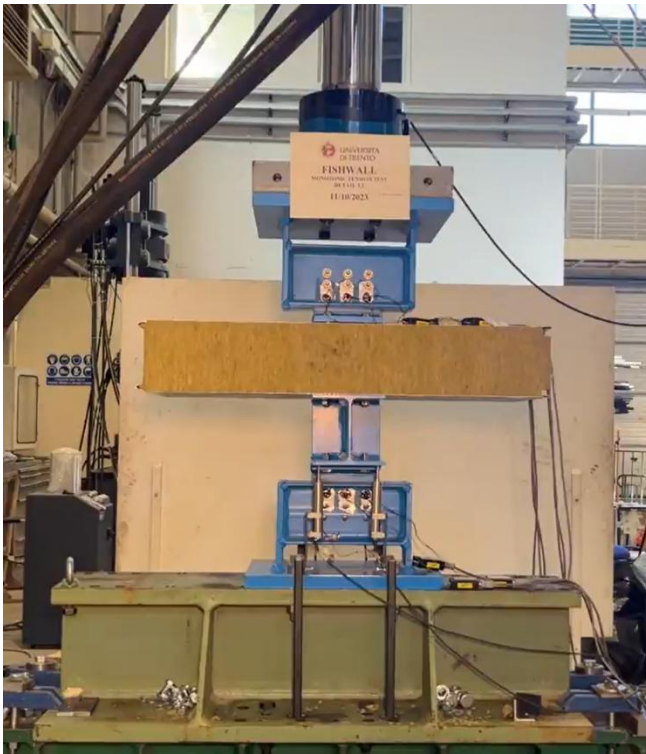
Tension test – max force reached: 130 kN

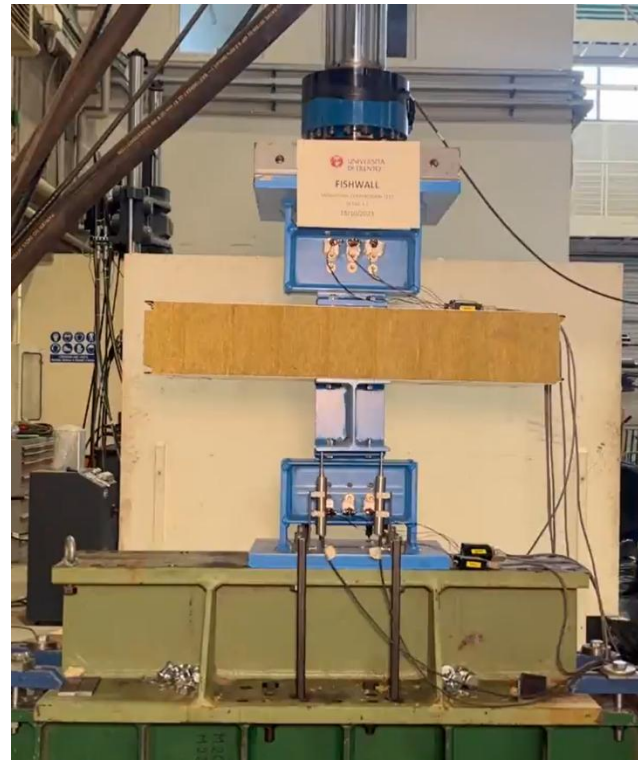
Compression test - max force reached: 205.2 kN

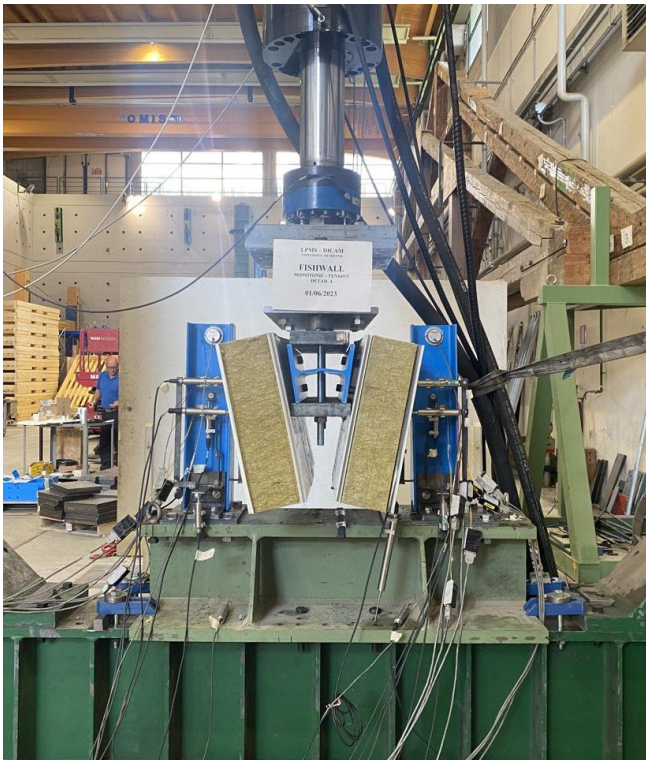
**Tension test – max force
reached: 56.9 kN**

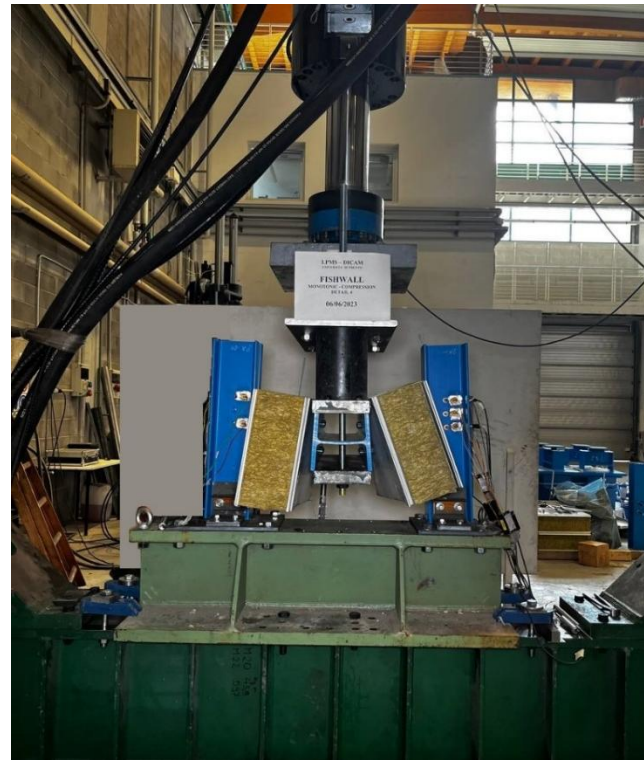
**Compression test - max force
reached: 52 kN**

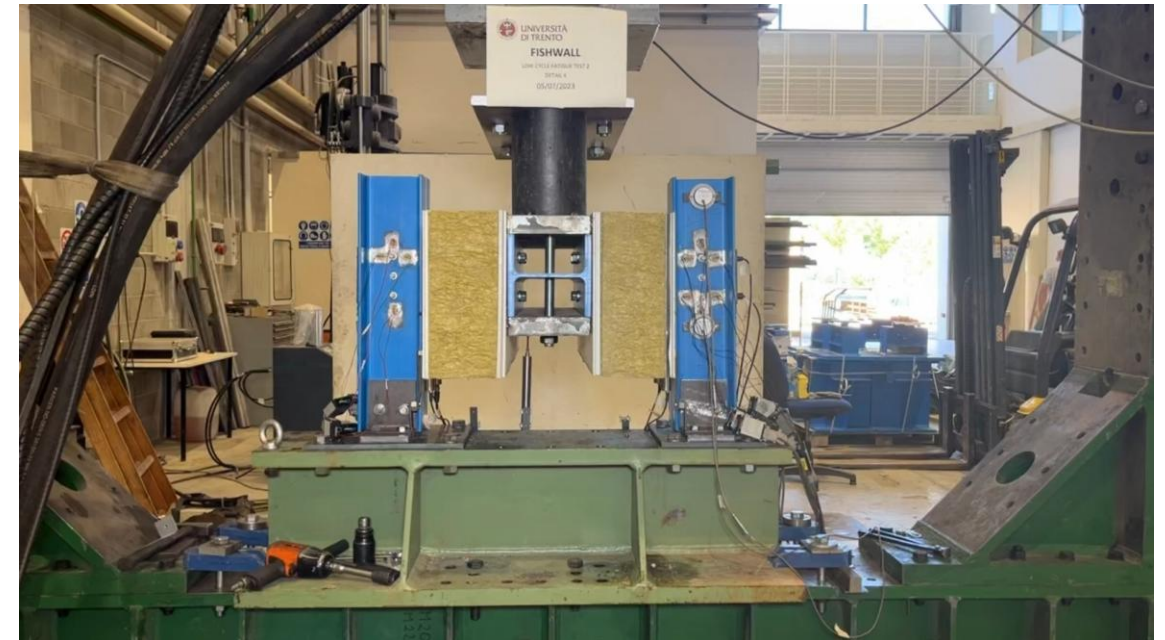
Cyclic tests

- The four tests are in a good agreement
- A progressive failure of one or more shear planes occurred
- Design force of 180 kN was not reached in any tests
- Presence of the sandwich panels led to large deformations that induced additional forces on the aluminium bolts

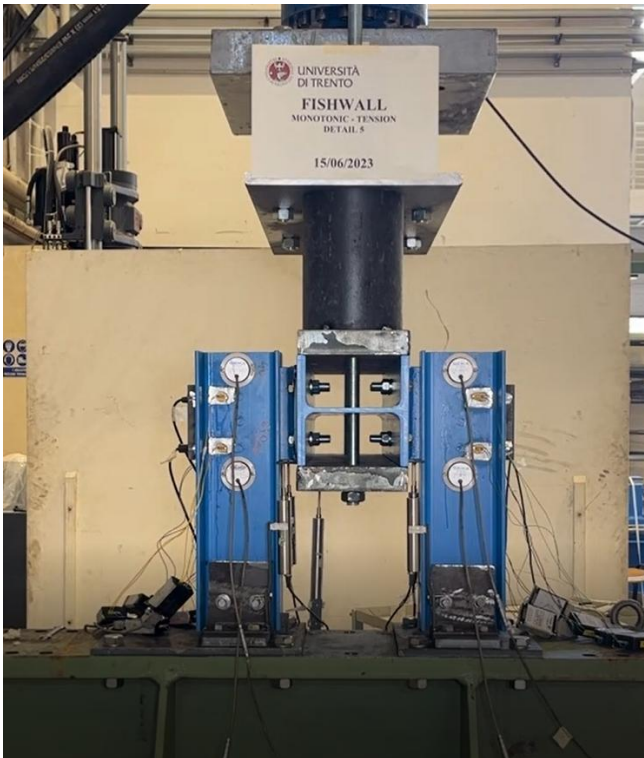
**Tension test – max force
reached: 147.6 kN**

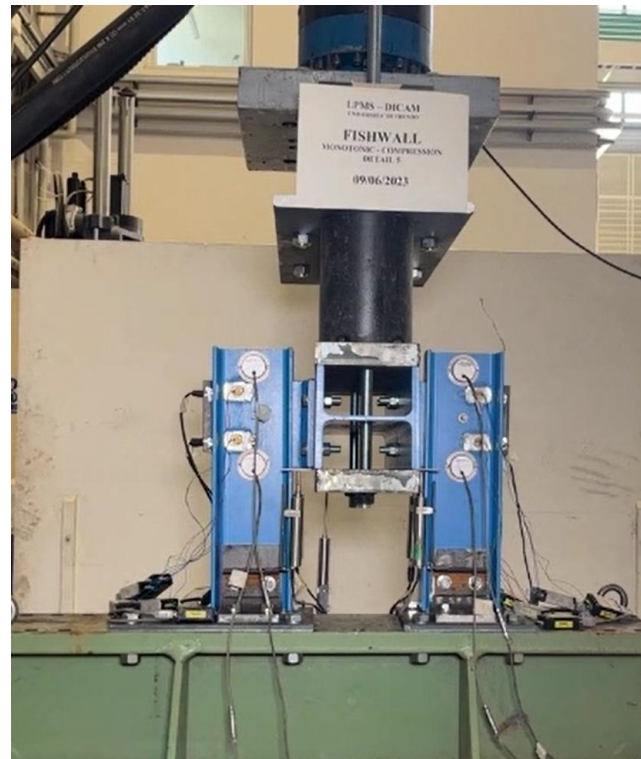
**Compression test - max force
reached: 185.9 kN**
