Fire and Seismic performances of Hybrid fire WALLs in case of single-storey industrial and commercial steel buildings (FISHWALL)

Fire test report on a sliding steel framed door system built into a lightweight sandwich wall panel

Deliverable: D2.2

**Sliding steel framed door system
Novoform Novoslide built into a lightweight
sandwich wall panels Eurobond Rainspan**

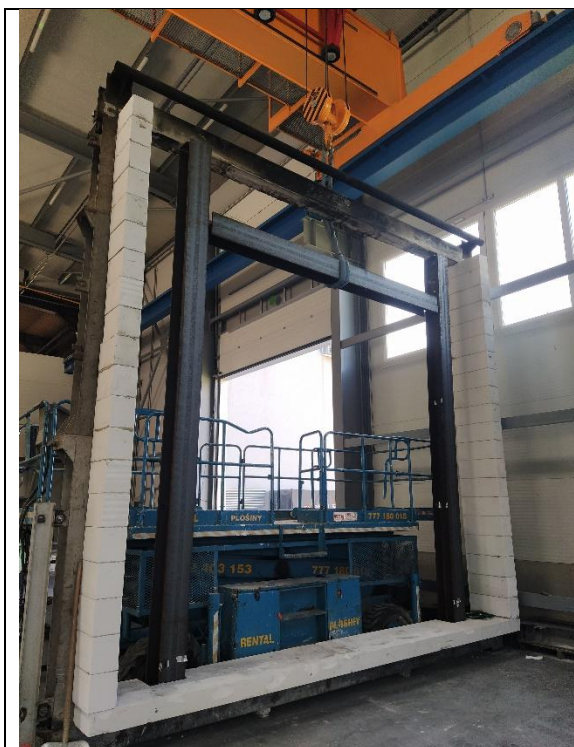
a) View of the support steel frame

b) View of the door opening in wall

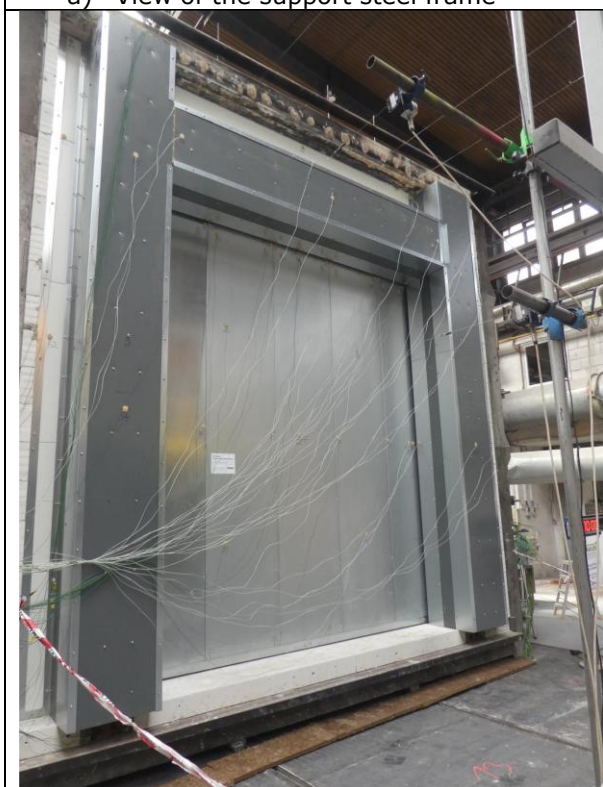
a) View of the specimen n°1 - fire-unexposed side

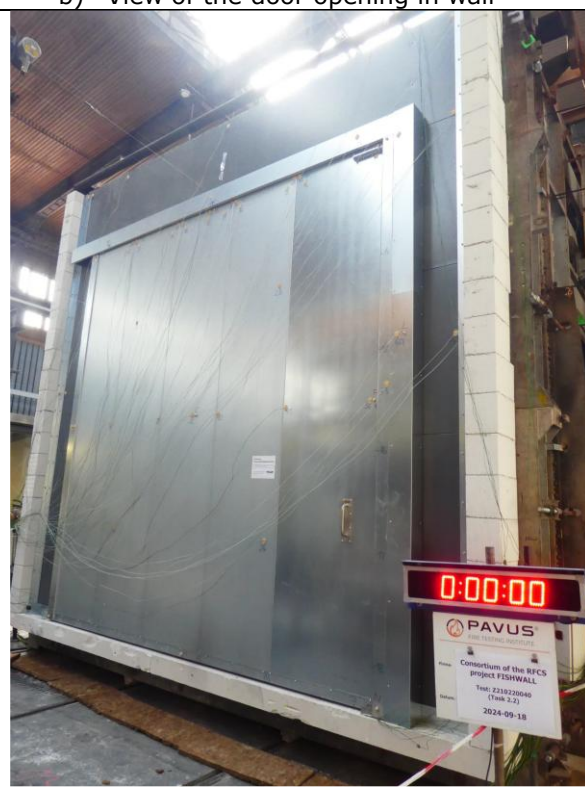
b) View of the specimen n°2 - fire-unexposed side

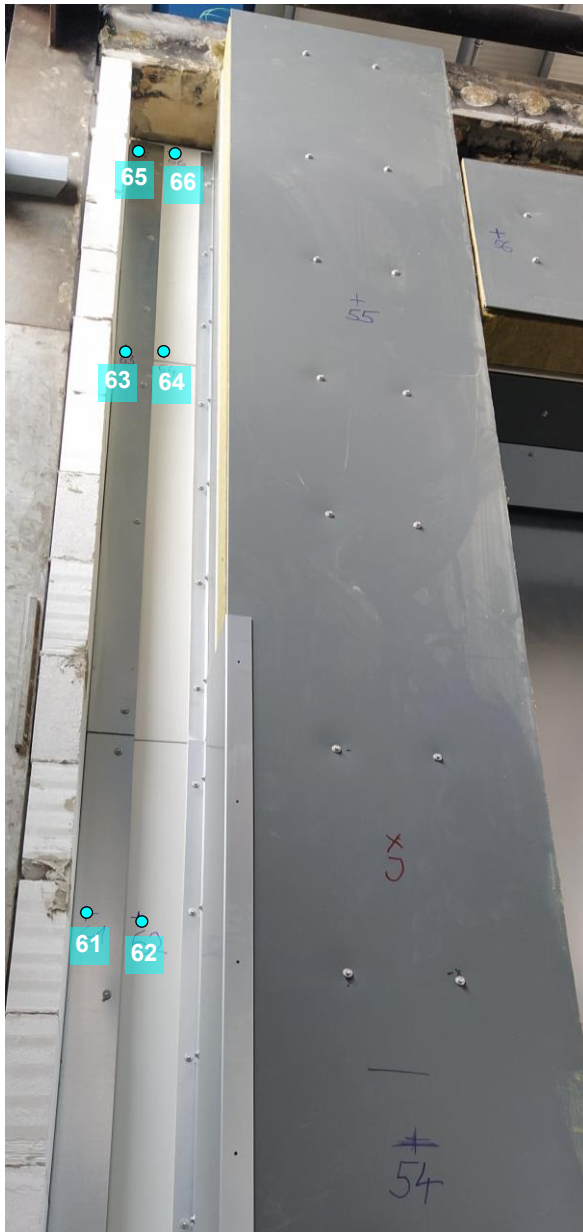
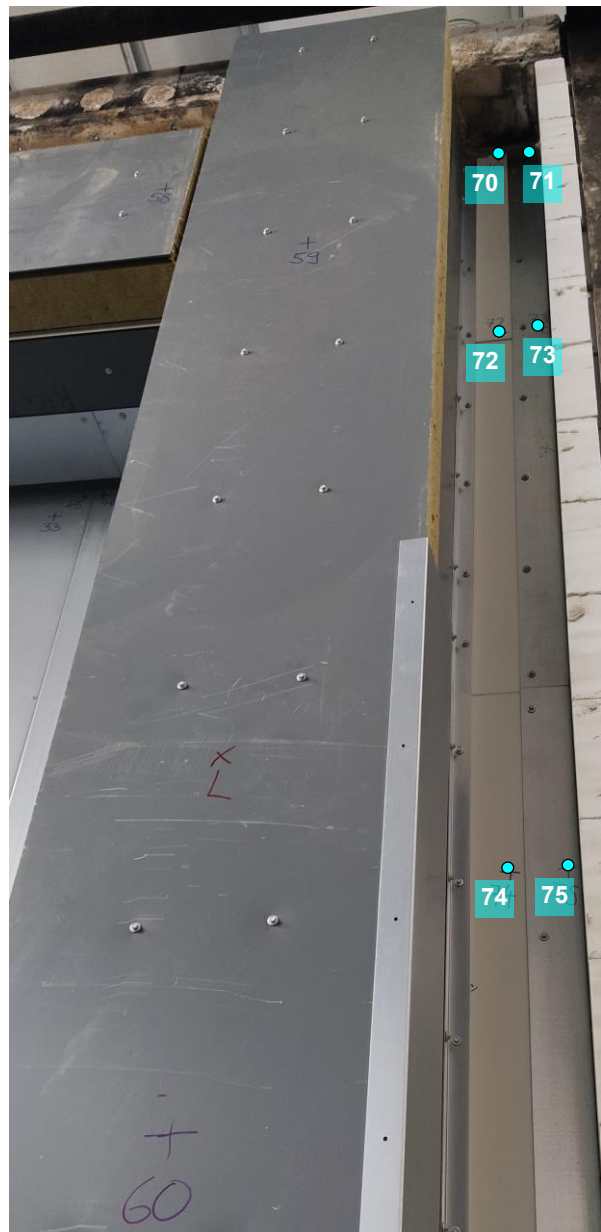
LAYOUT OF TC 61 TO 66 AND 70 TO 75 ON UF OF SPECIMEN 1 IN MORE DETAIL

Key:

61 ÷ 66, 70 ÷ 75

- TC for T_{max} on wall made of sandwich panels

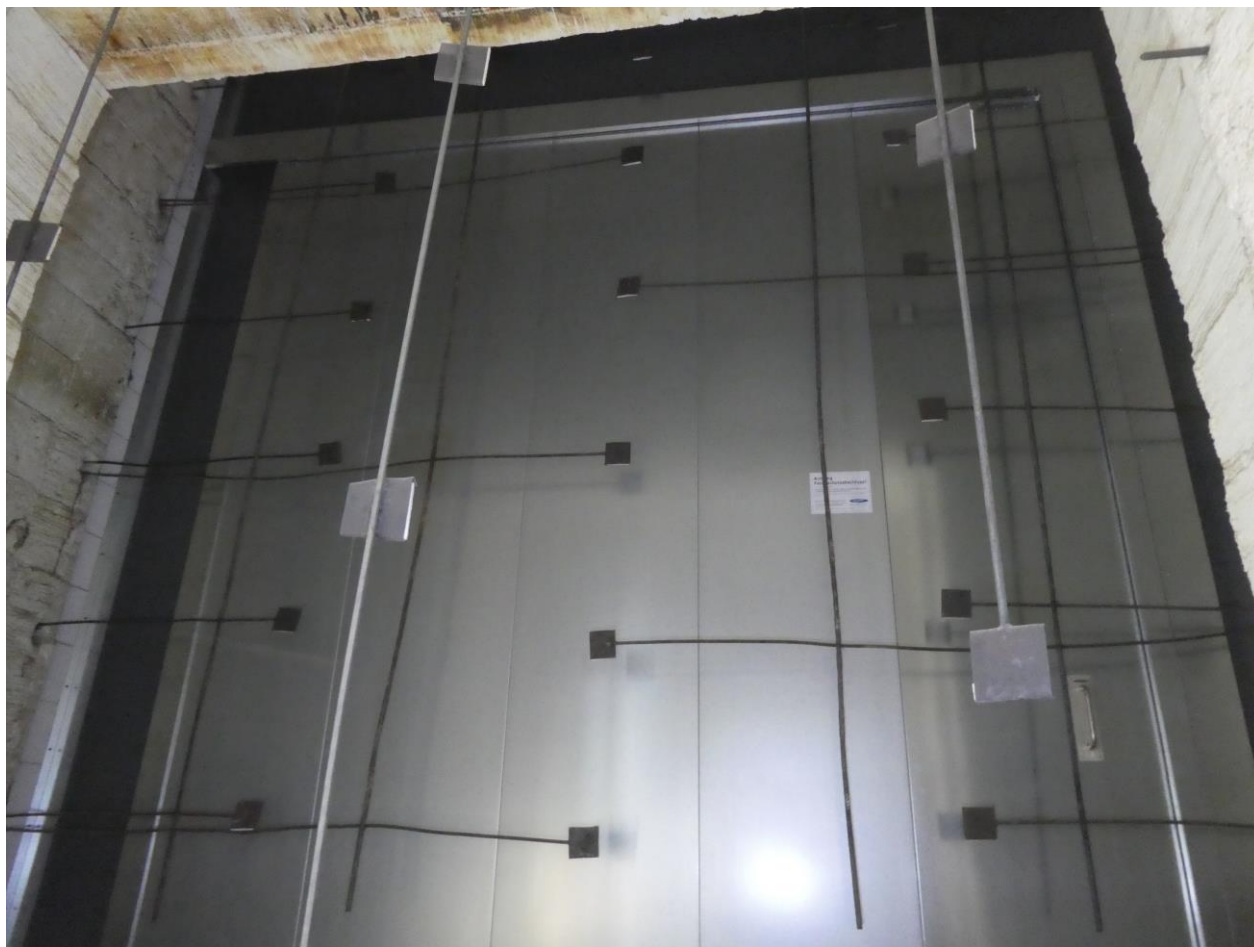
EF before the test

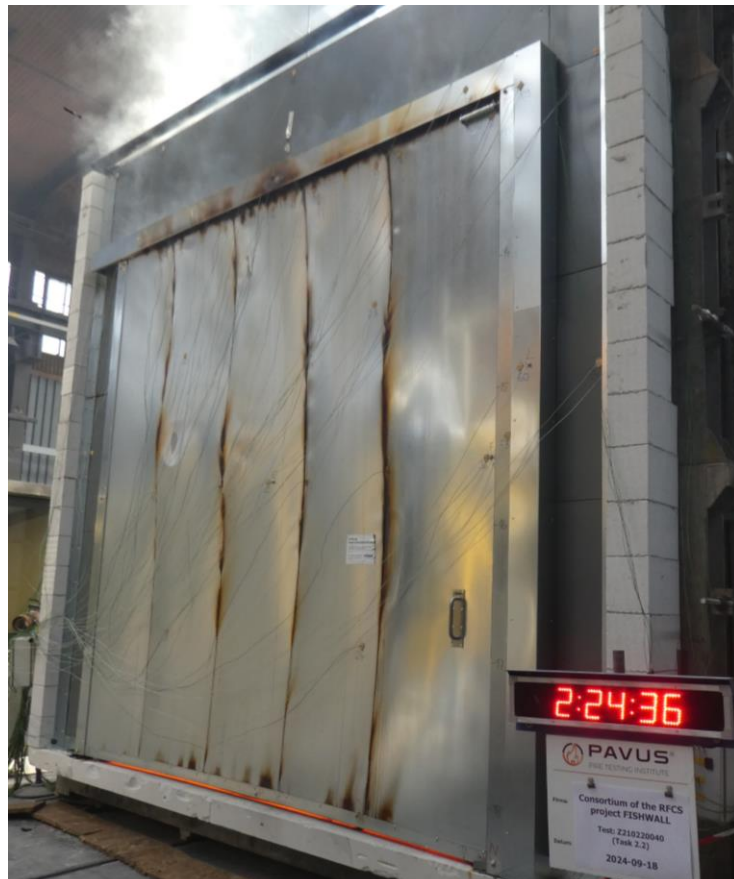
UF after 144 minutes of the test

The second test, with the door rail on unexposed side, was without integrity failure during whole testing time, i.e. 144 minutes. Time of insulation failure was similar to the first test, it failed after 105 minutes on the thermocouple placed on the top of the specimen, nearby joint in the door leaf. Insulation according to supplementary procedure failed after 45 minutes on the thermocouples placed on the top of the specimen, 25 mm from the visible edge of the door leaf, nearby joint in the door leaf. Maximum temperature of the steel portal frame was measured from 400 to 600 °C in the end of the test. The deflection was lower than measured in the first test, almost 130 mm in the centre of the specimen after 144 minutes of the test.
