Fire and Seismic performances of Hybrid fire WALLs in case of single-storey industrial and commercial steel buildings (FISHWALL)

Full seismic test report including all detailed experimental data gathered during the seismic tests

WP4: Seismic behaviour of a hybrid fire wall solution with "fusible" links

Deliverable: D4.1

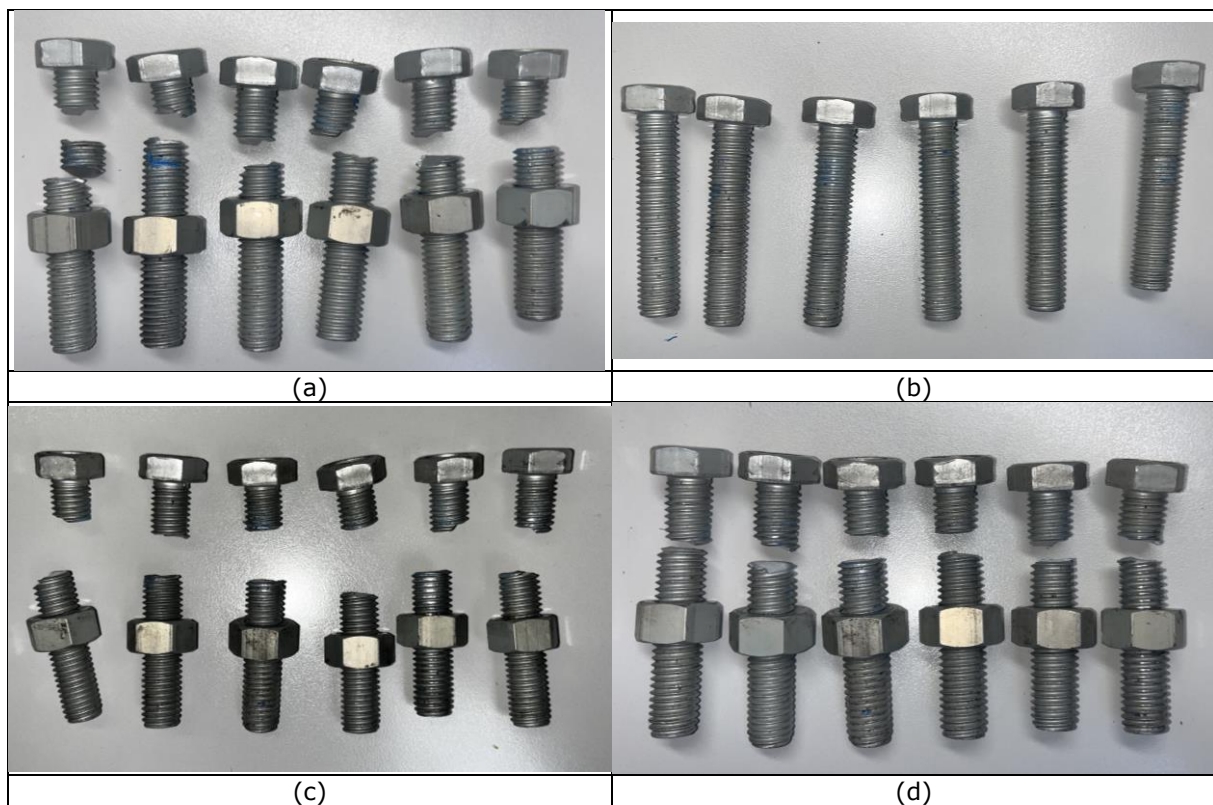
Figure 30. Detail 1 aluminium bolts at failure: (a) tension test; (b) compression test; (c) cyclic test 1; (d) cyclic test 2.

In conclusion, Table 7 summarizes the maximum experimental forces reached by each test at the first failure of an aluminium bolt, in comparison with the design force, in Figure 29 some specimens photos, after the tests, can be observed and in Figure 30 the aluminium bolts after the tests are shown.

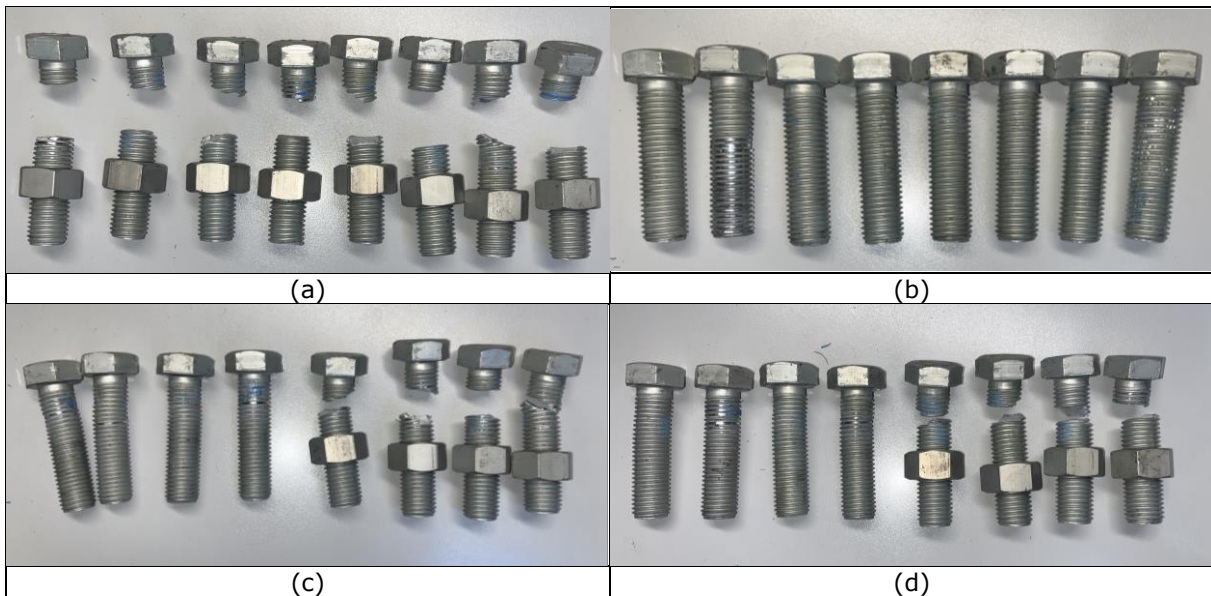
Figure 55. Detail 2 aluminium bolts at failure: (a) tension test; (b) compression test; (c) cyclic test 1; (d) cyclic test 2.

Some specimen photos, after the tests, can be observed Figure 54. The aluminium bolts after the tests are shown in Figure 55.

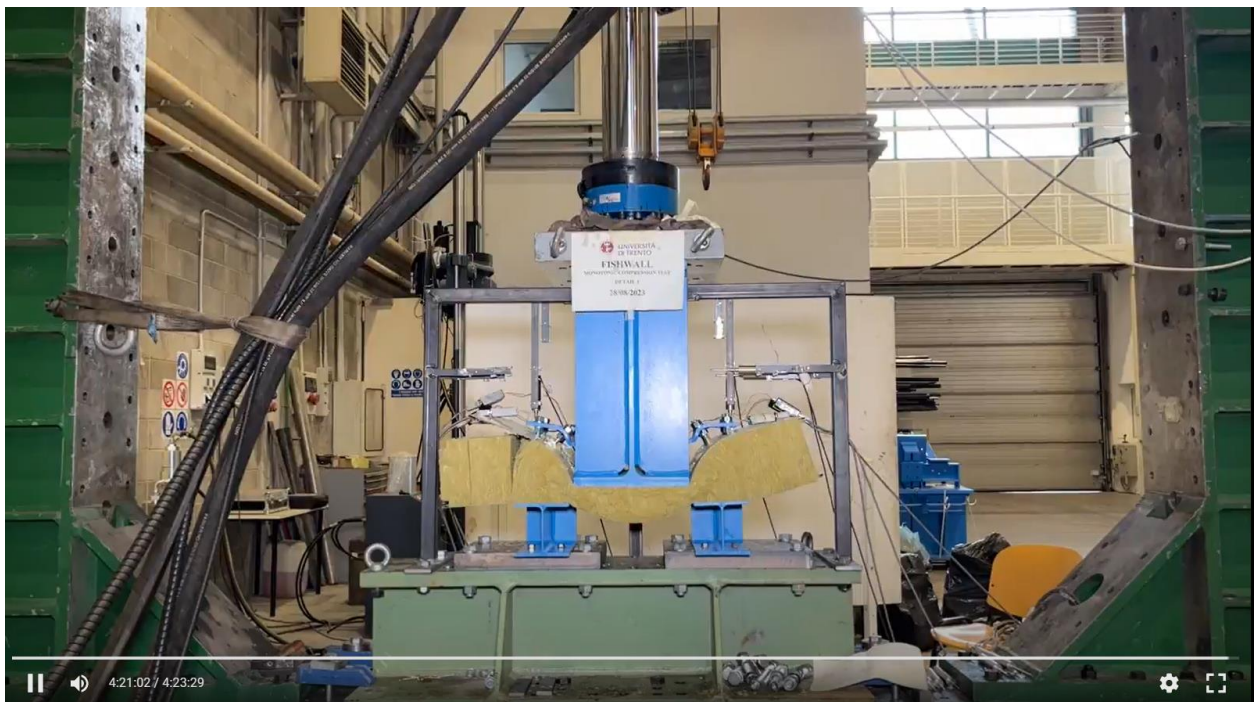
Figure A10. Detail 1 - compression test – deformation at failure

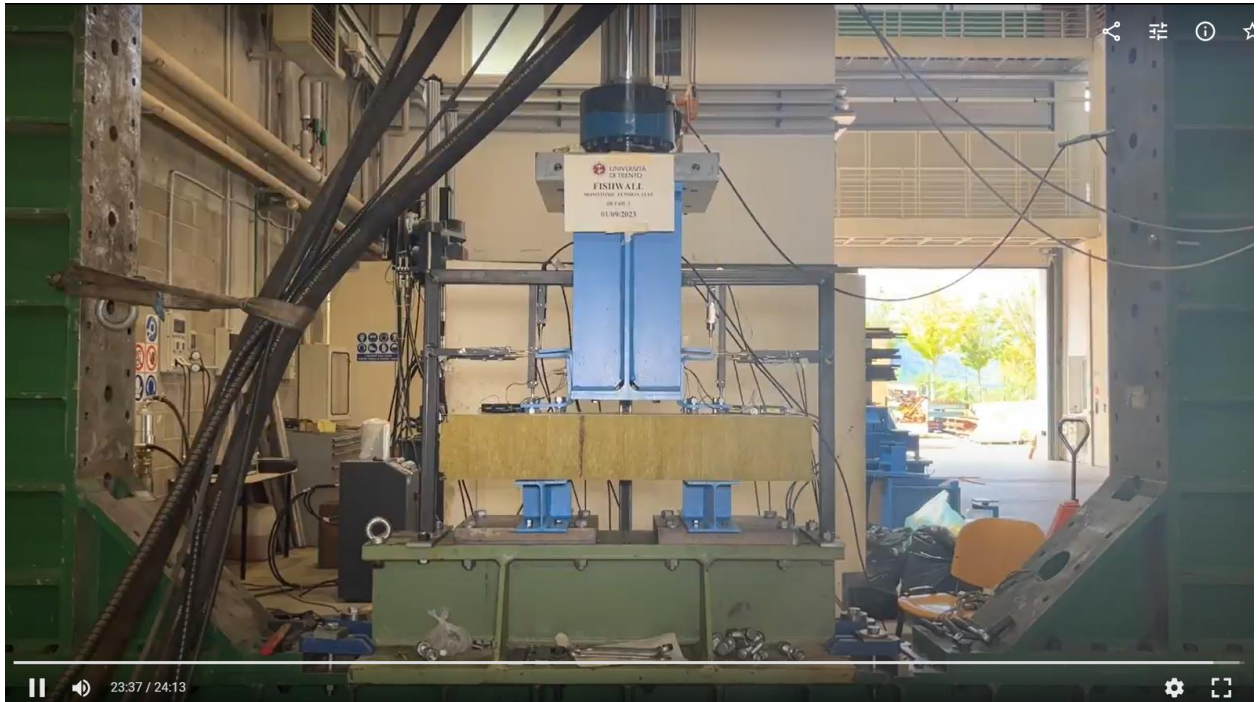
Figure A13. Detail 1 - tension test – deformation at failure.

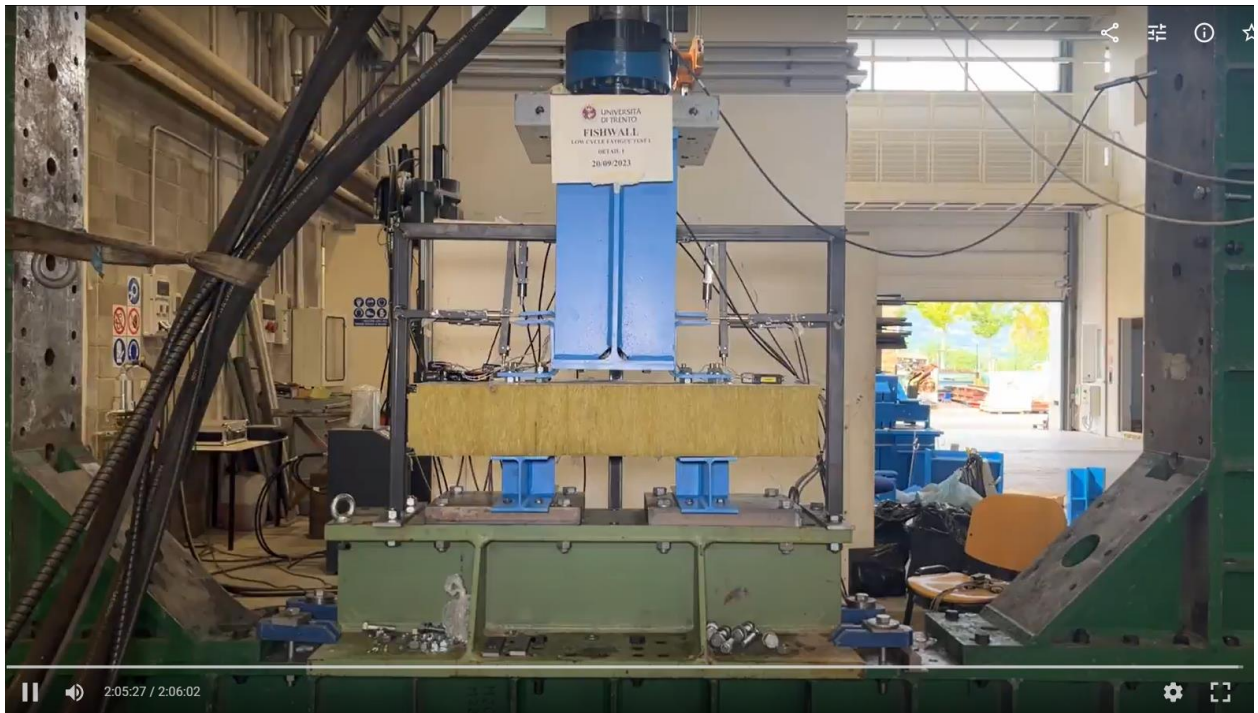
Figure A15. Detail 1 - cyclic test – deformation at failure

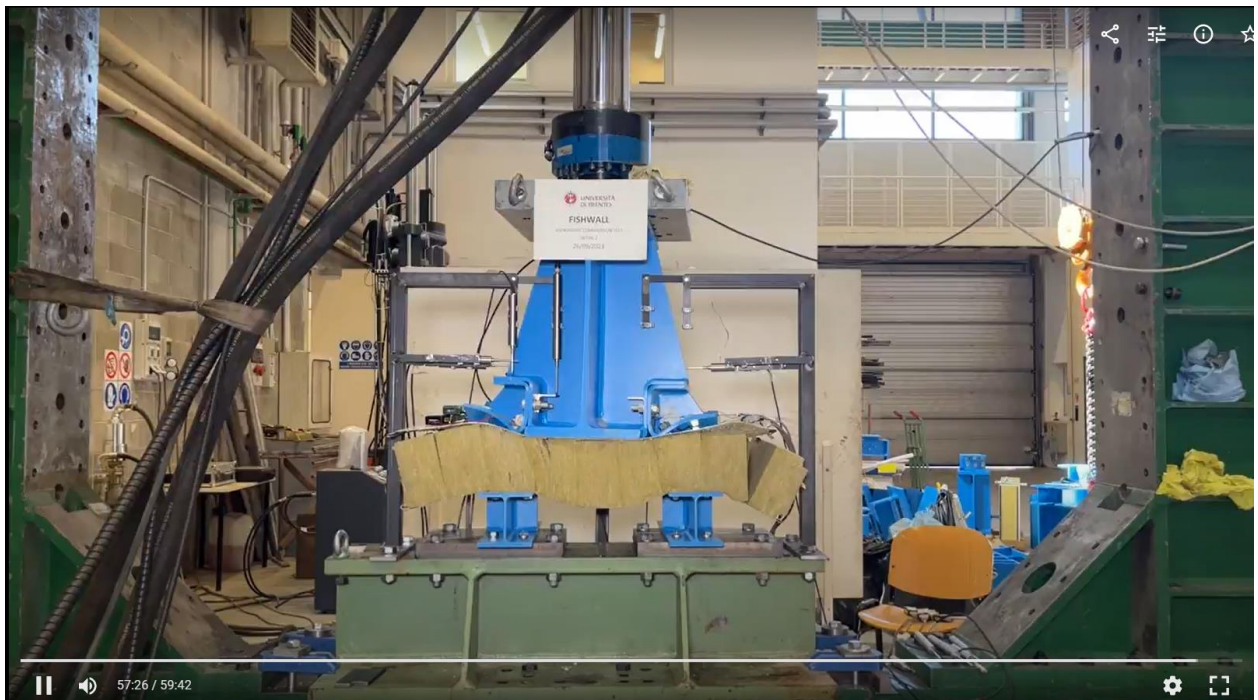
Figure A22. Detail 2 - compression test – deformation at failure.

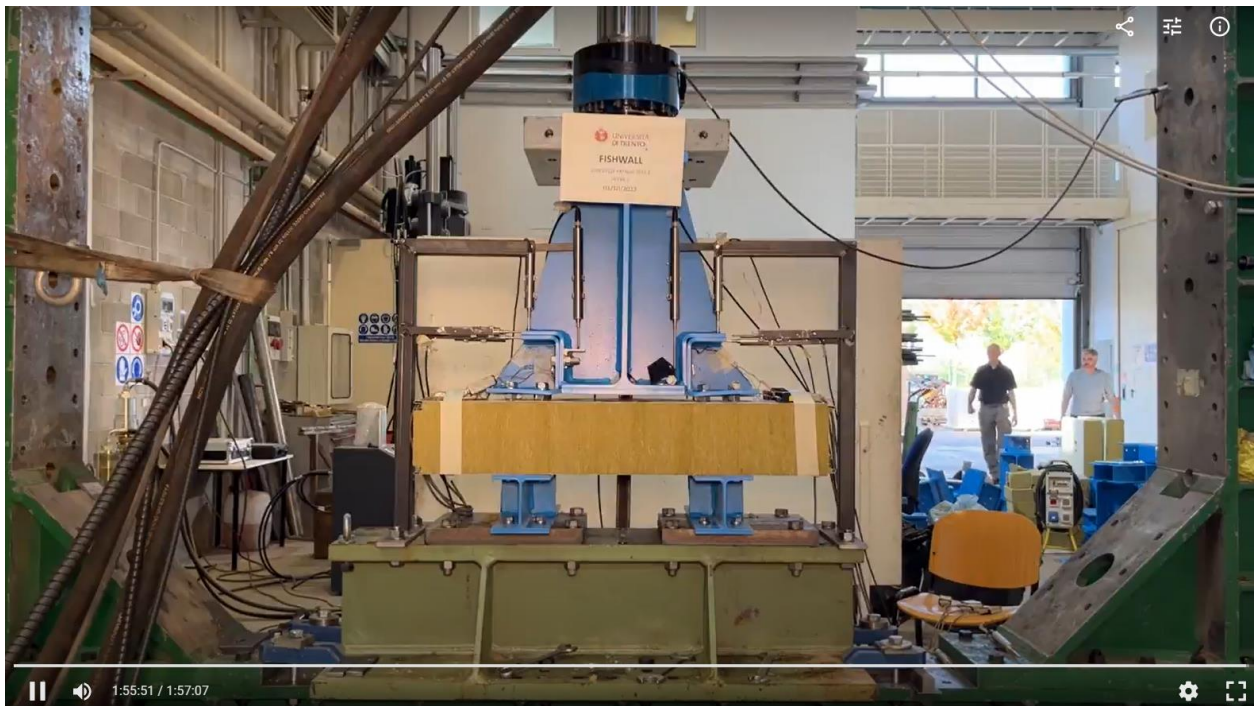
Figure A28. Detail 2 - cyclic test – deformation at failure.

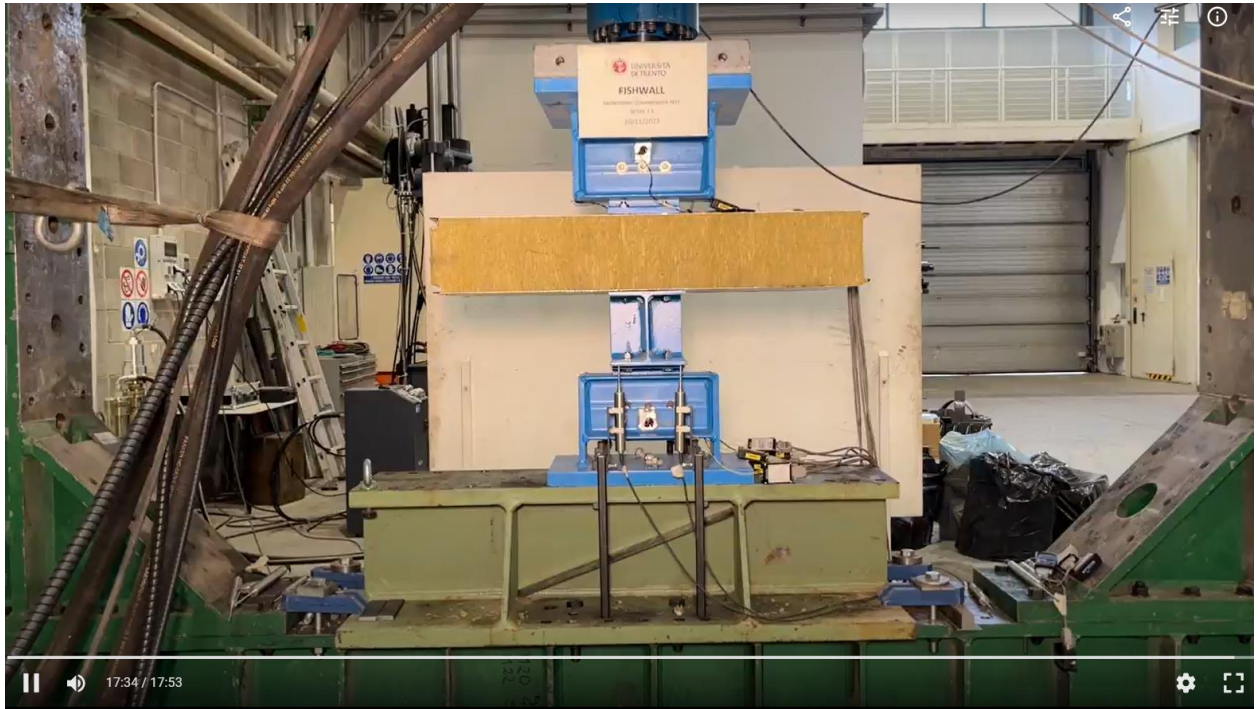
Figure A31. Detail 3.1 - compression test – deformation at failure.

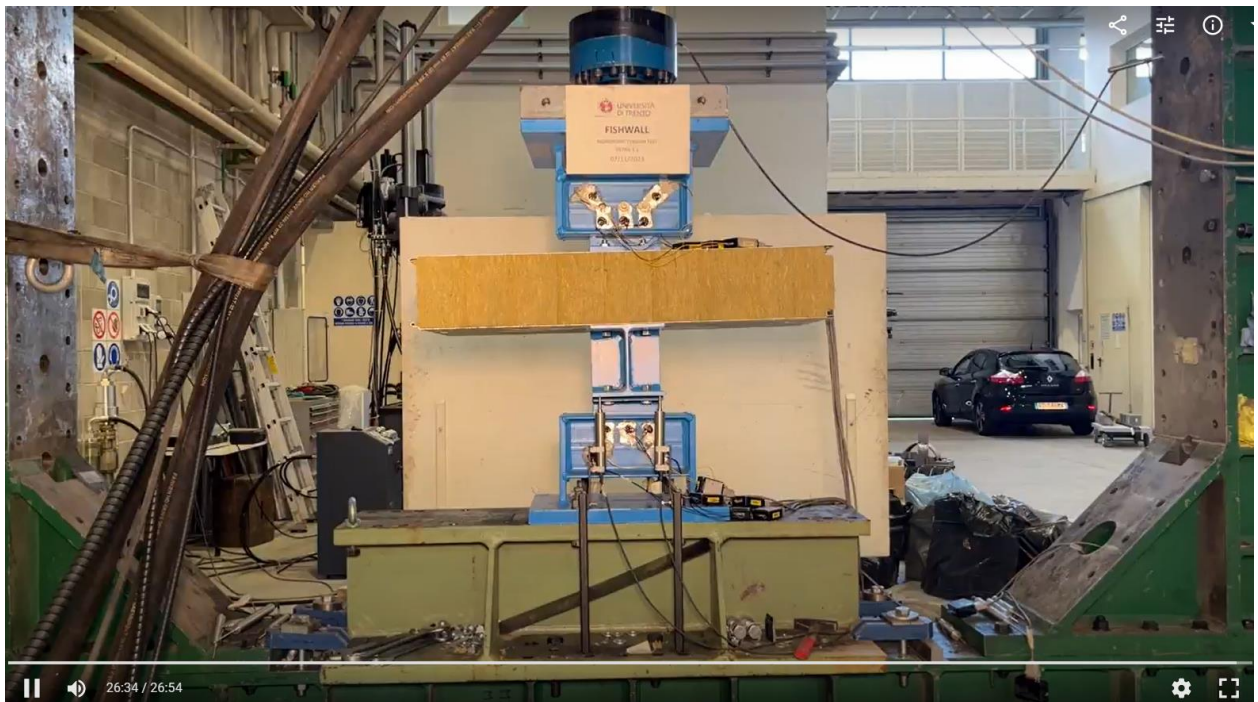
Figure A34. Detail 3.1 - tension test – deformation at failure.

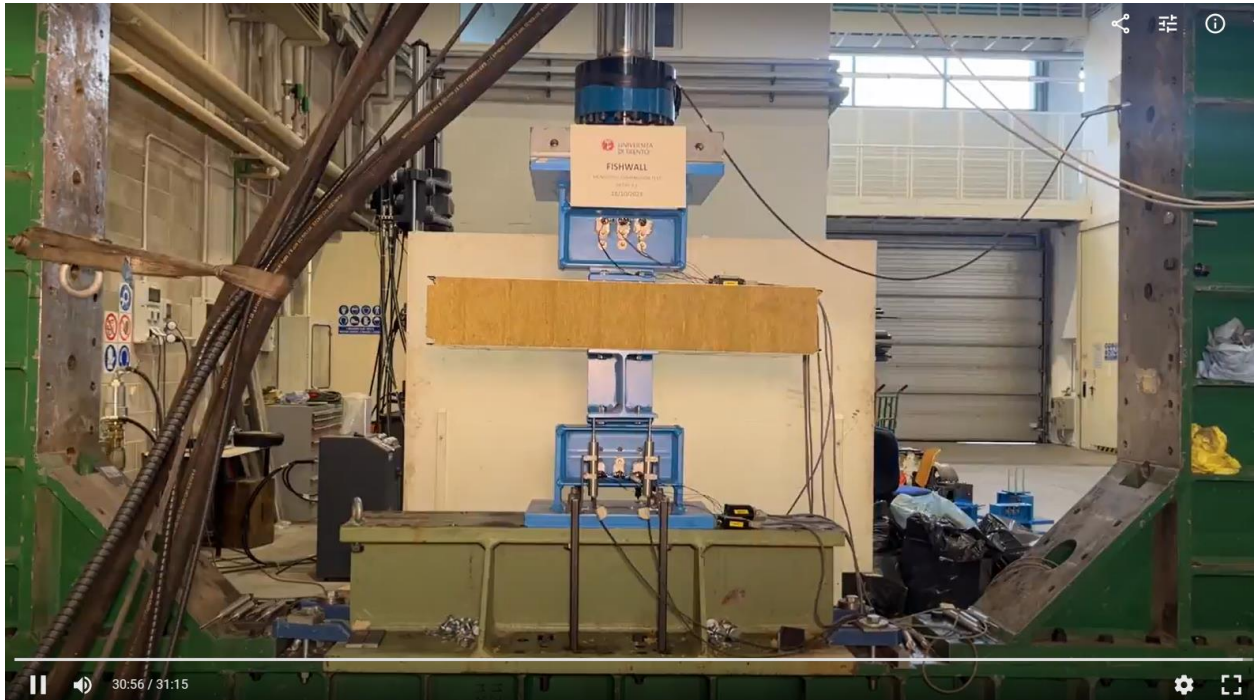
Figure A37. Detail 3.2 - compression test – deformation at failure.

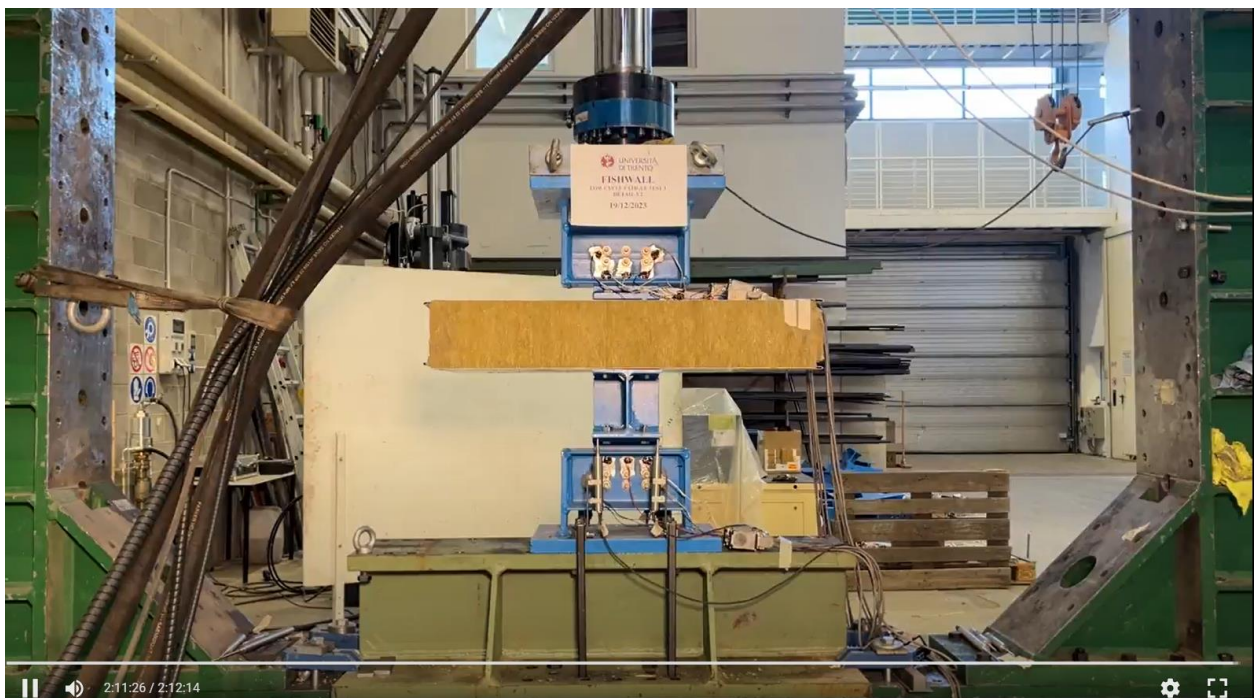
Figure A42. Detail 3.2 - cyclic test – deformation at failure.

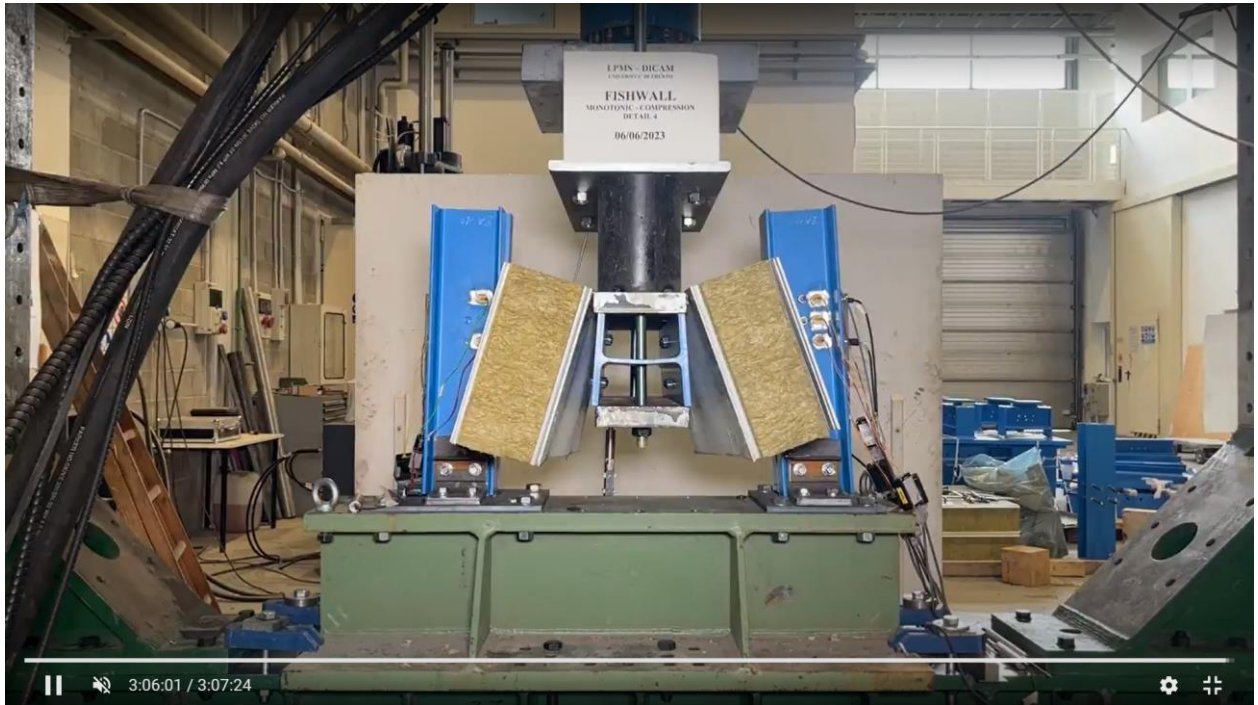
Figure A49. Detail 4 - compression test – deformation at failure

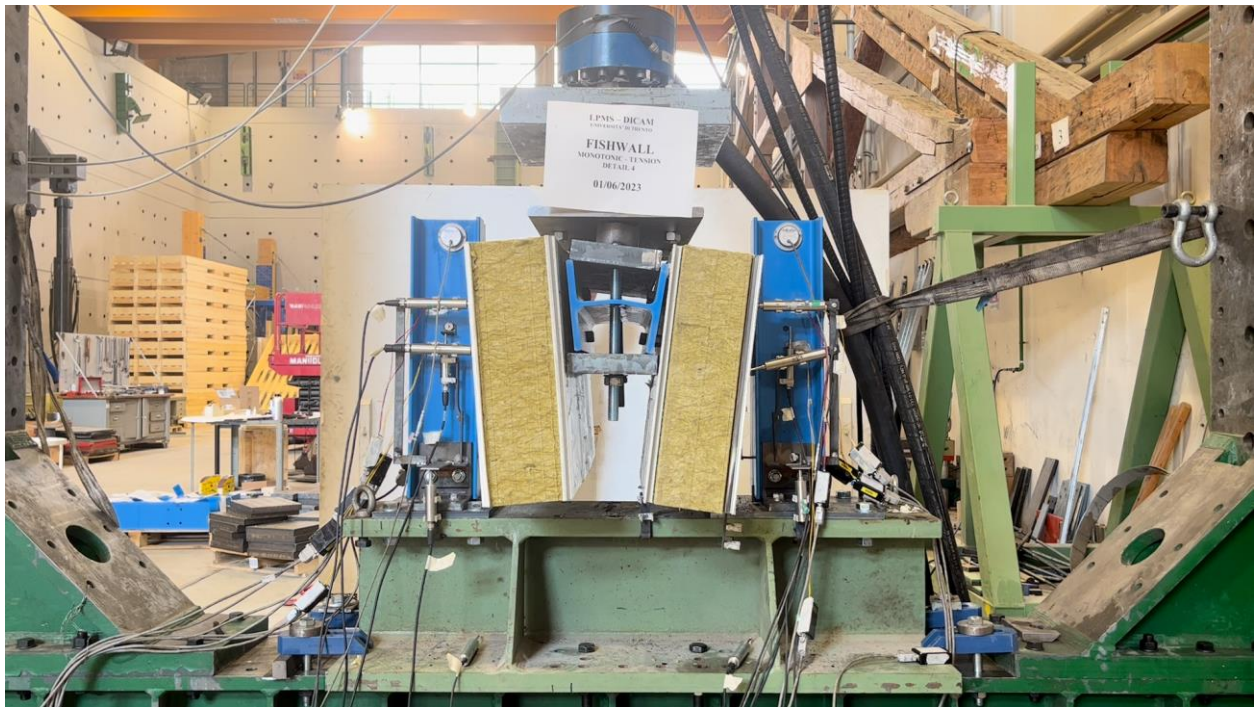
Figure A57. Detail 4 - tension test – deformation at failure.

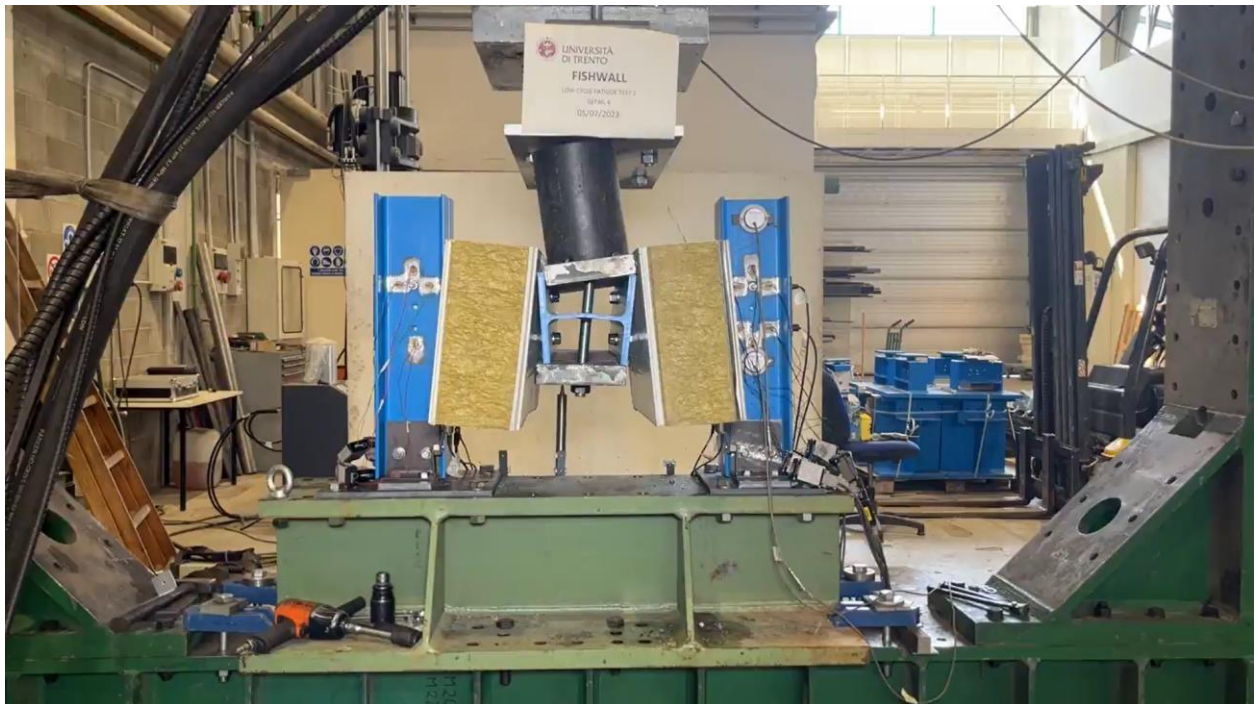
Figure A70. Detail 4 - cyclic test – deformation at failure

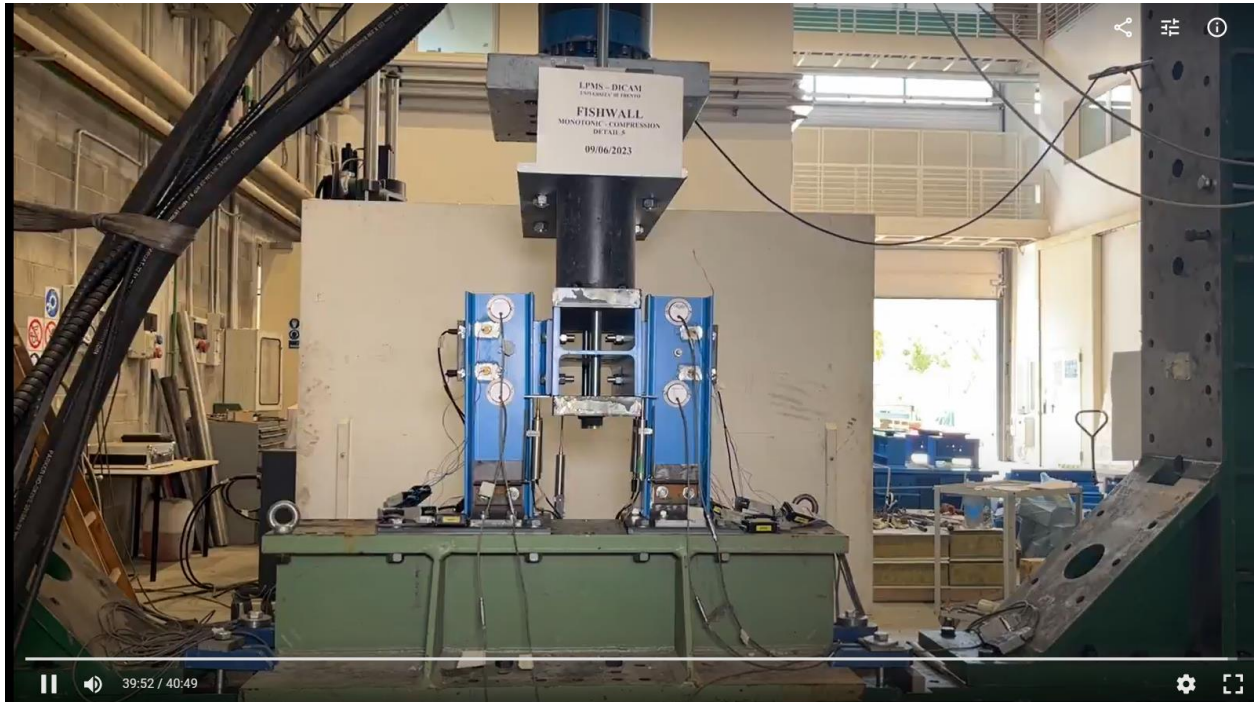
Figure A73. Detail 5 - compression test – deformation at failure.

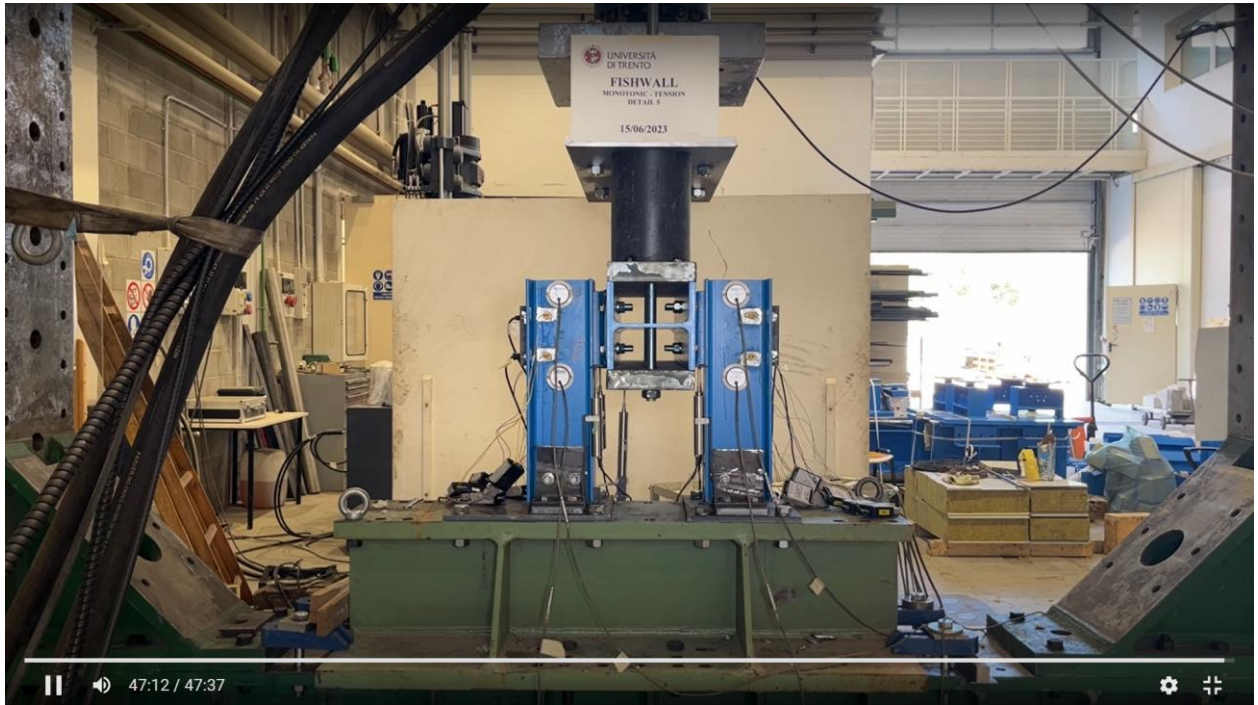
Figure A77. Detail 5 - tension test – deformation at failure.

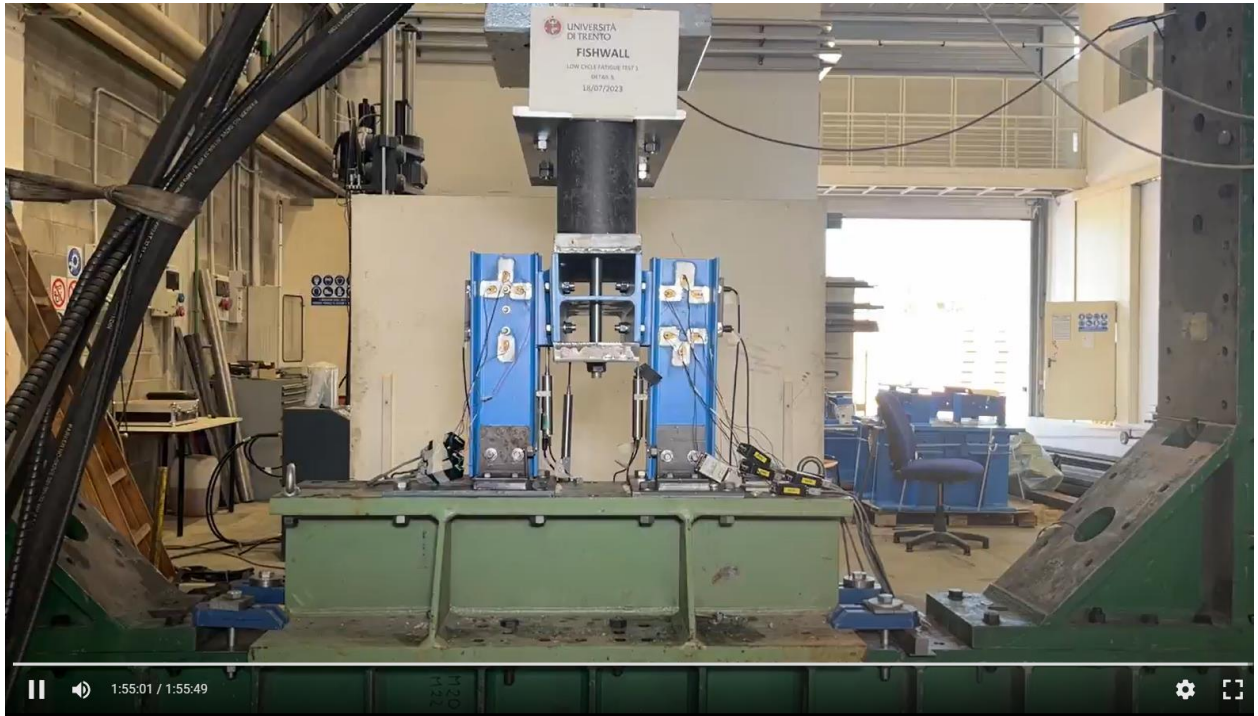
Figure A79. Detail 5 - cyclic test – deformation at failure.
