# FISHWALL

**Fire and Seismic performances of Hybrid fire WALLs in case of single-storey industrial and commercial steel buildings**

- **Title:** Sandwich panel fire wall with steel purlins penetration
- Jiri Vanek
- PAVUS, a.s.

**Fire wall connected to an unprotected steel  
structure and penetrated by steel purlins  
(Task 3.2)**

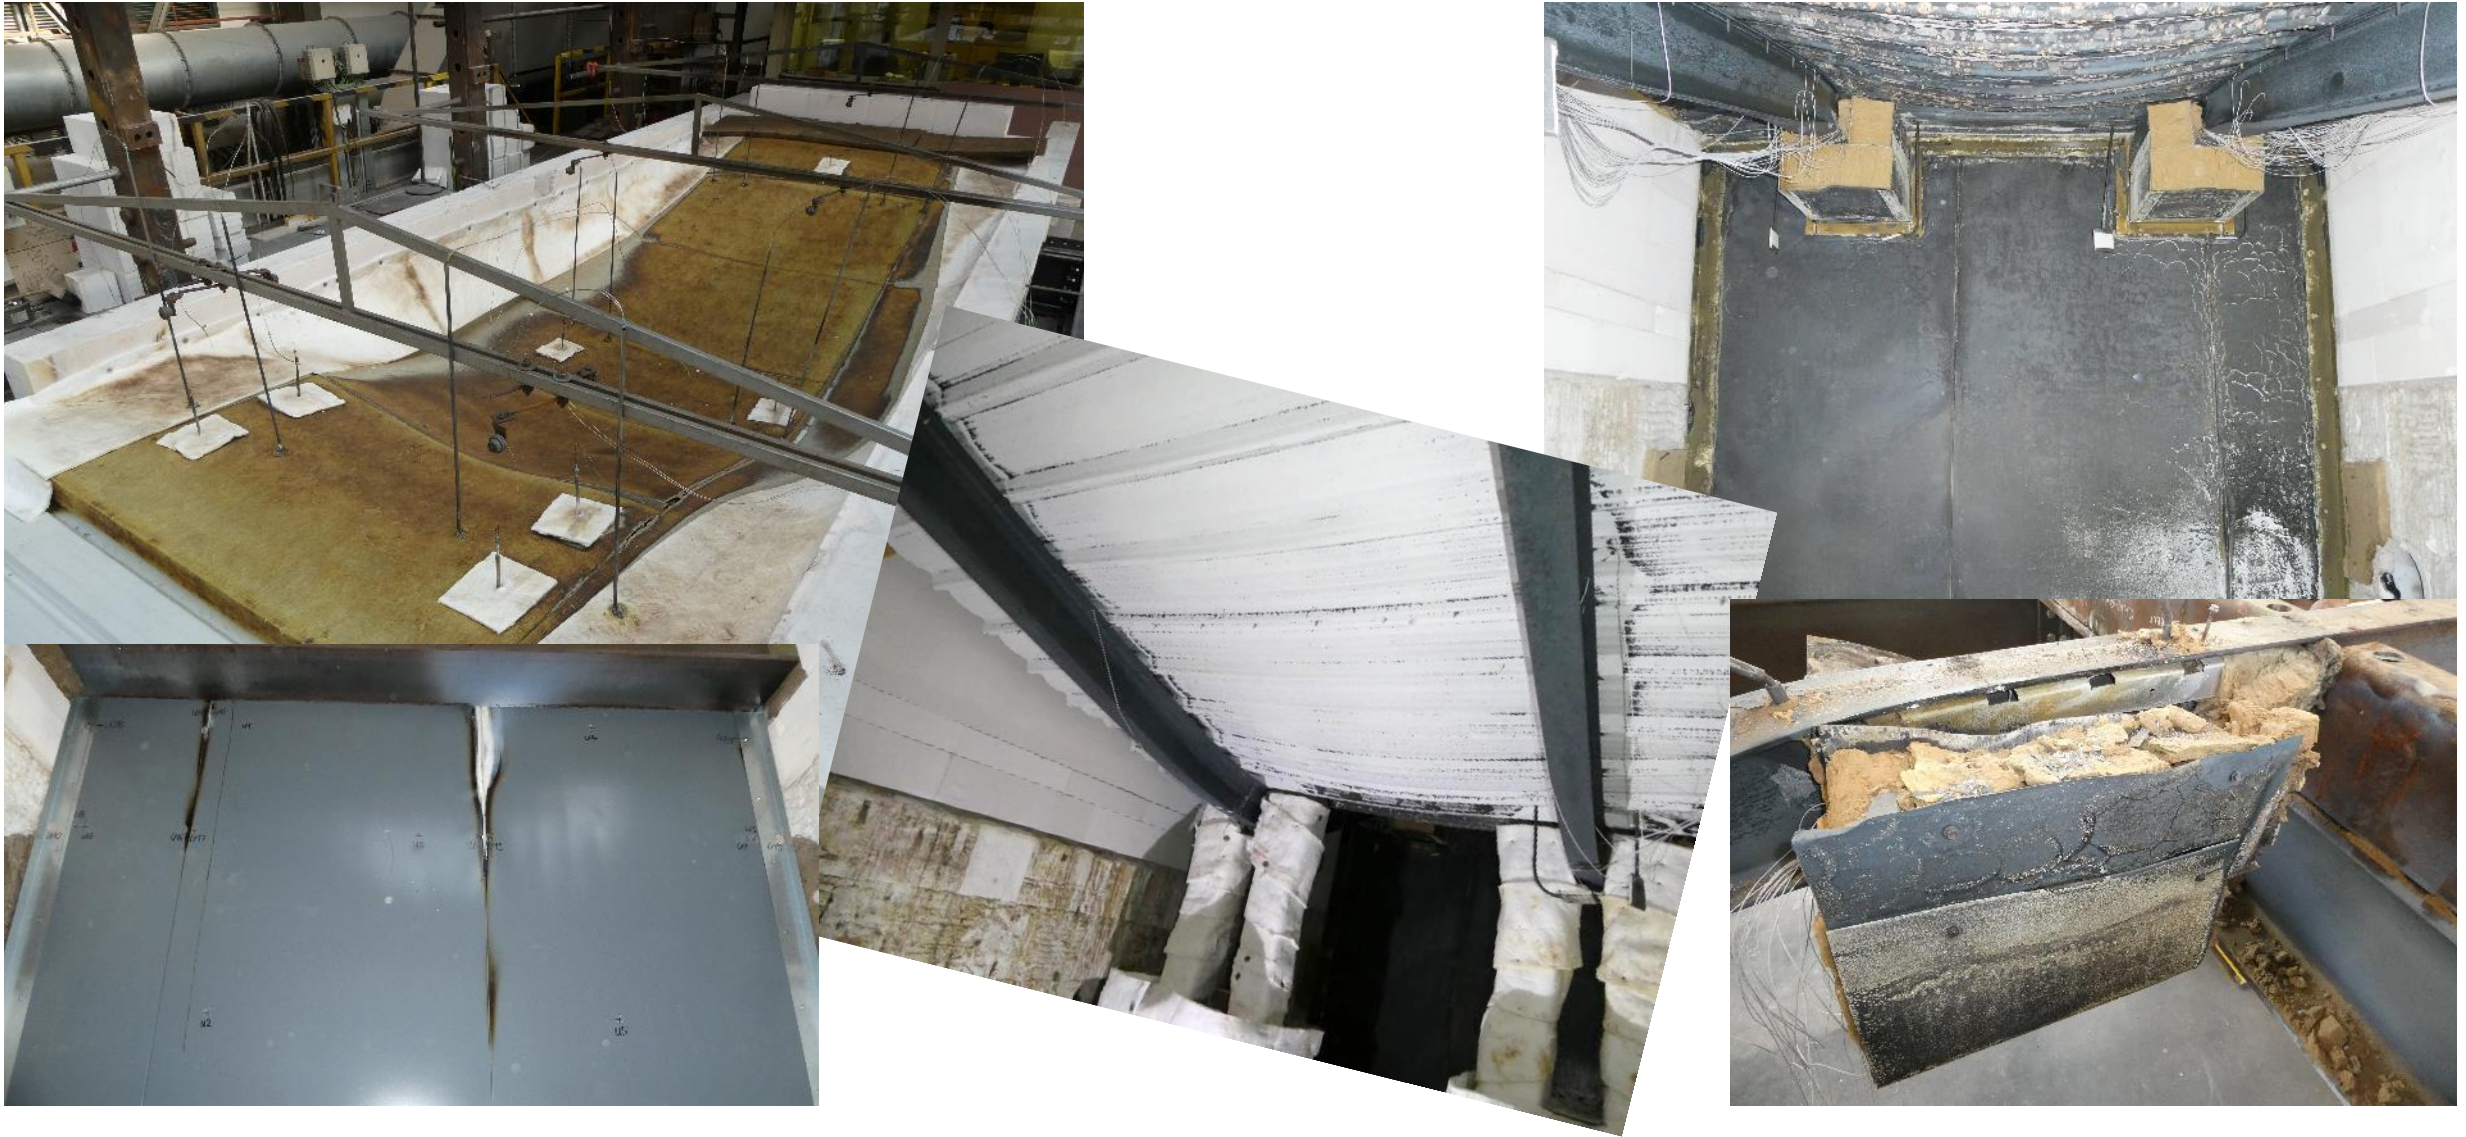
# Specimen after the test

The test results showed that the tested encasement system placed around purlins remained undamaged and was enable to avoid large wall damage in spite of the collapse of the heated steel purlins.

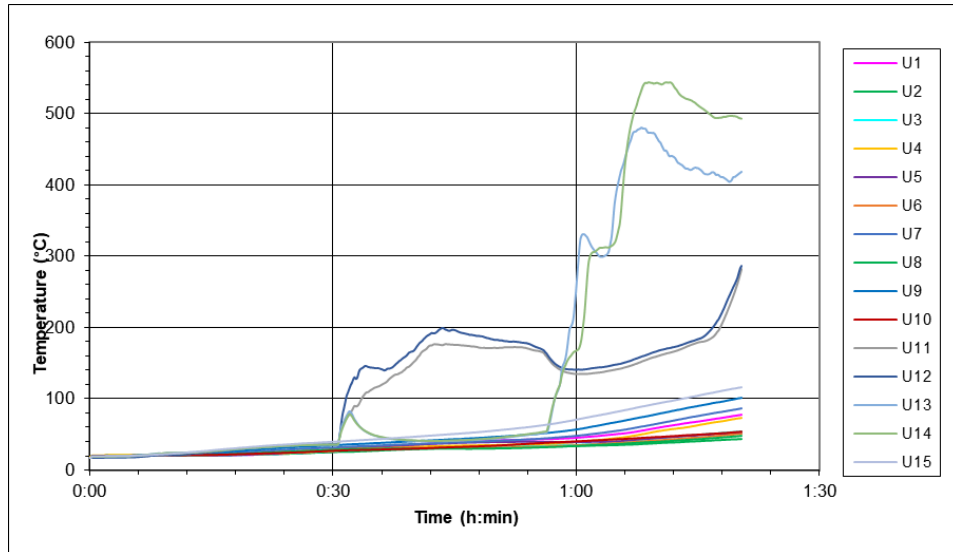
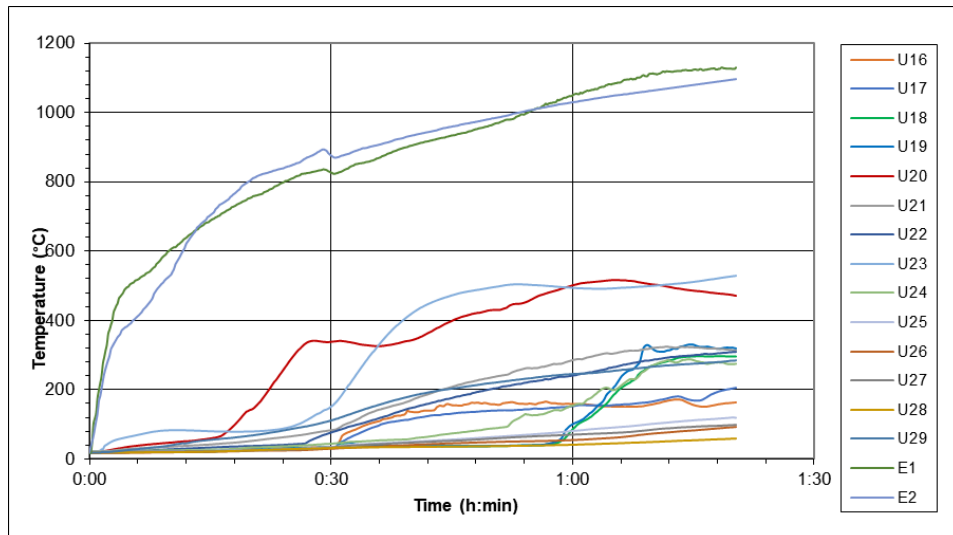
The temperature criteria related to the insulation performance of the wall was reached after 22 minutes on thermocouples U20 and U23. In 58<sup>th</sup> minute of the test there was integrity failure of the wall due to ignition of the cotton pad and sustained flaming in vertical joint by TCs U13, U14.
