# **Fire and Seismic performances of Hybrid fire WALLs in case of single-storey industrial and commercial steel buildings (FISHWALL)**

## **Fire test report on fire wall connected to an unprotected steel structure by means of fusible links**

### **WP3: Fire behaviour of a hybrid fire wall solution associated with unprotected steel structure**

#### **Deliverable: D3.3**

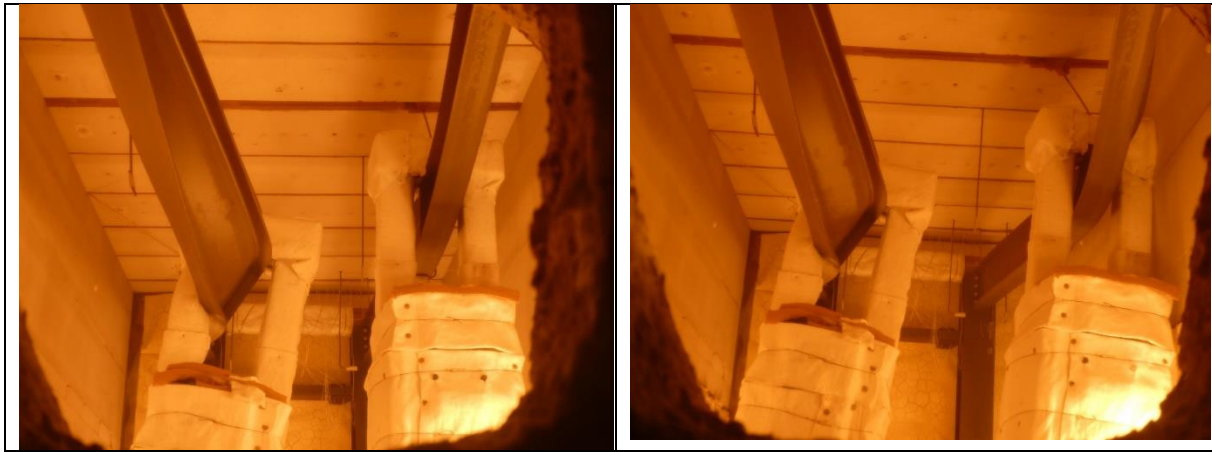
Figure 12: View of the test specimen during the test

As expected, the steel frames failed due to the lateral torsional buckling of beams under the combined effect of the applied mechanical load and the temperature rise (see Figure 12). The collapse of steel frames was not simultaneous, with one frame failing before the other: after 27 and 29 minutes of standard fire exposure, respectively.

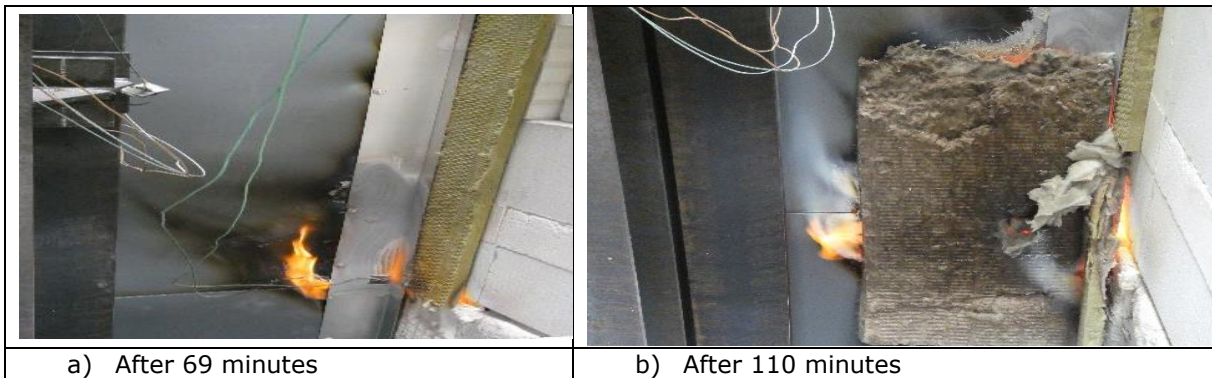
Figure 13: Sustained flaming of the vertical edge of the wall

However, it should be noted that the temperature criteria related to the insulation performance of the wall was reached after 18 minutes only, on a thermocouple placed in the upper corner of the wall. At 69th minute of the test, there was also integrity loss of the wall due to sustained flaming in the half of the wall's height, on one vertical edge (see Figure 13). This is mainly because the steel flashings placed on the edges of the wall could not be fixed to the furnace walls, therefore the sandwich panels were on vertical sides without fixing.
