Fire and Seismic performances of Hybrid fire WALLs in case of single-storey industrial and commercial steel buildings (FISHWALL)

Fire test report on a sliding steel framed door system built into a lightweight sandwich wall panel

Deliverable: D2.7

**Sliding steel framed door system
Novoferm Novoslide built into a lightweight
sandwich wall panels Eurobond Rainspan**

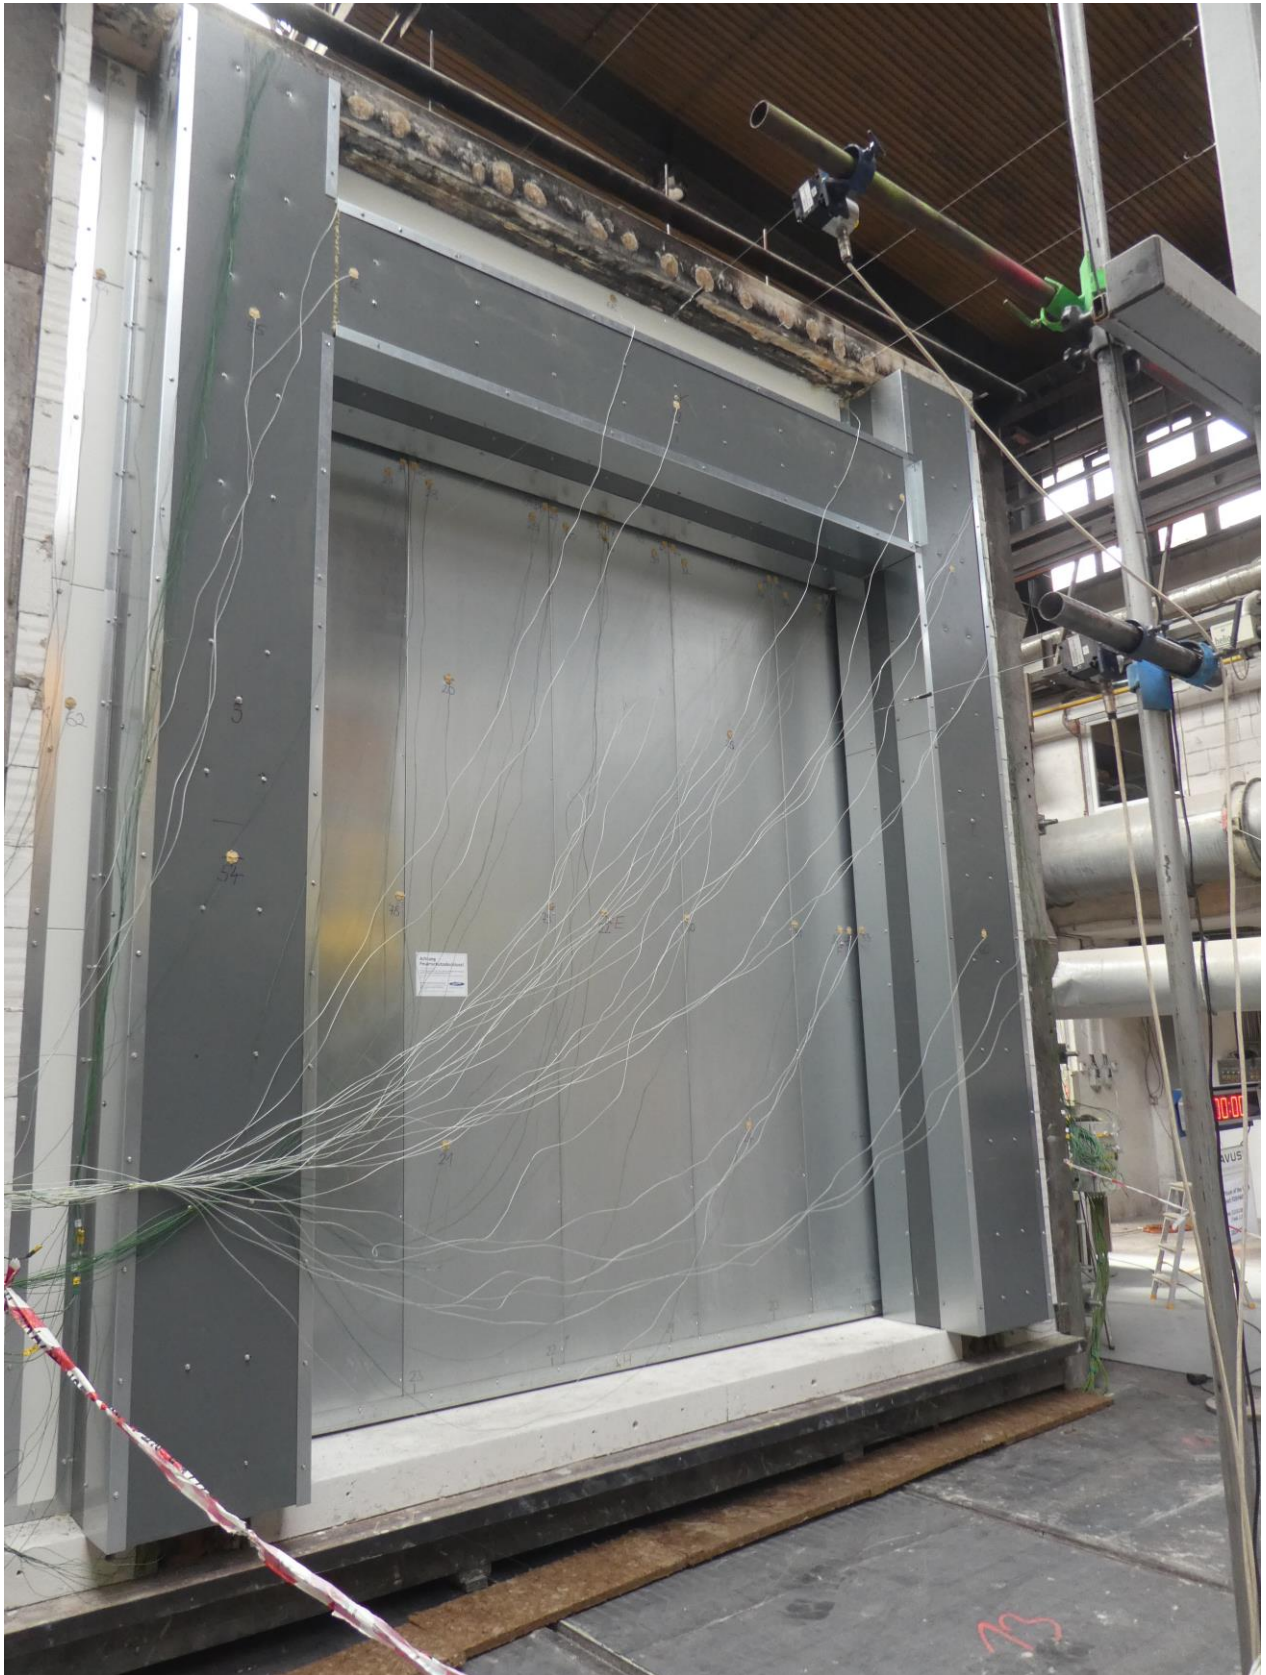
UF before the test

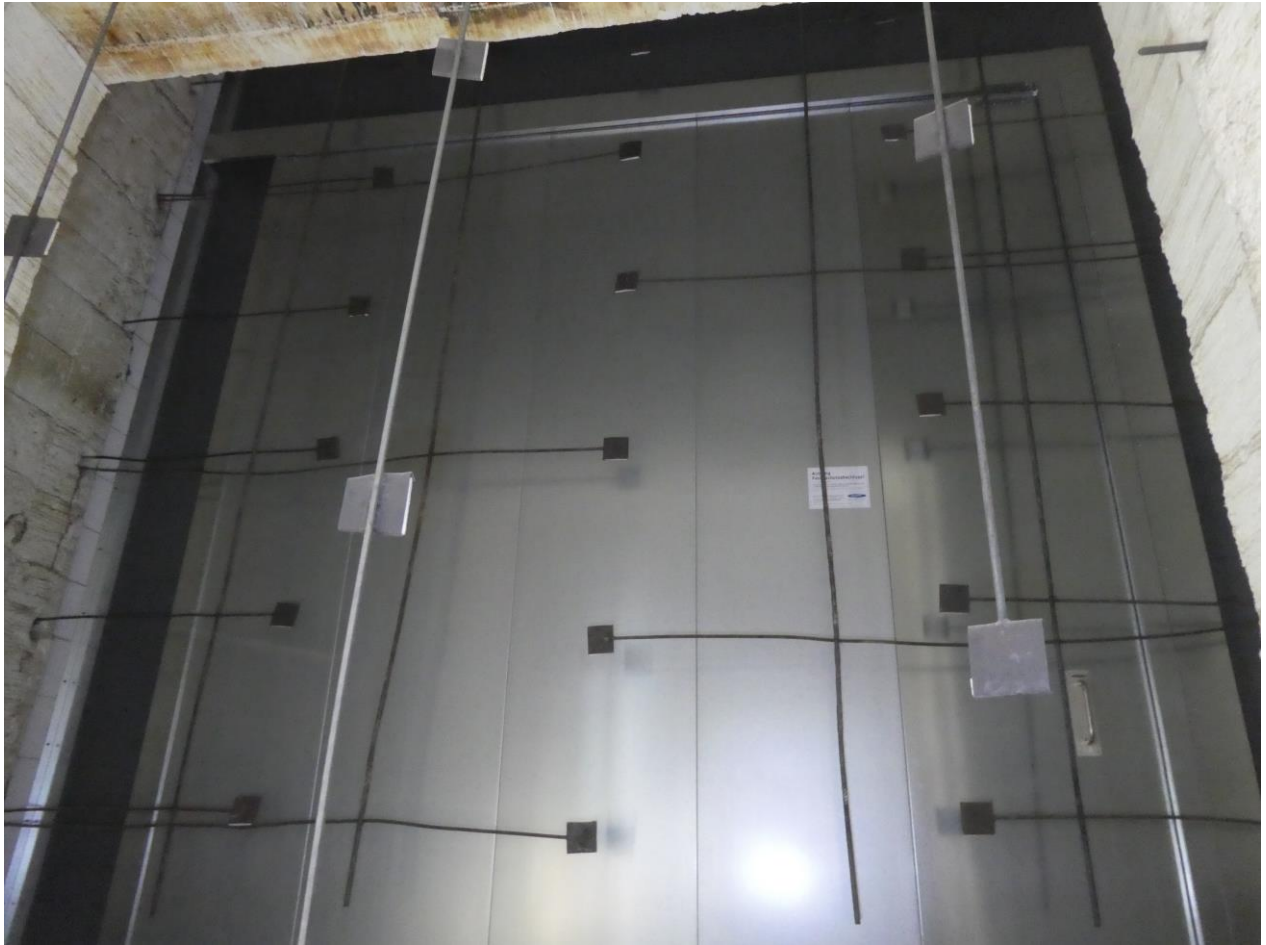
EF before the test

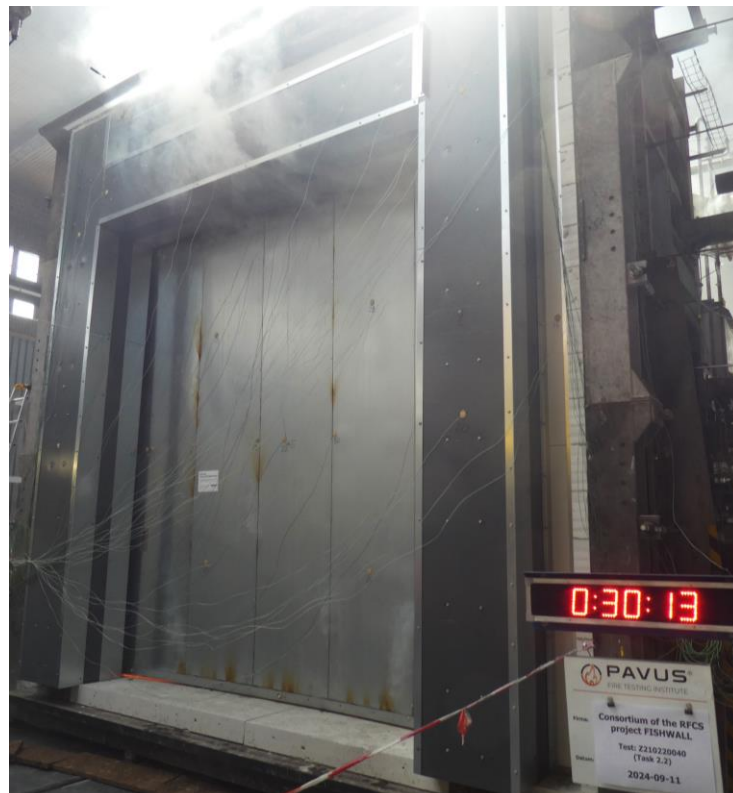
UF after 30 minutes of the test

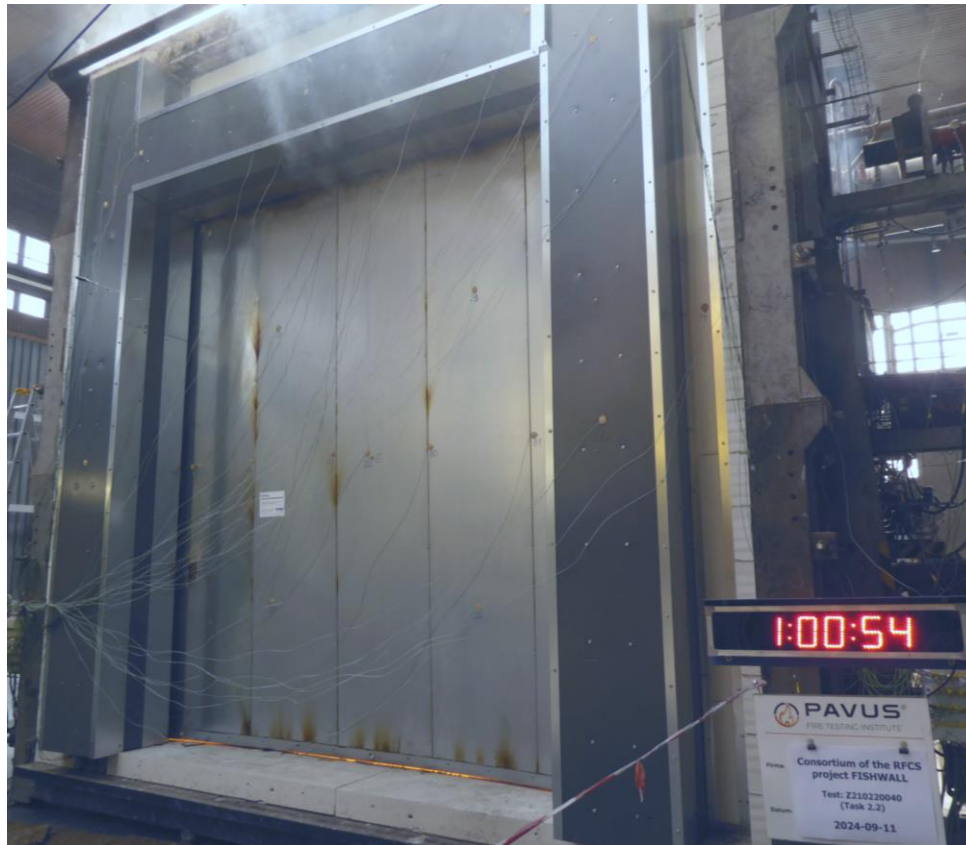
UF after 60 minutes of the test

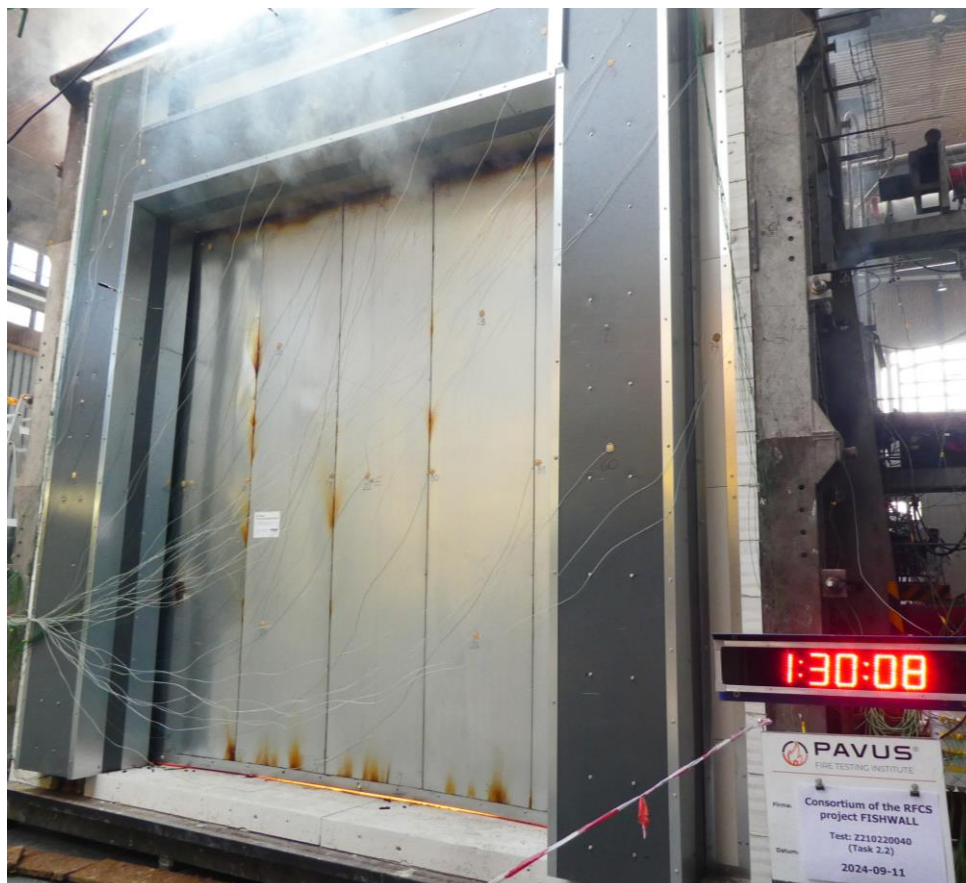
UF after 90 minutes of the test

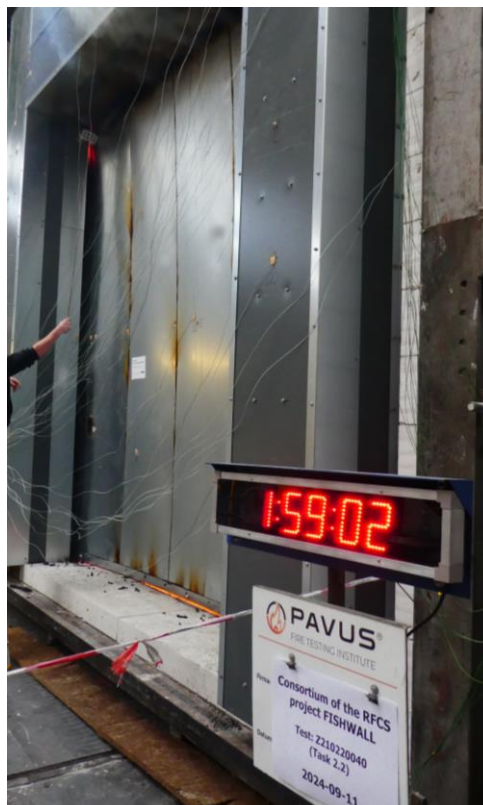
UF in 120th minute of the test

| 120. | UF - repeated cotton pad test nearby TC 38 - glowing of the pad - integrity failure |

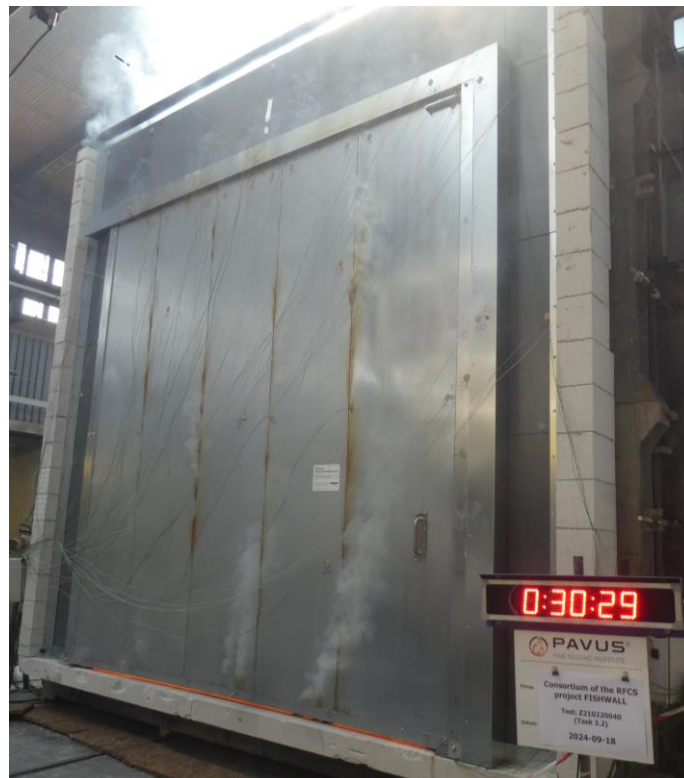
UF after 30 minutes of the test

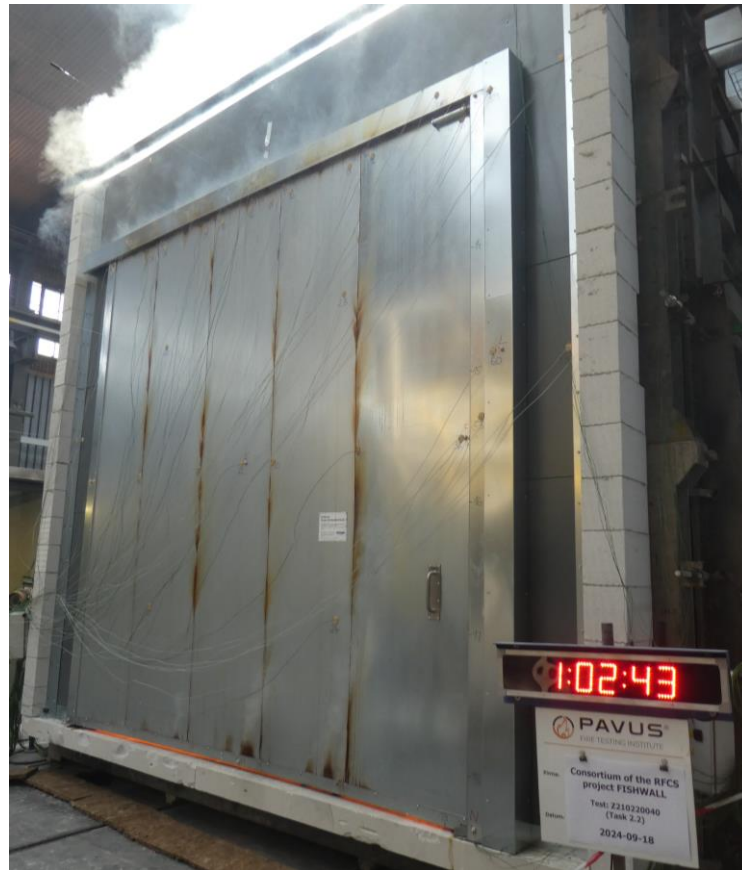
UF after 62 minutes of the test

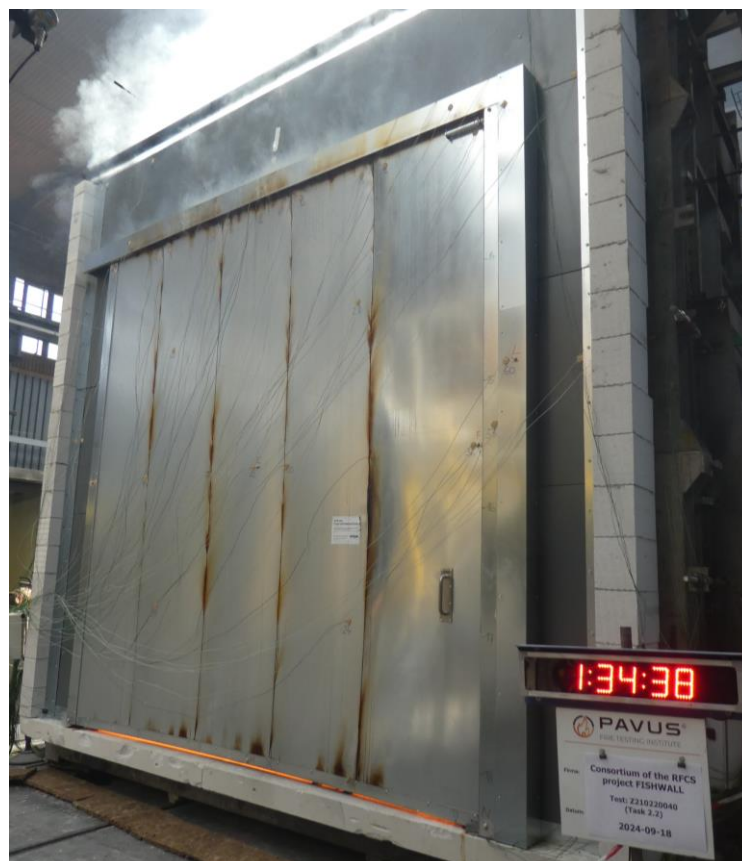
UF after 94 minutes of the test

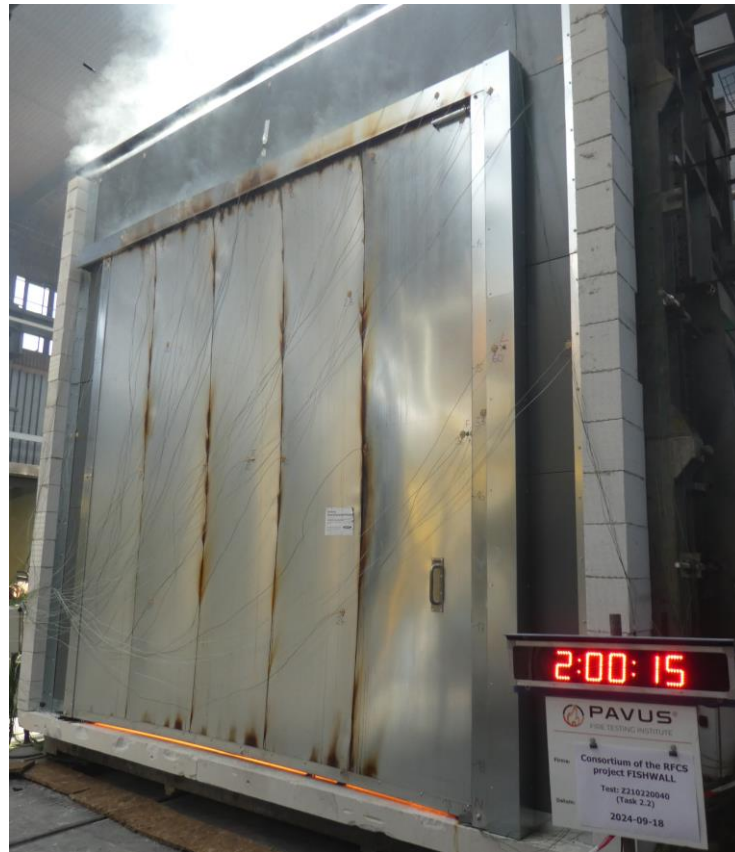
UF after 120 minutes of the test

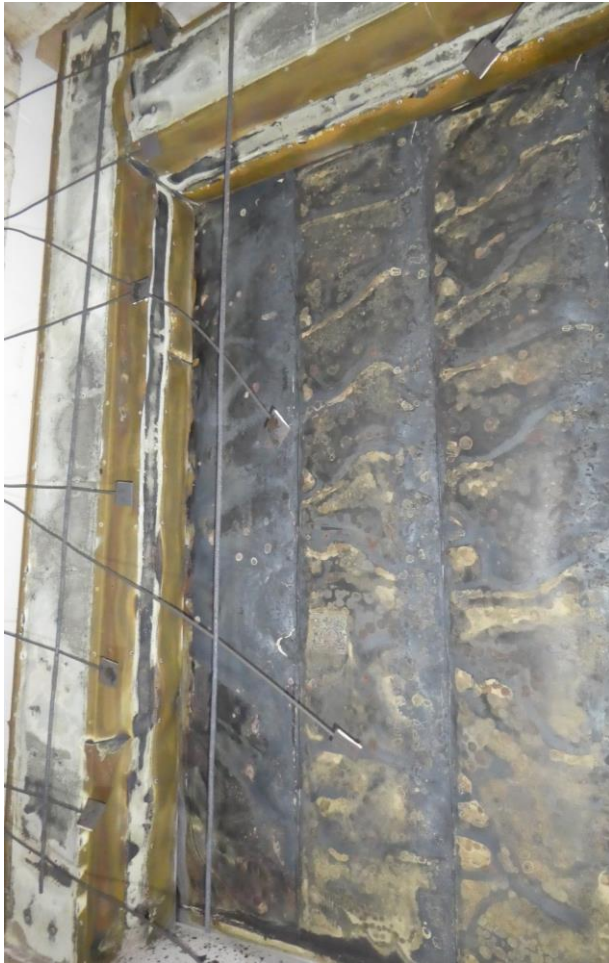
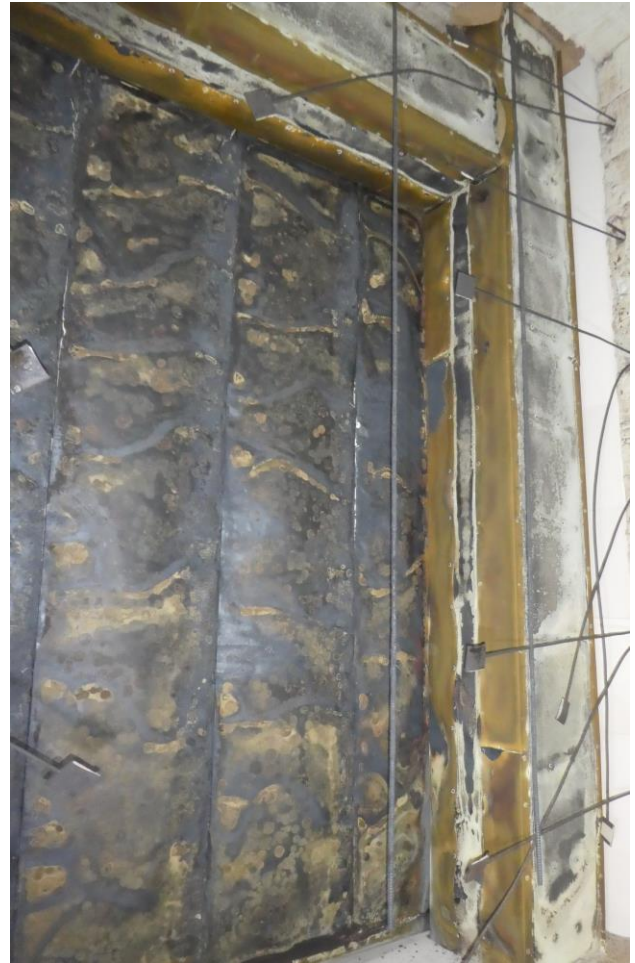
Specimen the second day after the test
